**AVIATION INVESTIGATION REPORT
A11W0151**

CONTROLLED FLIGHT INTO TERRAIN

**AIR TINDI LTD.
CESSNA 208B CARAVAN, C-GATV
LUTSEL K'E, NORTHWEST TERRITORIES, 26 NM W
04 OCTOBER 2011**

Report Number A11W0151

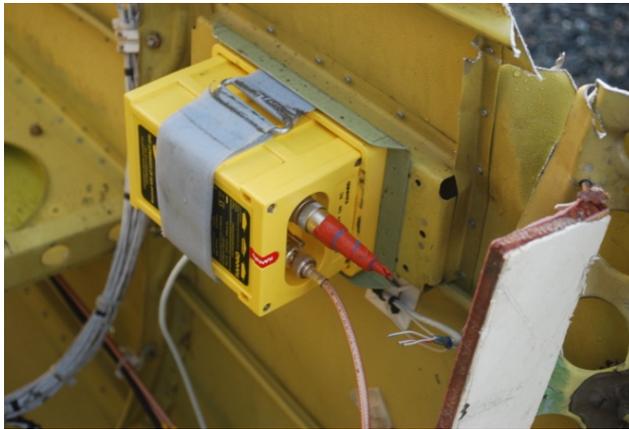
The ELT had been mounted in the aircraft on the upper right hand-side wall of the tail section, immediately behind the cargo bay. The mounting system consists of a rectangular composite tray affixed to the aircraft. The ELT rests within a raised box structure around the perimeter of the mounting tray, and is secured by a fabric strap featuring a hook and loop (Velcro) system. When the strap is tight, the ELT is firmly held in the mounting tray box (Photo 1).

Photo 1. Mounted ELT in C-GATV

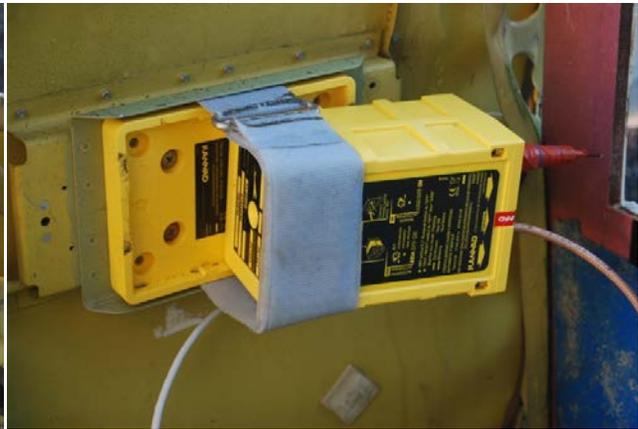
Photo 2. ELT sliding under loose strap

Field examination of the ELT and mounting bracket in C-GATV revealed that the retention strap was loosely fastened and that it was possible to slide the ELT under the strap and back into its mount (Photo 2). The unit could easily be removed in the same manner. After adjusting the strap by shortening it $\frac{3}{4}$ inch, the strap was tight around the ELT, which was then firmly secured in the bracket. The ELT then could not be manually removed without loosening the strap.

Instructions in the installation manual,¹⁹ directed installers to align the strap buckle with the centre line of the unit, and to “Fasten the self-stripping strap tightly.” There was no further definition of the degree of strap tightness required to adequately retain the ELT in the mounting tray.

Due to a loosely fastened hook and loop retention strap on the ELT installation, the ELT was ejected from its mounting tray during the impact. Since instructions do not describe a method for determining the required degree of tightness to retain the ELT in its mount, the installer's own judgement is relied upon to determine this. As a result, a wide variation in the quality of installation of ELTs that are retained by this method could increase the possibility of inadequate retention. In this accident, in the absence of a transmitted 406 MHz signal, the on-board GPS-based flight-following equipment (SkyTrac) was effective in directing the search party to the accident site and reduced the time for the search and rescue of the survivors.

1. Installation instructions for the ELT did not provide a means of determining the necessary degree of strap tightness to prevent the ELT from being ejected from its mount during an accident. Resultant damages to the ELT and antenna connections could preclude transmission of an effective signal, affecting search and rescue of the aircraft and occupants.
2. Flying beyond gliding distance of land without personal floatation devices on board exposes the occupants to hypothermia and/or drowning in the event of a ditching.

The TSB promulgated *Safety Advisory 825-A11W0151-D1-A1, Loose Attachment of Kannad 406 AF-Compact (ER) ELT*, dated 19 April 2012. This advisory indicated that Transport Canada may wish to inform owners, operators and maintainers of aircraft with ELTs featuring fabric hook and loop retention systems of the necessity to ensure adequate retention of the ELT in the event of an accident.

On 12 June 2012, Kannad Aviation (Orolia Group) issued Service Bulletin S1800000-25-04 that outlines the instructions for properly securing the ELT during installation and reinstallation and the instructions for inspecting fasteners of mounting brackets; it also defines the replacement interval for the mounting bracket fasteners.

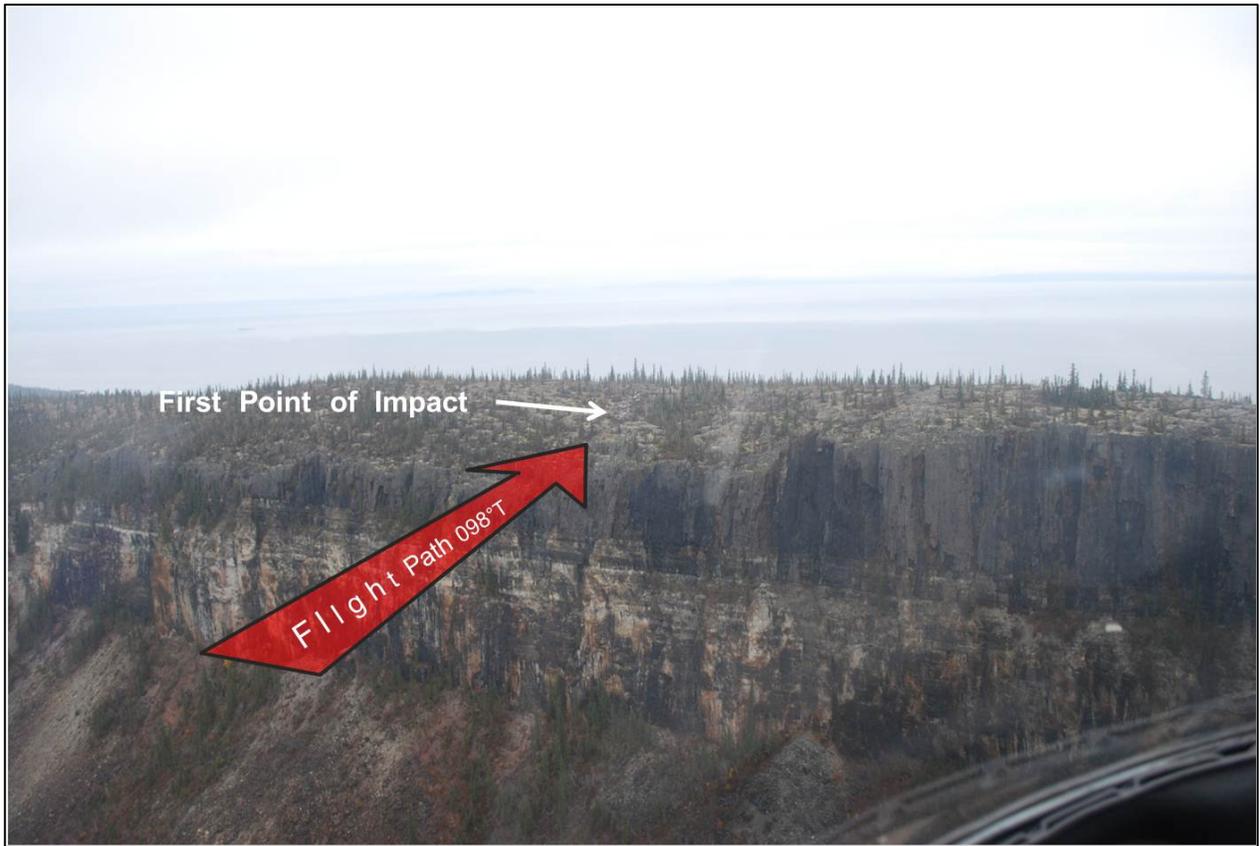
Appendix B - Impact Point on Pehtei Peninsula

The first point of impact was at an elevation of 1013 feet asl, 38 feet below the top of the peninsula, and 20 feet above the face of a vertical cliff. As indicated by light wing strikes on tree-tops and ground scars, the aircraft was in a nearly level attitude in pitch and roll. First ground impact was by the landing gear, followed by the belly cargo pod and the propeller, all of which separated from the aircraft at this point. The aircraft continued up a 10° slope over the top of the hill, became airborne, and came to rest inverted 477 feet down the eastern slope of the peninsula. The cockpit was crushed, and the forward passenger cabin was distorted, with the forward cabin bulkhead mostly dislodged from its attachments. The left wing had folded back, and rested on the ceiling of the cabin.

The conduct of the flight and the nature of the impact were characteristic of a CFIT event: the aircraft struck rising terrain under the pilot's control at cruise speed, with a wings-level attitude and a heading generally consistent with the direct track to the destination. Because no effective evasive manoeuvres were made before impact, it is likely that the crest of the Pehte Peninsula was obscured in fog, and not visible to the pilot. The application of increased engine power immediately before impact was likely made when the terrain in front of the aircraft suddenly became visible.
