AVIATION INVESTIGATION REPORT
A12P0079

**LOSS OF VISUAL REFERENCE AND COLLISION WITH
TERRAIN**

**BAILEY HELICOPTERS LIMITED
EUROCOPTER AS350-B2 (HELICOPTER), C-FBHN
TERRACE, BRITISH COLUMBIA 14 NM W
01 JUNE 2012**

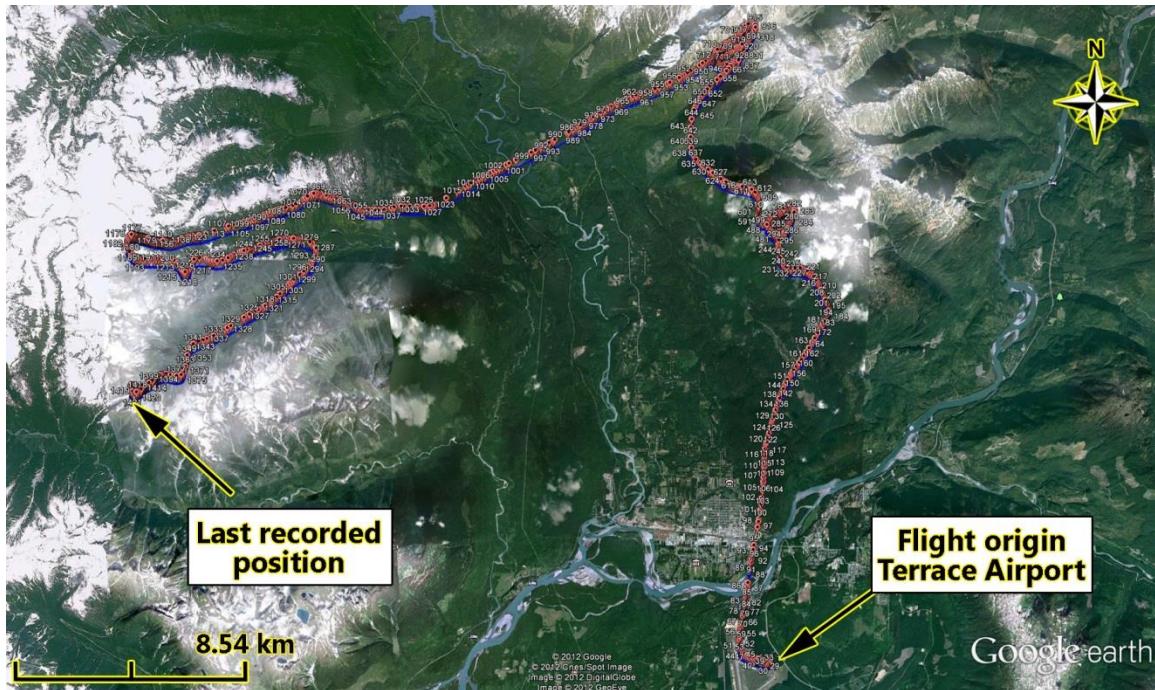
The helicopter was climbing at about 1000 feet per minute (fpm) until it quickly levelled off at about 4500 feet asl and 45 knots ground speed. It commenced a right-hand turn near the top end of the ravine. As the helicopter turned, it maintained 4500 feet for about 9 seconds before it began descending at an accelerating rate, with increasing ground speed and tightening radius of turn. Recovered data recorded at 1-second intervals showed that the helicopter completed a turn of about 285° in 25 seconds and descended the last 220 feet to the accident site in 3 seconds (4400 fpm). It struck the 30°-inclined snow-covered slope in a slightly left-of-centre, frontal collision at about 4000 feet asl (54.563° N, 128.933° W) at 0841.

Figure 1. Plot of GPS data from the occurrence flight (image: Google Earth)
