## **AVIATION INVESTIGATION REPORT A12P0134**

### **ENGINE POWER LOSS AND DITCHING**

**HELIJET INTERNATIONAL INC.  
SIKORSKY S-76A (HELICOPTER), C-GHJT  
LANGARA ISLAND, BRITISH COLUMBIA  
13 AUGUST 2012**

Report Number A12P0134

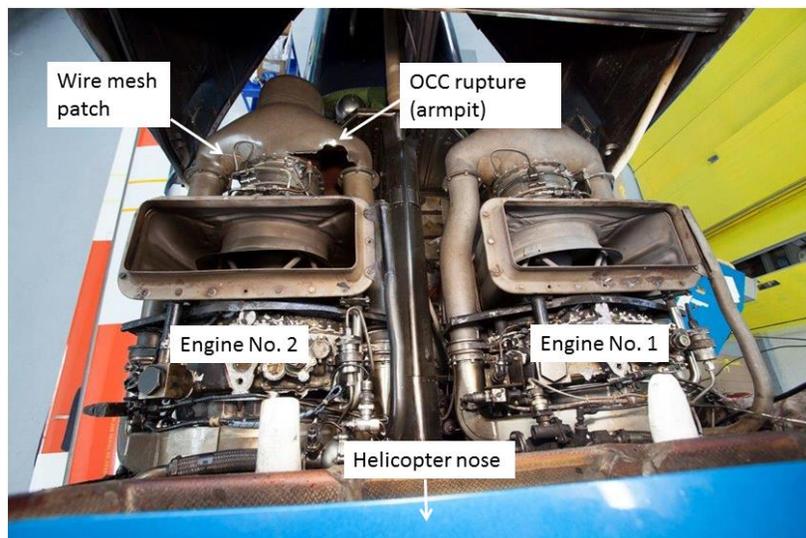
A preliminary examination of the engine during retrieval from the water revealed that the No. 2 engine (starboard) had experienced a catastrophic failure of the outer combustion case (OCC). Photo 1 shows the damage to the No. 2 OCC.

**Photo 1.** Engine No. 2 combustion case damage

- The rupture of the OCC occurred in the left-side armpit; it was the result of an overstress extension of a pre-existing fatigue crack when this crack had grown to a critical length.

- The main fatigue crack was formed by merging small cracks initiating from numerous separate points along the inside and outside surfaces of the horizontal butt weld and surrounding areas.

- Two other small cracks were observed in the left-side armpit. One fatigue crack was located at the circumferential seam weld under the gas producer attachment flange. This crack eventually merged with the main fatigue crack via an overstress crack. The other crack was parallel to the main crack on the other side of the horizontal butt weld.

- Two short cracks were also found in the right-side armpit region.
- The fatigue cracking was driven by pressure cycles (engine start-stop cycles) in the OCC as part of normal engine operation. The fatigue cracks were located under the reinforcing wire mesh patches, which made the cracks difficult to detect at the initial formation stage.

- At the main fatigue crack location, the OCC skin was thinner than elsewhere, and its thickness was below the minimum specified value for the skin wall thickness. It is likely that the thin areas facilitated fatigue cracking.

The cracks in the OCC likely started because thin metal was exposed to pressure and heat cycles.

1. The No. 2 engine outer combustion case failed due to a fatigue crack that was not detected using the recommended inspection method and intervals.
2. The in-flight failure of the outer combustion case resulted in a power loss after the landing decision point.

Rolls-Royce has amended the inspection cycle instructions for the M250-C30-series engine to require a Leak-Tek check or fluorescent penetrant inspection (FPI) every 150 hours. The inspection descriptions have been changed accordingly. Additionally, a new design for the outer combustion case with re-inforced armpits was released in December of 2013.
