**AVIATION INVESTIGATION REPORT
A13O0045**

RUNWAY INCURSION AND RISK OF COLLISION

**SUNWING AIRLINES VEHICLE AND
AIR CANADA EMB190 C-FLWH
TORONTO LESTER B. PEARSON INTERNATIONAL AIRPORT
11 MARCH 2013**

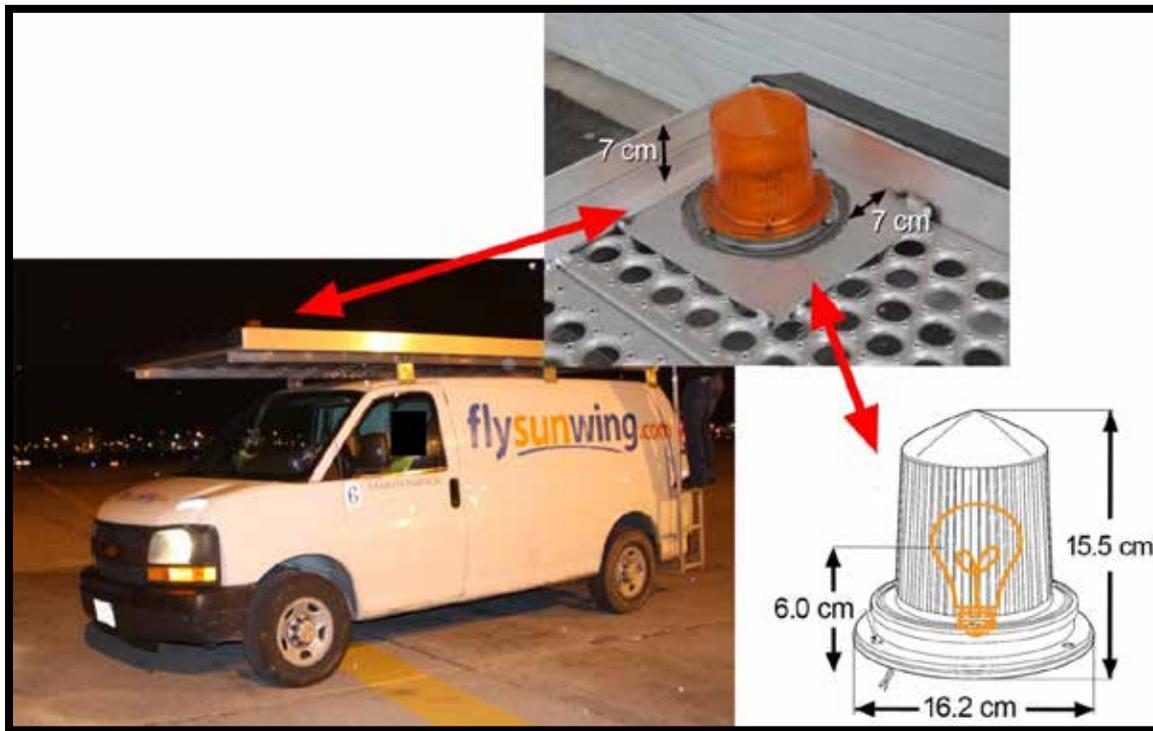
Figure 2. Grote beacon light installation on the maintenance van

Affixed to the roof of the van was a large aluminum work platform with a ladder running down the left side. Attached to the front left corner of the platform was an orange beacon light. The beacon was approximately 15.5 cm tall and was mounted 7 cm from a 7 cm tall skirt, which surrounds the platform. From a position 3 degrees above horizontal, similar to an approaching

aircraft's perspective, the bottom 6.6 cm of the beacon would not be visible. The filament of the bulb was located 6 cm from the base (Figure 2).

The beacon is designed to use a #1295 bulb, which is 37.5 W, to provide the 40 candelas specified by Transport Canada.⁶ After the incident, it was determined that the bulb inside the occurrence beacon was only 7 W. It could not be determined why or when the incorrect bulb was installed.

The vehicle was not noticed as it moved slowly across the apron. The ground controller first saw a very slow-moving unidentified airport surface detection equipment (ASDE) target shortly after its appearance on intersection DV but was unaware of the target's identity or intentions. The controller planned to monitor the target, and returned to other tasks. When attention was returned to the target 2 minutes later, the target was on the runway. The 3 controllers attempted to determine the target's identity but could not visually see the vehicle, possibly due in part to the inadequate vehicle beacon.

- Airside vehicle beacon safety blitz: GTAA aviation safety officers undertook spot checks and airside traffic stops of any vehicle that appeared to have a weak or inoperative roof beacon, and directed drivers to have vehicle beacons repaired or replaced.

Sunwing Airlines reported to Transport Canada Civil Aviation that it had inspected all of its airside vehicles' rotating beacon bulbs, and that bulbs found not to meet the specifications of TP312 were replaced to meet it.
