**AVIATION INVESTIGATION REPORT  
A13W0009**

**LOSS OF CONTROL AND IN-FLIGHT BREAKUP**

**GEMINI HELICOPTERS INC.  
ROBINSON R44 RAVEN II (HELICOPTER), C-GOCM  
FOX CREEK, ALBERTA 21 NM SW  
27 JANUARY 2013**

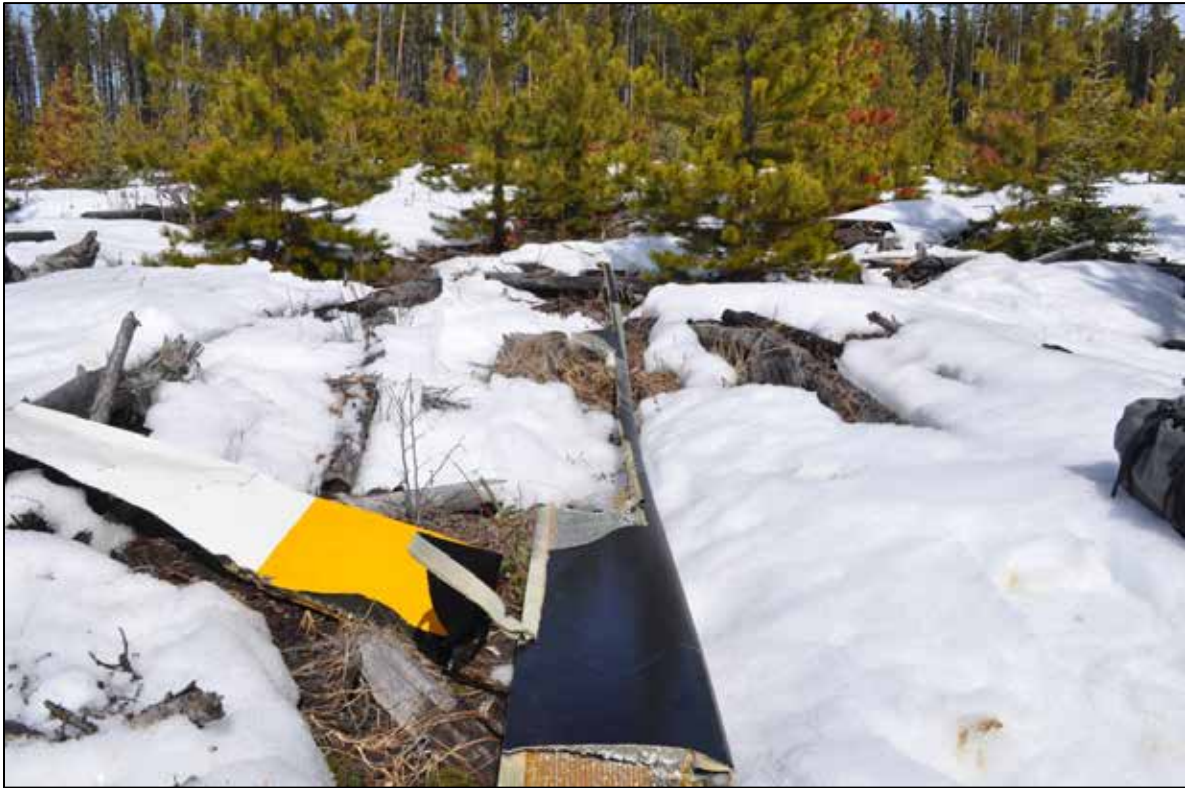
Photo 1. Detached main rotor blade

Examination of the detached rotor blade indicated a bend in the downward direction from approximately mid to outer span. Damage to the blade was consistent with overload forces as a result of downward bending, air loads, and impact with the ground. The investigation determined that the blade failed at the root, very close to the mast, in an upward direction. The other main rotor blade was shown to have struck the right side of the cabin immediately beside the pilot. It also struck the cabin on the left side above the left windshield and at the left front passenger-side upper door frame. Examination of the engine and flight controls did not reveal any system failures or abnormalities that would be considered contributory to the in-flight breakup.

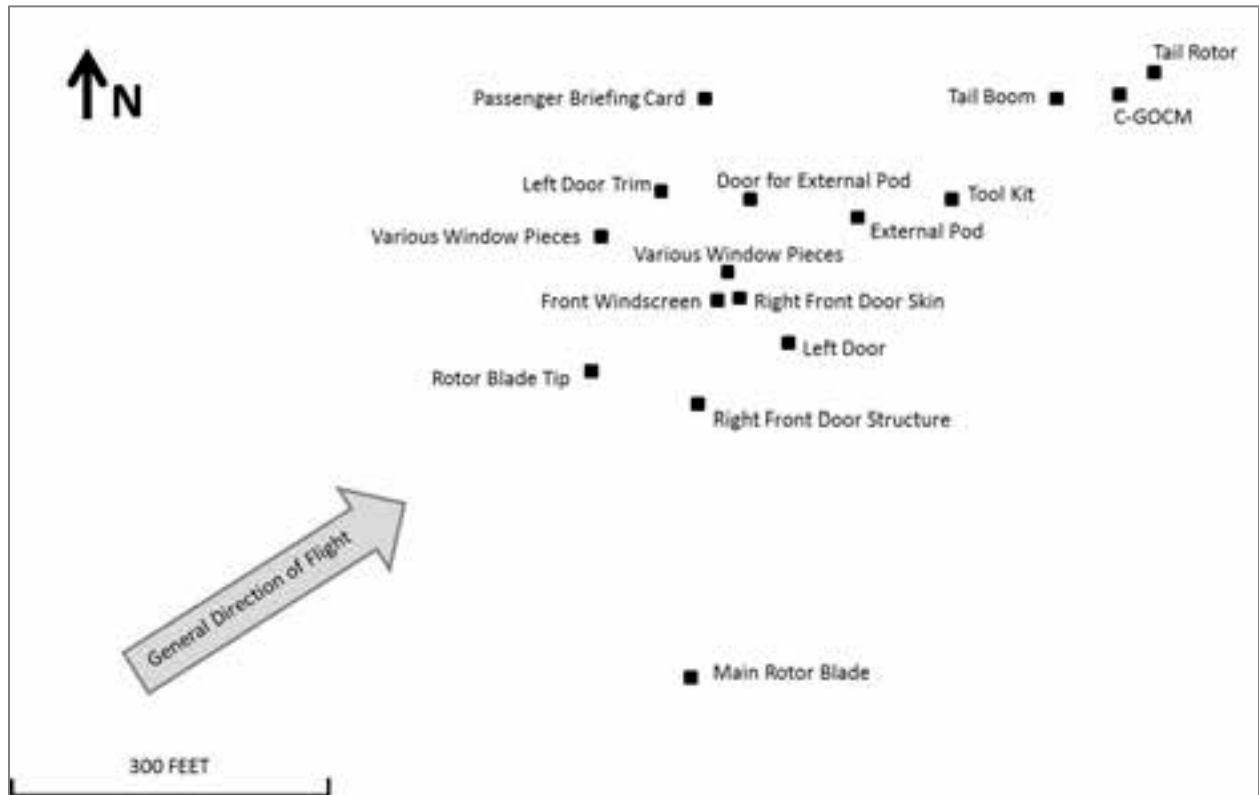
## Appendix B – Wreckage distribution

The helicopter suffered an in-flight breakup at approximately 820 feet above ground level (agl). The total length of the wreckage trail (Appendix B) was 758 feet, with the first item being one of the rotor blades (Photo 1).
