**AVIATION INVESTIGATION REPORT
A14A0067**

COLLISION WITH TERRAIN

**MANAN AIR SERVICES (dba ATLANTIC CHARTERS)
PIPER PA-31 NAVAJO, C-GKWE
GRAND MANAN, NEW BRUNSWICK
16 AUGUST 2014**

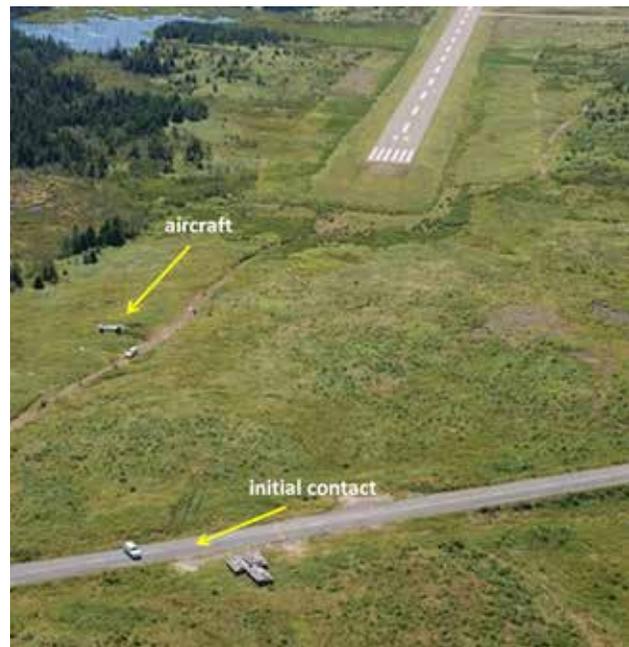
The aircraft continued across the approximately 25-foot-wide road and straight through 100 feet of brush and uneven terrain. All 3 tires made distinctive marks on the road and as the aircraft continued through the brush. The left outboard landing gear door

Photo 1. Occurrence site (Source: Royal Canadian Mounted Police, with TSB annotations)

separated, a portion of the nose landing gear strut fractured, and the left main wheel contacted a tree stump before the terrain dropped off. The aircraft became airborne and began to bank to the left, then the lower portion of the nose landing gear strut and wheel assembly separated from the aircraft.

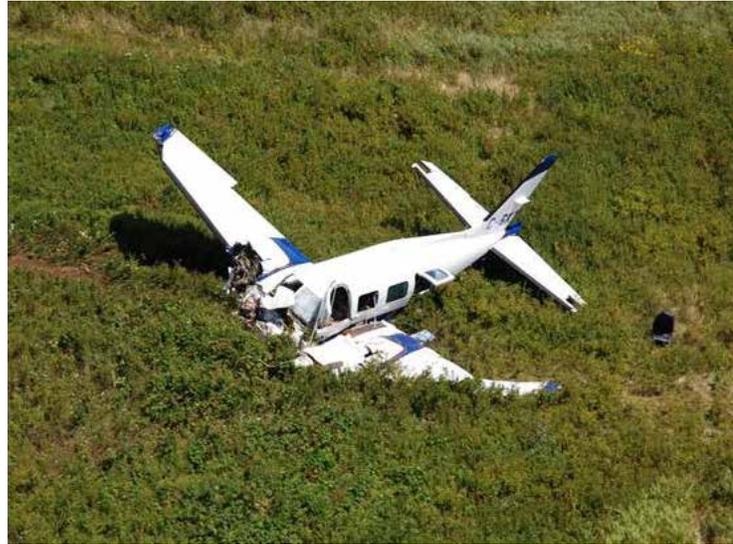
The aircraft nose structure forward of the cockpit instrument panel was crushed and displaced to the right. The instrument panel and cockpit floor were buckled so that the cockpit volume was reduced. The fuselage structure was buckled between the cockpit and cabin sections and deformed such that the cockpit door could not be closed and latched. The cockpit door support rod had separated at the fuselage, allowing the door to travel beyond its normal range.

Photo 2. Occurrence aircraft (Source: Royal Canadian Mounted Police)

The non-structural interior partitions between the aft baggage area and cabin, and between the cabin and cockpit were fractured and separated from their attachment points. Both the captain's and the rear forward-facing passenger's seats had separated from their seat mounting points.

The flaps were in the full down position and the landing gear was fully extended. The left main landing gear lower leg piston fractured and separated inboard. The nose gear lower leg piston fractured and separated aft. The right main landing gear upper torque link attachment point fractured.

The left wing separated at the wing root, remaining connected to the fuselage by control cables, wires and tubing. About 6 feet of the outer portion of the left wing separated from the main wing but remained connected by control cables, wires and tubing. There was no indication of pre-impact structural failure or failure of the flight control system. Both engine mount trusses had separated from the wings. Fuel was observed in the fuel supply lines, between the emergency fuel pump and the engine-driven pump, for both engines.

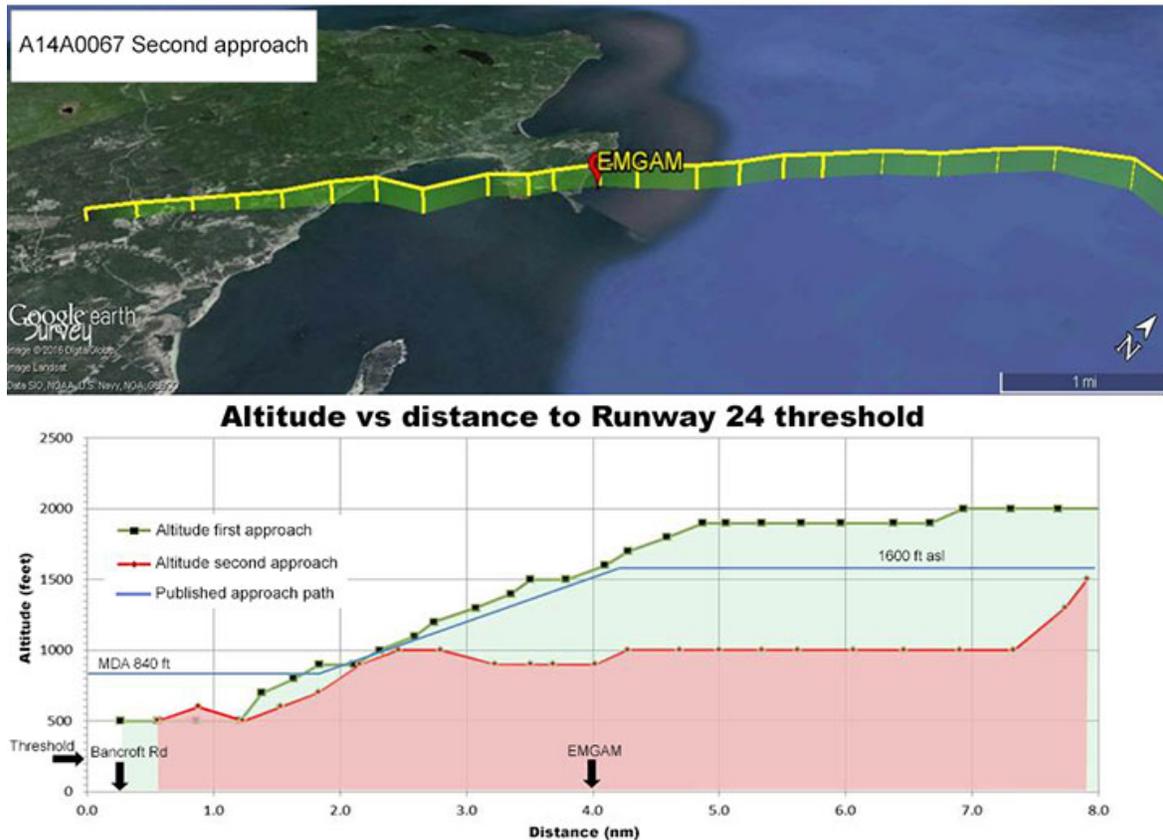
Figure 1. Altitude vs distance, first and second approach (Source: GoogleEarth, with TSB annotations)

The aircraft began its approach from 1900 feet asl, 4.87 nm from the threshold. The aircraft continued on a constant descent until it was at 500 feet asl, at 1.2 nm from the threshold. The aircraft’s ground speed was 90 knots. At this ground speed, the descent rate would have been approximately 470 fpm. This rate of descent is consistent with what the CAP identifies for a constant descent angle for a GPS approach.
