**AVIATION INVESTIGATION REPORT
A14O0105**

LOSS OF CONTROL ON LANDING

**SUDBURY AVIATION LIMITED
DE HAVILLAND DHC-2 MK. I, C-FHVT
KENNEDY LAKE, ONTARIO
25 JUNE 2014**

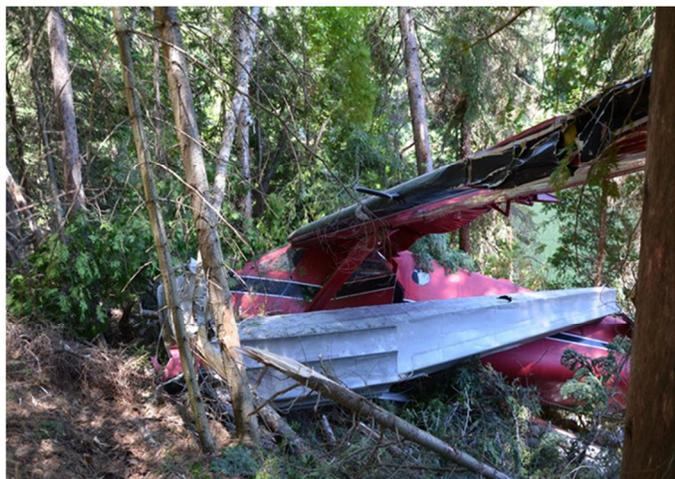
After coming to a stop, the aircraft was leaning to the right such that the right front and cabin doors faced down the slope (Photo 1). The right wing had separated from the fuselage. There was concern that the aircraft could slide down the slope and caution was taken while moving inside the cabin towards the left cabin door. The 3 occupants exited the aircraft through the left cabin door, which they were able to open only partially, as the substantially damaged left wing was blocking it.

Photo 1. Wreckage of C-FHVT, a float-equipped de Havilland DHC-2

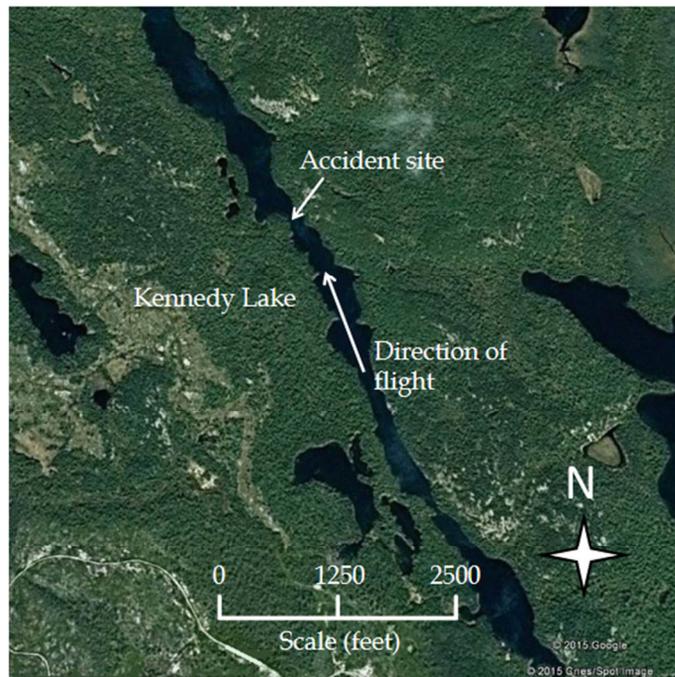
Figure 1. Kennedy Lake

Kennedy Lake has a narrow middle section and wider open water areas at both ends of the lake. The lake is oriented on a 300/120° magnetic heading, with rising tree-covered terrain on either side of the shoreline. At the accident location (Figure 1), the height of the slope above the lake surface was approximately 50 feet, with trees of approximately 30 feet in height. The aircraft came to rest approximately 30 feet above the water surface. The width of the lake at the landing site was estimated to be 170 feet. The aircraft's wingspan is 48 feet, which leaves approximately 60 feet between the wingtip and the shoreline on either side of the aircraft.

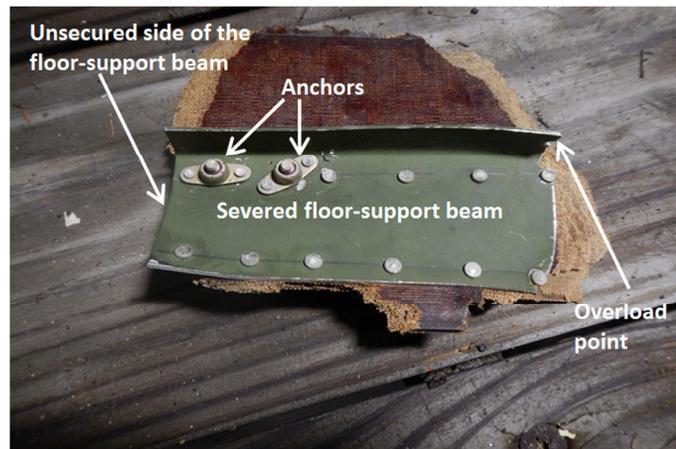
The bench seat and its floor attachments were examined. The bench seat appears to be part of an STC incorporated on the aircraft at some time during its service life. The left-rear of the seat had been attached by 2 anchors through the floor to the floor-support beam. A section of floor containing the anchors as well as part of the floor-support beam were found detached (Photo 2 and Photo 3).

Further examination determined that the rear of the floor-support beam had not been secured or supported, which allowed the seat and its attachment to bend and fail in overload in a forward direction during the impact.

Photo 2. Detached left-rear seat attachment

The bench seat aft floor mount attachment was secured to the underfloor beam, but the beam was not secured on the aft side and failed in bending overload during the impact. Although the lap belt was worn, it was attached to the seat and did not prevent the occupant from shifting forward with the seat. This resulted in minor injury to the passenger in the rear seat.

recommends that during every 100-hour inspection, the seat, seat belts, floor attachments and reinforcements be checked for integrity, especially when those seats are frequently removed to provide additional space for carrying freight.

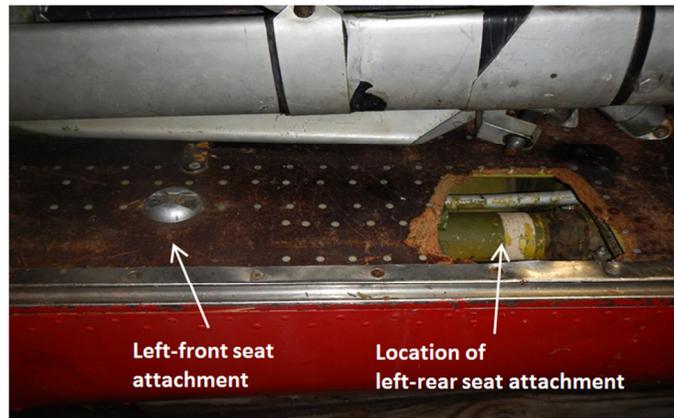
Photo 3. Left-front seat attachment and location of detached left-rear attachment
