AVIATION INVESTIGATION REPORT A15C0146

Engine failure and collision with terrain

Oceanview Helicopters Ltd.

Hughes 369D (helicopter), C-FOHE

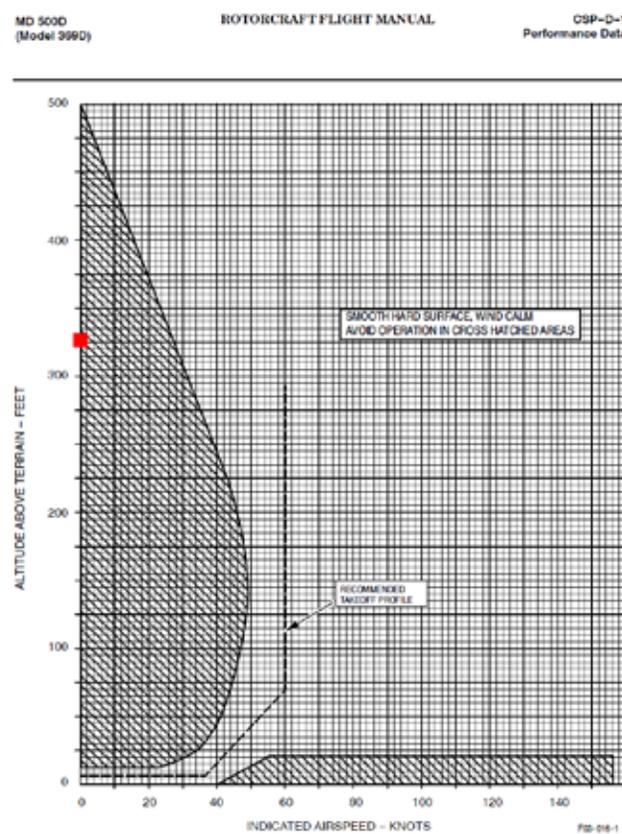
Figure 1. Height velocity diagram, showing altitude and airspeed at the time of the engine failure (red square) (Source: Rotorcraft flight manual for the Hughes 369D, with TSB annotations)

The Hughes 369D RFM also states: "Operation of the helicopter in the cross-hatched area is not prohibited, but should be avoided."⁸ In addition, the RFM emergency procedures state, "Flight within the cross-hatched regions represent [*sic*] airspeed/altitude combinations from which a successful autorotation landing may be difficult to perform. Operation within the cross-hatched area should be undertaken with caution."⁹ At the time of the engine failure, the helicopter was at

325 feet above ground level in a hover with an airspeed of 0 knots, which placed the helicopter within the cross-hatched region of the diagram in Figure 1 (marked with red square).

The investigation determined that the helicopter was conducting aerial work operations within the cross-hatched region of the Height Velocity Diagram (Figure 1). The engine failure occurred while the helicopter was in a hover at an altitude from which a successful autorotation was unlikely. If a single-engine helicopter is operated within the confines of the cross-hatched region of the Height Velocity Diagram, the likelihood of a successful autorotation after an engine failure is significantly reduced, increasing the risk of injury or death.

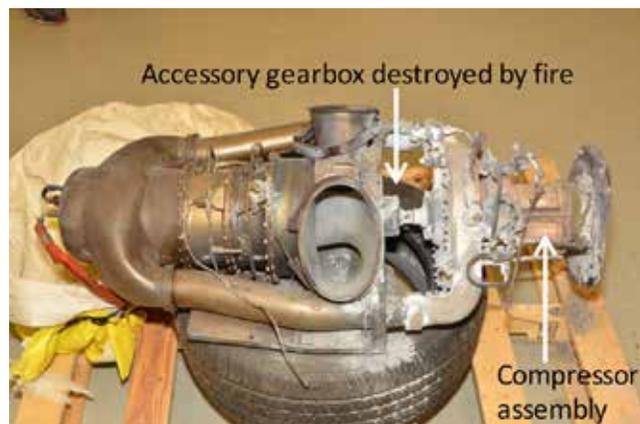
Photo 2. Rolls-Royce 250-C20B engine

The helicopter was equipped with a Rolls-Royce 250-C20B turbine engine, which was substantially damaged by the post-impact fire (Photo 2). An external inspection of the engine revealed protrusions and radial deformation to the compressor housing.

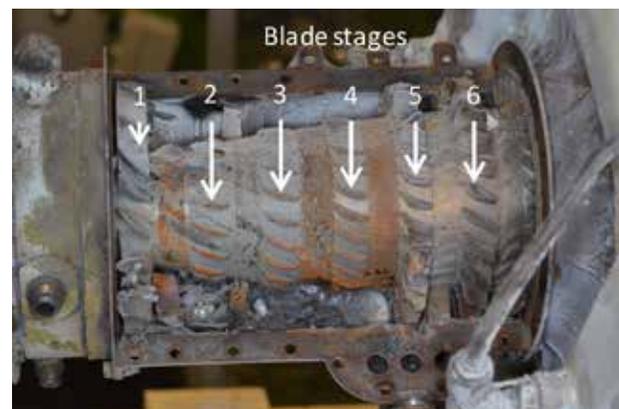
Figure 2. Axial compressor, showing blade stages 1 to 6

Disassembly of the compressor assembly (part number 6890550, serial number CAC80174) revealed complete failure of stages 2, 3, and 4 of the axial compressor blades. The compressor front support struts did not exhibit any pre-impact anomalies. The stage 1 compressor blades were fully intact. Examination of the compressor front support struts and stage 1 compressor blades did not show any signs of pre-existing erosion/corrosion. The stage 5 and 6 compressor blades showed progressively less damage (Figure 2).

Examination of the compressor assembly revealed that all of the stage 2, 3, and 4 compressor blades had separated near the root. Six of the failed compressor blade roots had partial, readable fracture surfaces. Inspection of the fracture surfaces under the scanning electron microscope revealed overstress failures. The remaining fracture surfaces of the failed compressor blade roots exhibited post-fracture rub and smear.¹²

The progression of damage suggests that the initial failure was located either in the stage 2 compressor blade or the stage 2 stator vanes. Because the stage 2 compressor blades were completely destroyed and there was no damage upstream, it is considered likely that the lead event was the failure of a stage 2 compressor blade, resulting in a loss of engine power.

It was determined that the lead event was likely the failure of a stage 2 compressor blade; therefore, it is likely that the failed compressor blade was subject to fatigue and eventual overload failure before the prescribed overhaul period had elapsed; research suggests that this sort of failure is rare.

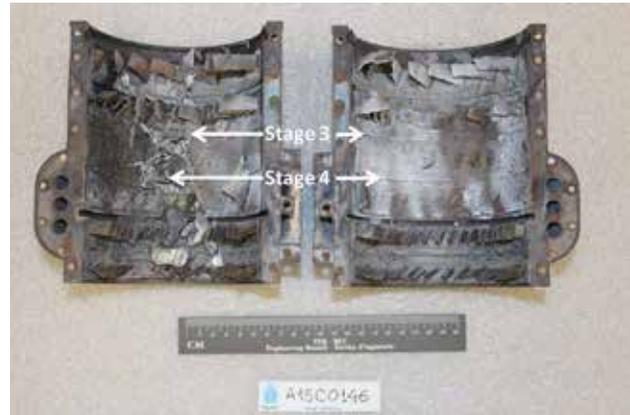
Figure 3. Compressor case halves, showing stages 3 and 4

Examination of the compressor case assembly revealed that the stage 1, 5, and 6 stator vanes were all present but exhibited bending and distortion. All of the stage 3 and 4 stator vanes had fractured near the root (Figure 3). All fractures exhibited post-fracture rub and smear. All but 3 of the stage 2 stator vanes were present. The 3 missing stage 2 stator vanes had fractured near the root. Examination of these fracture surfaces revealed post-fracture rub and smear as well as a layer of high-temperature oxidation. Fracture analysis of the recovered airfoil fragments found further downstream in the engine were inconclusive because of smearing and secondary impact damage.
