# AVIATION INVESTIGATION REPORT

## A16P0078

### **Hard landing on water**

Inland Air Charters Ltd.  
de Havilland DHC-2 Mk. I (Beaver), C-FJOM  
Kitkatla, British Columbia  
24 May 2016

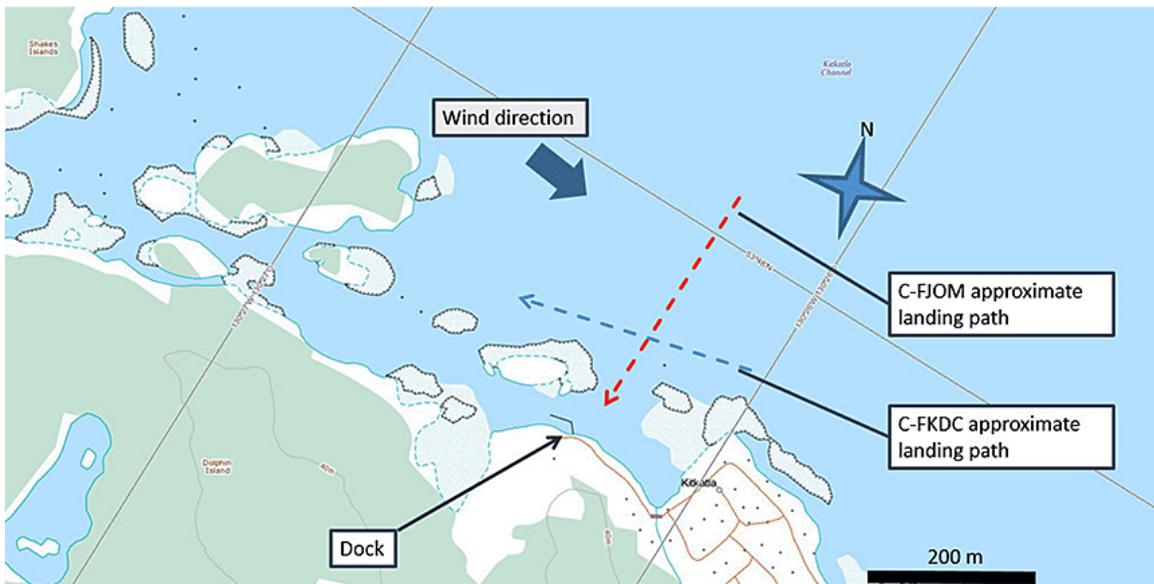
The pilot of C-FJOM determined that the wind and water-surface conditions at Kitkatla were suitable for a crosswind landing, and carried out an approach directly toward the shoreline and dock (Figure 1). The aircraft touched down approximately 200 m from shore.

Figure 1. Landing paths of the 2 Inland Air Charters Ltd. aircraft (Source: Natural Resources Canada, with TSB annotations)

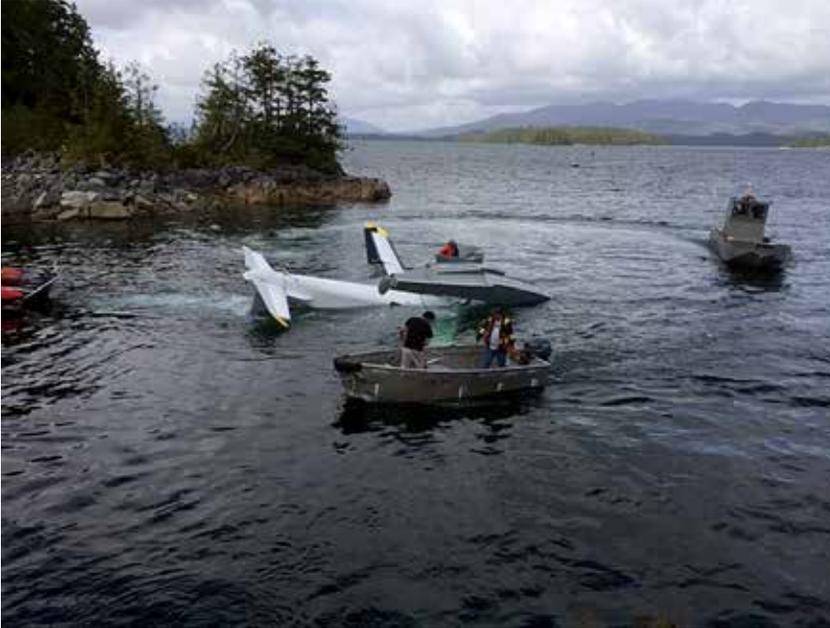
When the aircraft subsequently touched down on the right-hand float, the float support structure collapsed. C-FJOM entered the water in a steep nose-down attitude before coming to rest inverted and partially submerged. The aircraft rapidly filled with water. The occupants, who were submerged in cold water and partially upside down, were able to escape the submerged cabin with varying degrees of difficulty. Boaters arrived on scene immediately and assisted with the egress of the aircraft occupants (Figure 2).

Figure 2. The partially submerged occurrence aircraft (Source: Royal Canadian Mounted Police)

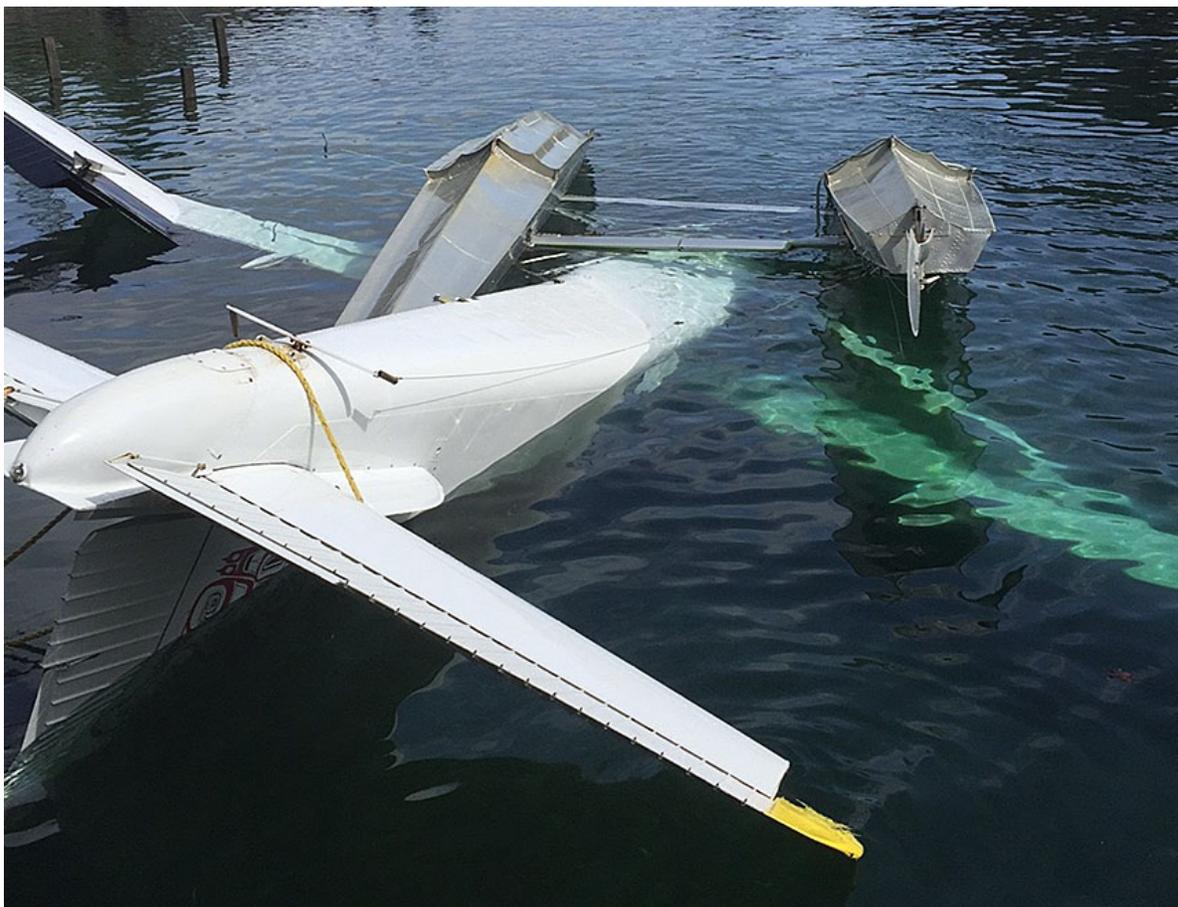
The initial impact of the aircraft on the water produced a side load from the left, which in turn applied a counter-clockwise roll moment (viewed from behind) to the left-hand float. This event fractured the left-hand support struts at the bottom-end attachments. The side load was transmitted through the spreader bars to the right-hand float. Strut geometry forced the right-hand float out and upward. The right-hand float strut fractures exhibited a clockwise rotation (opposite to the left-hand float), indicating that a second impact had occurred on the right side, which pushed the right-hand float further upward. The right-hand float contacted and bent the right-hand wing strut, and the float transom gouged a hole in the aft fuselage. At some point in the sequence, the front left spreader bar attachment fractured and the left-hand wingtip struck the water (Figure 3).

Visual examination of the fracture surfaces on the ends of the float struts and attachments revealed overload fractures in all cases, with no evidence of pre-existing progressive failure modes. The front left spreader bar attachment was examined in greater detail and also revealed an overload fracture. Its material composition, electrical conductivity, and hardness were assessed and found to be within the specifications for the material. The float attachment fittings were appropriate for the modifications to the aircraft.

Figure 3. The partially submerged occurrence aircraft showing damage to the float structure (Source: Royal Canadian Mounted Police)

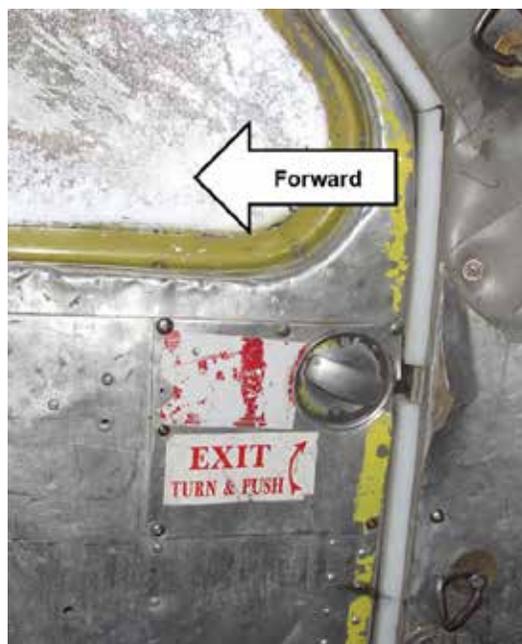
The interior handle on the main cabin doors is located near the aft edge of the door, immediately below the window. The handles are most easily accessed by passengers sitting in the rear sling seat. All of the aircraft's interior door handles (Figure 4) consist of a short metal bar mounted in a shallow circular recess. Occupants open the cabin doors by rotating the bar with their thumb and fingertips. Because the aircraft is usually positioned such that the dock is to its left side, the doors on the right are rarely used. Inland Air did not require that passengers physically open and close the doors as part of the safety briefing, and the passengers on the occurrence flight did not do so.

Figure 4. Interior right-hand door handle
