# AIR TRANSPORTATION SAFETY INVESTIGATION REPORT A17C0146

## **LOSS OF CONTROL AND COLLISION WITH TERRAIN**

West Wind Aviation L.P.  
Avions de Transport Régional ATR 42-320, C-GWEA  
Fond-du-Lac, Saskatchewan  
13 December 2017

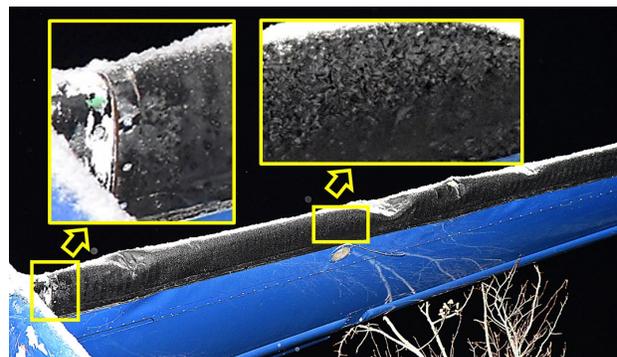
Although there was no observable precipitation or fog while the aircraft was on the ground, weather conditions were conducive to ice or frost formation. This, combined with the residual mixed ice on the aircraft, which acted as nucleation sites that allowed the formation of ice crystals, resulted in the formation of additional ice or frost on the aircraft's critical surfaces.

Figure S1. Ice contamination on leading edge of left horizontal stabilizer following the accident (Source: Royal Canadian Mounted Police, with TSB annotations)

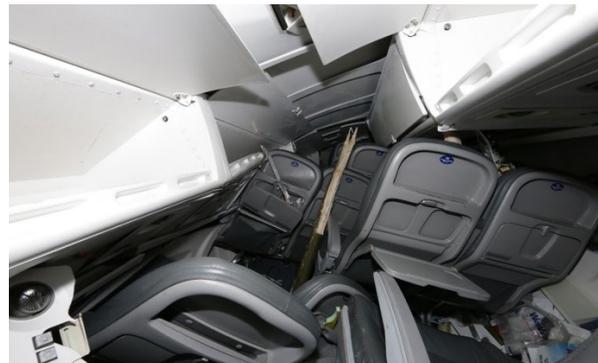
As a result of unapproved repairs, the flight attendant seat failed on impact, resulting in injuries that impeded her ability to perform evacuation and survival actions in a timely manner.

Figure S3. Image of the displaced cabin seats  
(Source: TSB)

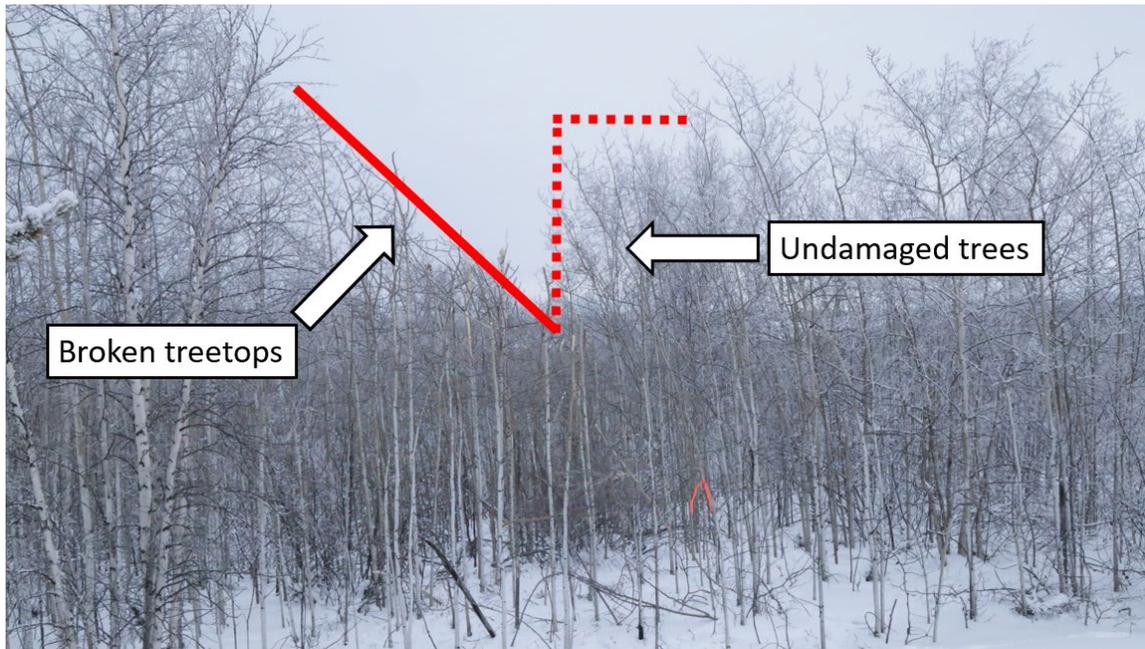
Figure 7. Photo of initial impact with trees (image facing towards the airport and showing the aircraft's bank angle at the time of impact) (Source: TSB)

The aircraft made initial ground contact about 20 m following these tree strikes, on a track of approximately 258°T, which matched the track through the trees.

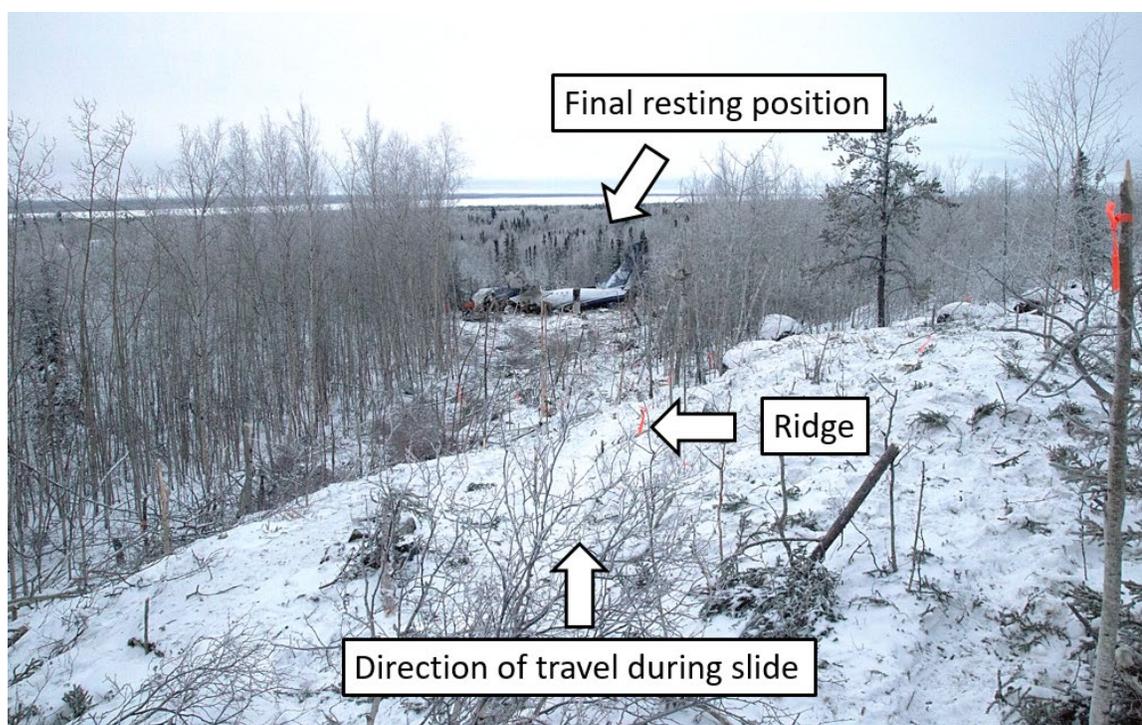
Figure 8. Photo showing the path of the aircraft's slide over the ridge (Source: TSB)

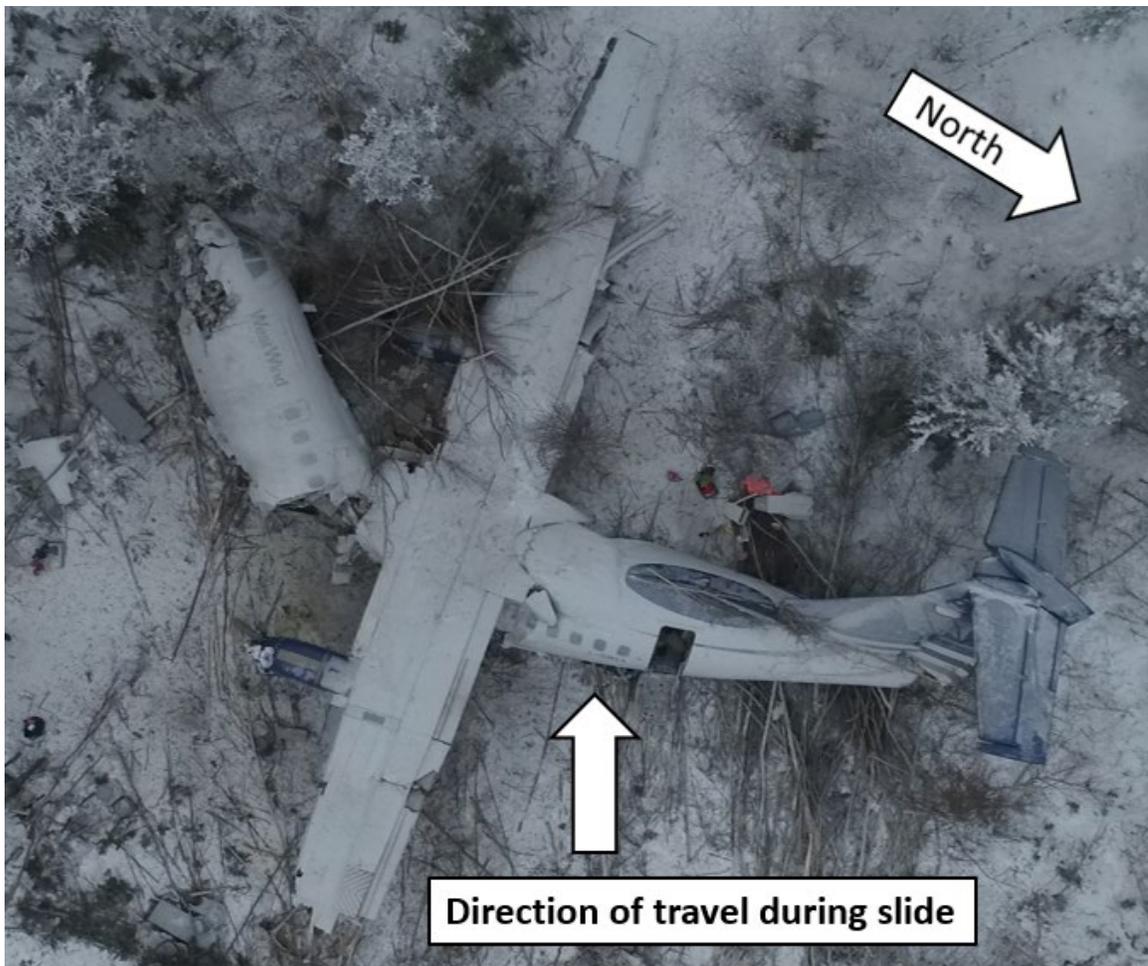
Figure 9. Photo of aircraft wreckage, as seen from above (Source: Royal Canadian Mounted Police, with TSB annotations)

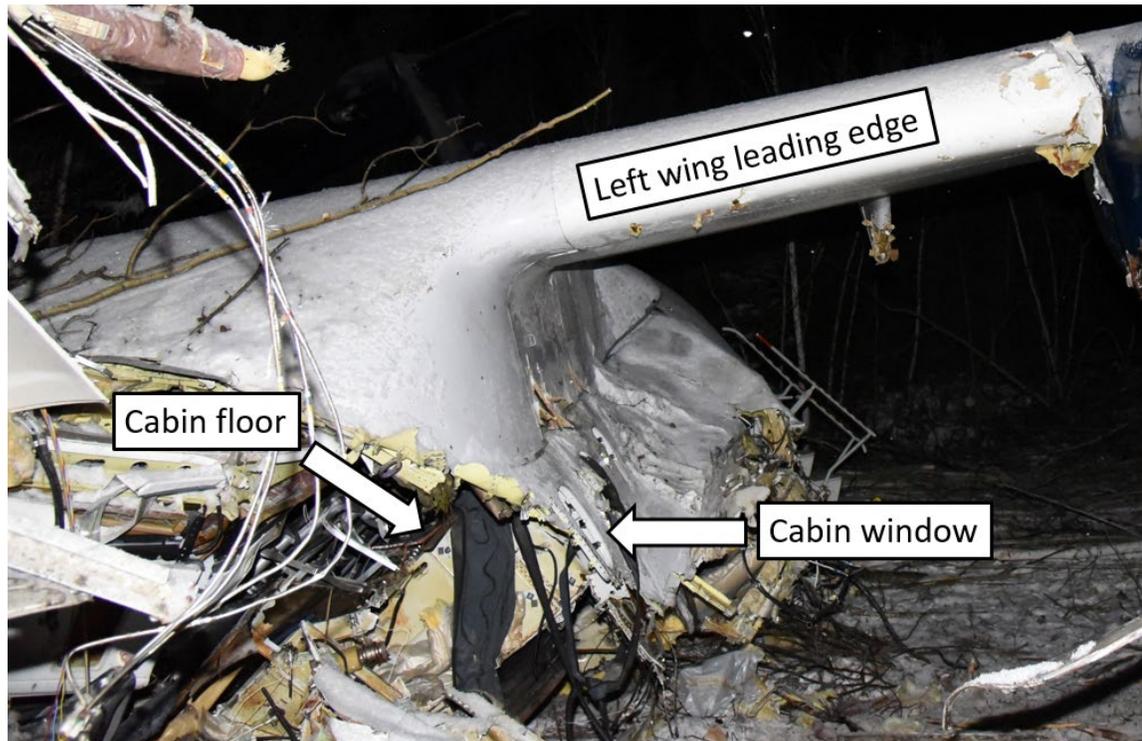
Figure 10. Close-up view of the fractured fuselage forward of the wing (Source: Royal Canadian Mounted Police, with TSB annotations)

Examination of the upper portion of this centre fuselage section underneath the wing showed that the 2 strongest circular frames (frames 25 and 27), also called lift frames, had fractured. Since these lift frames support the wing and maintain the circular integrity of the cabin, these fractures had resulted in the collapse of this fuselage section.

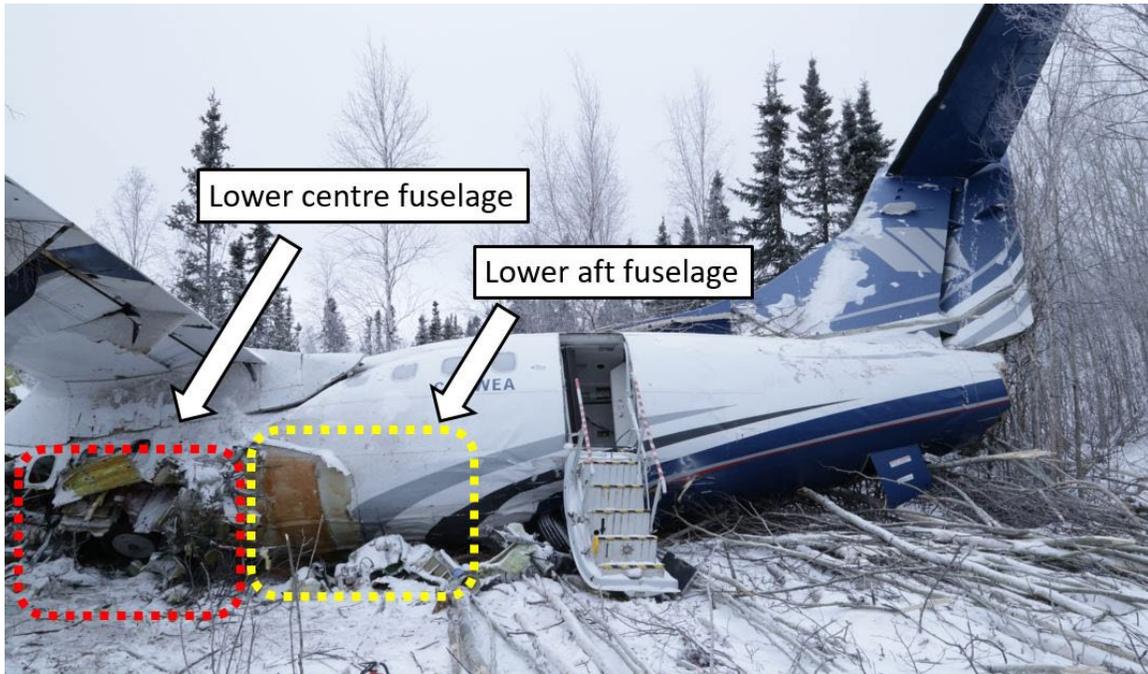
Figure 11. Left side view of the lower centre and aft fuselage sections of the aircraft at the crash site  
(Source: TSB)

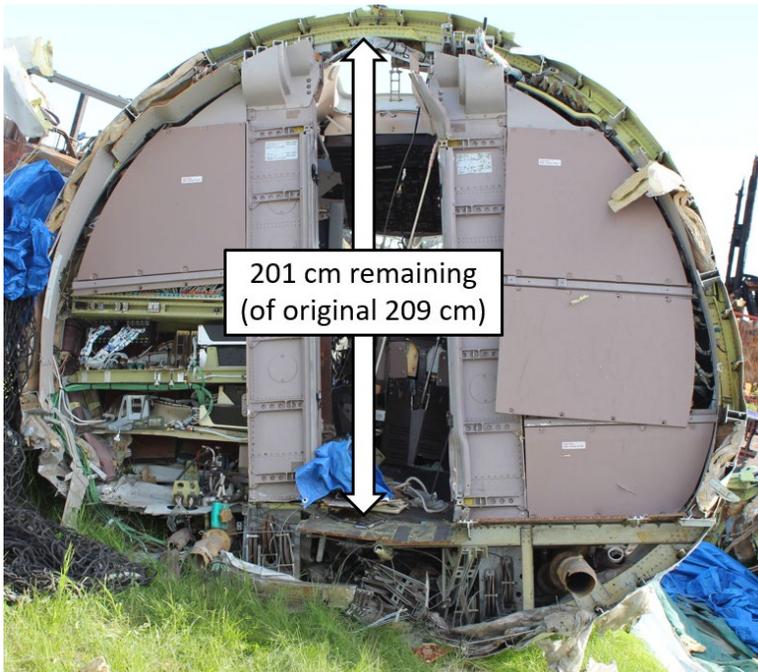
Later off-site examination of the forward fuselage section, just aft of the cockpit, showed that the left bottom area of the fuselage and the stanchions underneath the floor were crushed to some extent.

Figure 12. Cross-sectional view of the forward fuselage, just aft of the cockpit, looking forward, from later off-site examination (Source: TSB)

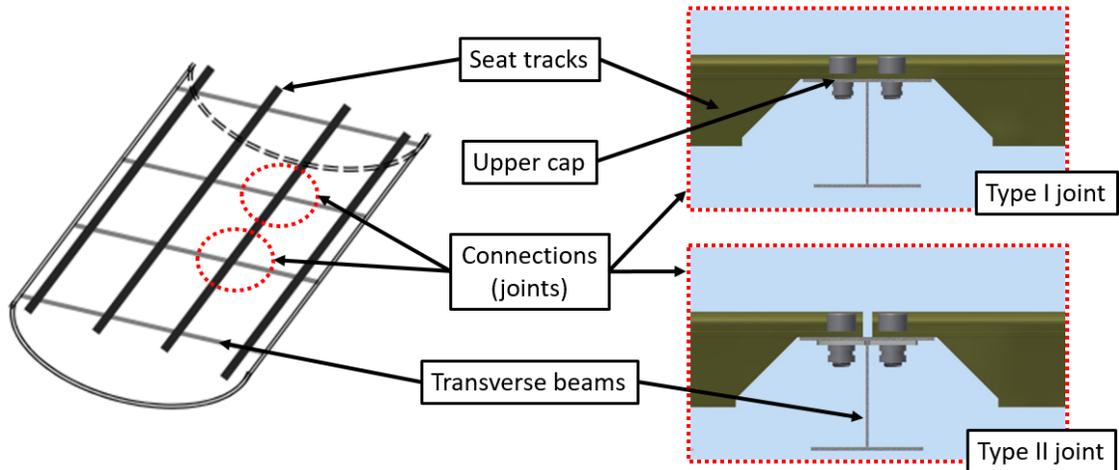
Figure 13. Diagram showing the floor structure with inset images showing examples of type I and type II joints (Source: TSB)

The floor structure, including the seat tracks, failed and buckled in several locations. Examination found that, among all seat tracks examined, several type II joints had failed, whereas none of the type I joints had failed. The failure modes were either failure of the bolt or shear failure of the plate with the bolt holes on the upper cap of the transverse beam.

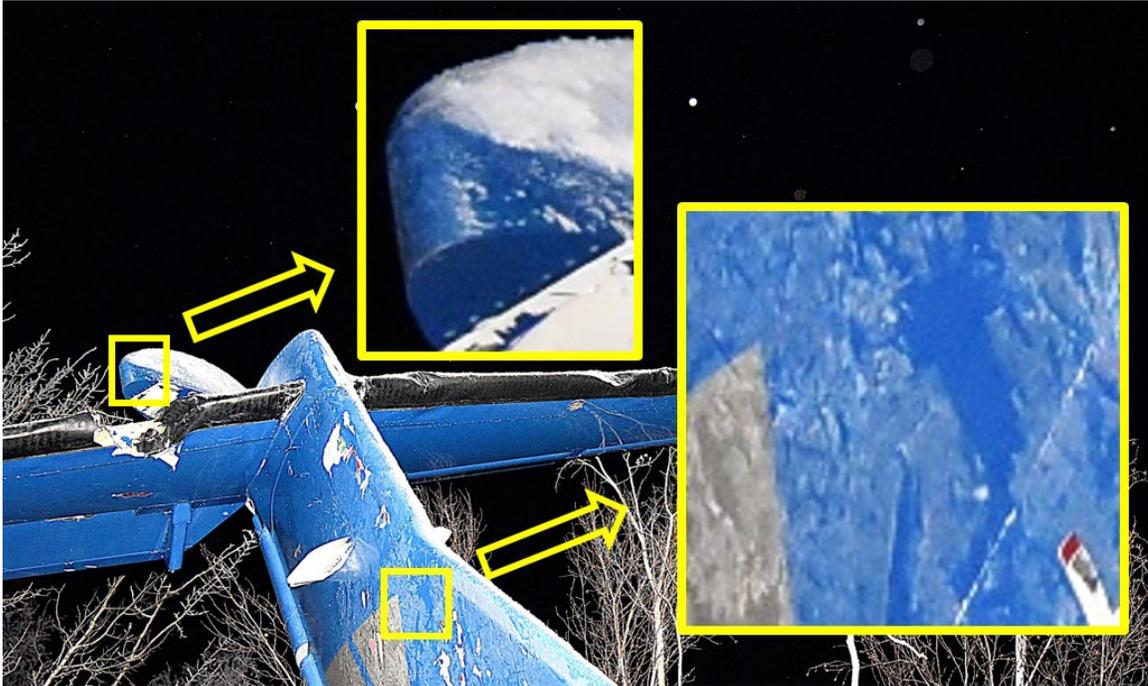
Figure 17. Photo of vertical stabilizer, with 2 inset images showing ice contamination on the leading edge of rudder horn and the right side of the stabilizer (Source: Royal Canadian Mounted Police, with TSB annotations)

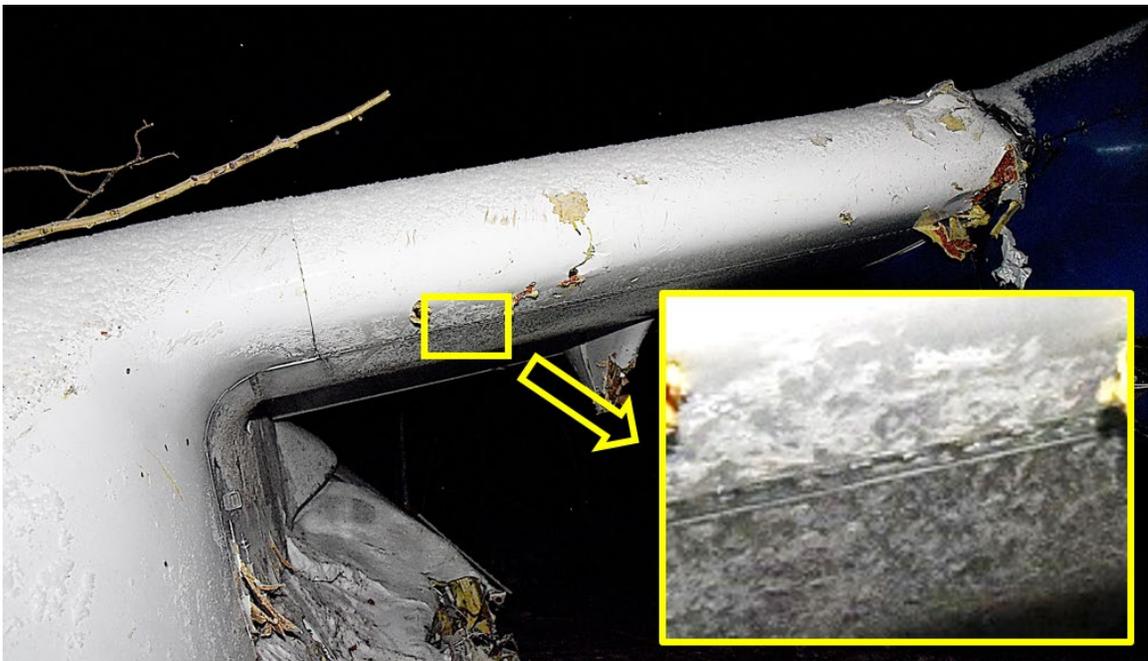
Figure 18. Photo of inner left wing with inset image showing surface contamination on lower leading edge (Source: Royal Canadian Mounted Police, with TSB annotations)
