AVIATION INVESTIGATION REPORT

A17O0025

Runway excursion

Airbus Industrie A320-211, C-FDRP

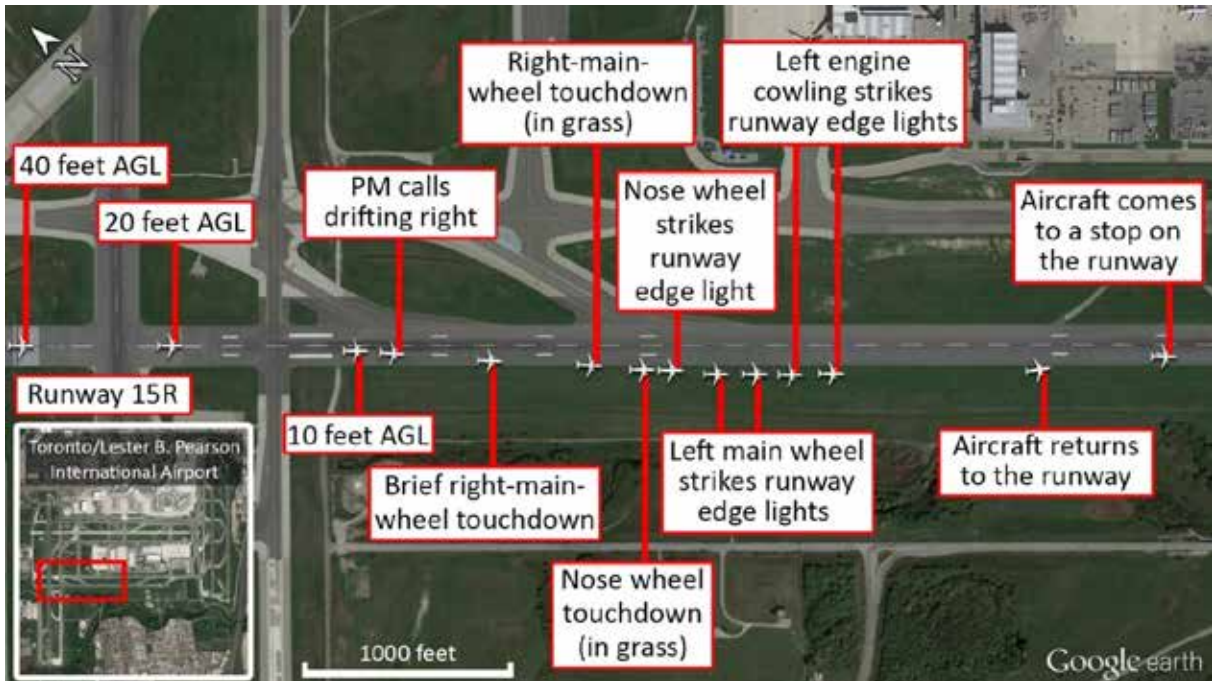
At 0002:07, the left main wheels touched down on the runway surface, followed quickly by a very brief right-main-wheel touchdown, or skip. At this point, the aircraft was on the paved runway surface, 2227 feet from the displaced threshold and 64 feet to the right of the runway centreline. The outboard wheel of the right main gear was approximately 20 feet from the right runway edge. The aircraft continued drifting to the right following the skip, and when

the right main wheels touched down again, they were approximately 8 feet to the right of the paved runway surface, in wet grass.

As the aircraft continued to move laterally to the right, the nose wheel touched down on the grass, approximately 280 feet beyond the final right-main-wheel touchdown point, and struck 1 runway edge light. The outboard left main wheel and left engine cowling then each struck 2 runway edge lights, and the outboard left tire was punctured and deflated.

The PF engaged reverse thrust, and the aircraft engines began to ingest debris. Once the speed had been reduced, the PF steered the aircraft back onto the paved runway surface, then came to a stop 5422 feet from the displaced threshold (Figure 1). The aircraft had travelled 2390 feet through the grass.

Figure 1. The aircraft's track from 20 feet AGL until it came to a stop on the runway (Source: Google Earth, with TSB annotations)
