**AIR TRANSPORTATION SAFETY ISSUE
INVESTIGATION REPORT A17O0038**

Runway Incursions Between the Parallel Runways at Toronto/Lester B. Pearson International Airport, Ontario

Released 31 January 2019

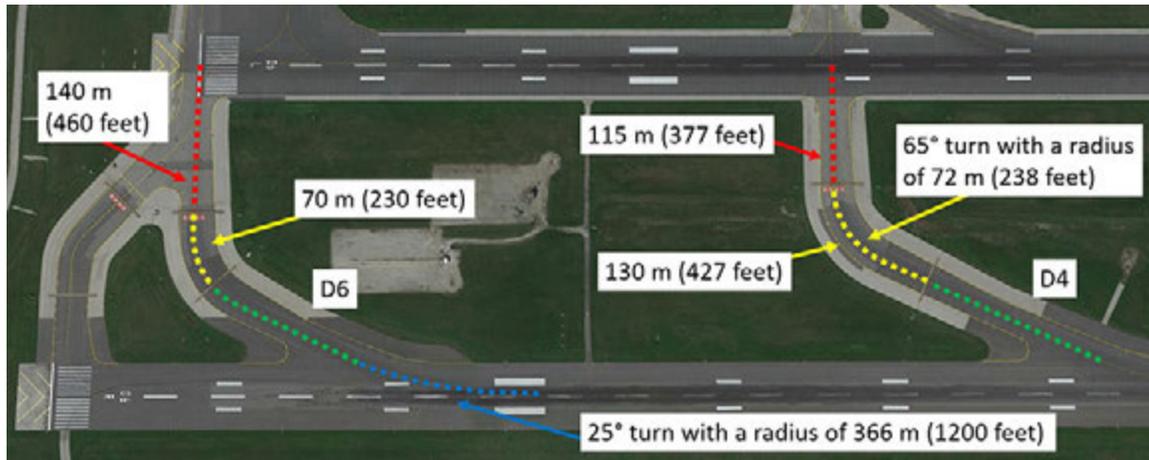
Figure 6. Distances on the rapid exit taxiways of Runway 06L/24R that have direct access to the adjacent runway (Source: Google Earth, with TSB annotations)

Neither TP 312 nor ICAO's Annex 14 to the *Convention on International Civil Aviation*²¹ provides restrictions or recommendations for a minimum distance between runway holding positions on RETs. Furthermore, neither document sets out any restriction on direct access from one runway to another without an intermediate, transitional taxiway. By contrast, a comparable document published by the U.S. Federal Aviation Administration (FAA) instructs as follows: "Do not provide direct access from a high speed exit [i.e., a RET] to another runway."²²

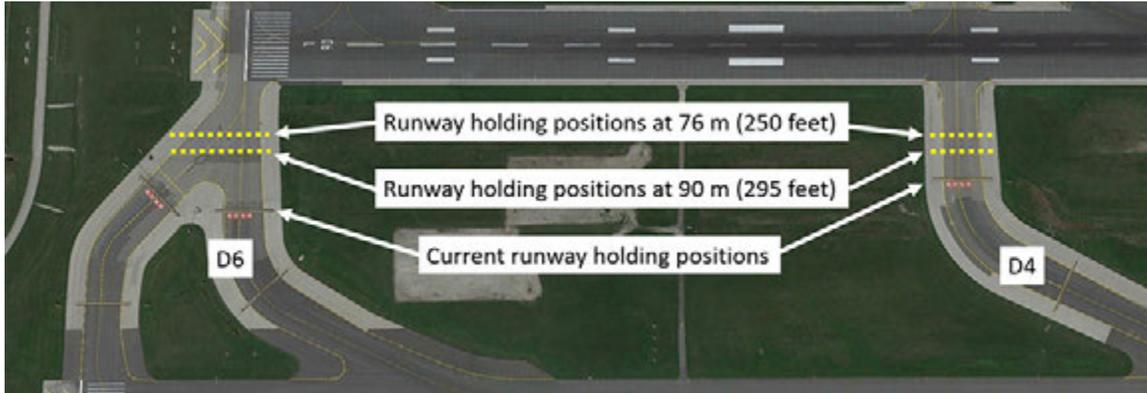
Figure 7. Comparison of the distances of the current runway holding positions from the Runway 06L/24R centreline with distances that correspond to the U.S. standard of 250 feet (76 m) and the standard in the 5th edition of TP 312 of 90 m (295 feet). (Source: Google Earth, with TSB annotations)

As the taxiways are currently configured, 3 of the 11 aircraft in the 11 most recent occurrences reached the runway surface (Table 3, column 4). The TSB re-calculated the stopping position of the aircraft assuming that the holding positions were located at 90 m rather than the current 115 m and that the aircraft crews did not see the 90 m holding position. Given these assumptions, 6 of the 11 aircraft would have reached the runway surface (Table 3, column 5). Thus, the aircraft that incurred on the runway and were instructed to stop by ATC in fact stopped further from the inner runway surface than they might have if the holding position had been located at 90 m.

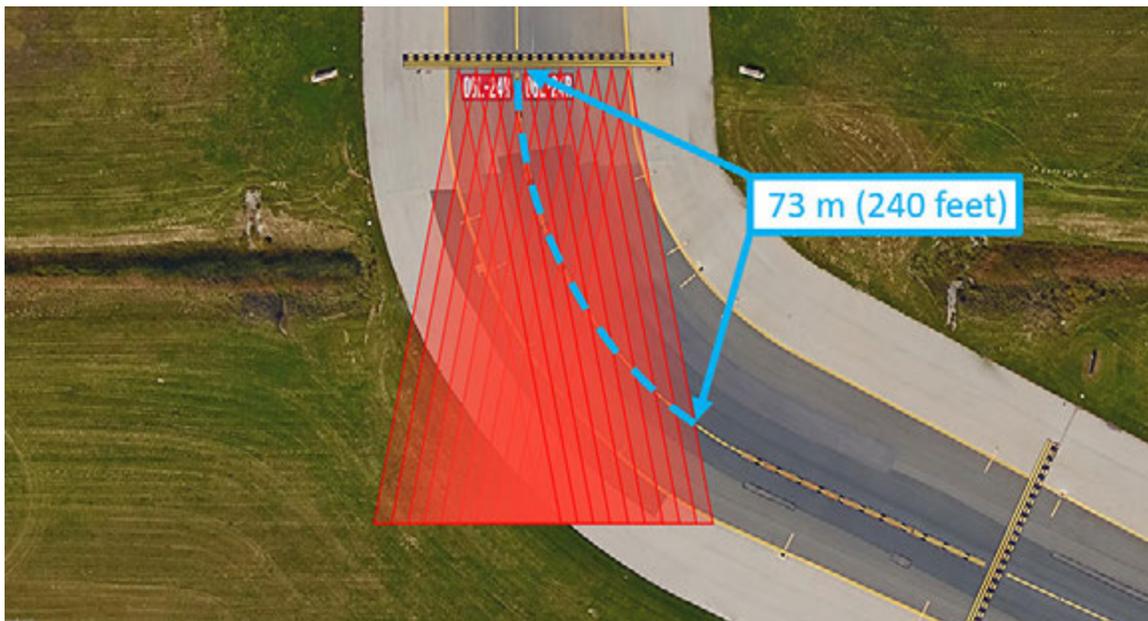
Because the lights are angled relative to the taxiway, the inset stop-bar light located on the side closest to the inside of the turn, which is aimed parallel to the taxiway, would be the first stop-bar light to become visible to an approaching aircraft. In its current placement, if the light is operating at the minimum specification, the angular limitations mean that this main beam would become visible only when the aircraft is within 73 m (240 feet) of the stop-bar position. The main beam of the outer 3 inset stop-bar lights would not be visible to aircraft at any point on the taxiway centreline (Figure 12).

Figure 12. Angular orientation and main beam spread of individual inset stop-bar lights at rapid exit taxiways of Runway 06L/24R (Source: Google Earth, with TSB annotations)

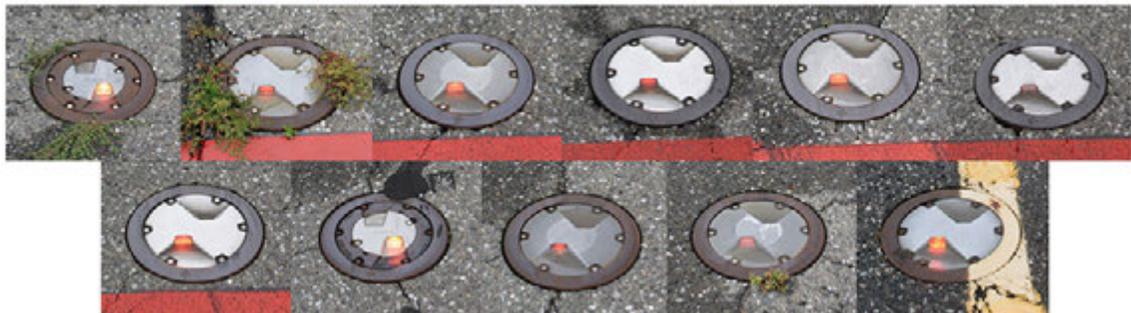
During this investigation, the inset stop-bar lights were examined and photographed on a few different occasions (Figure 14). It was noted that, to the naked eye, the strengths of the individual lights varied, and several different levels of intensity were often evident among lights within the same row. In addition, their fixtures occasionally differed and were mixed within the same row.

Figure 14. Composite image of inset stop-bar lights installed at rapid exit taxiway D4, showing varied intensities and differing fixtures

It was determined that light fixtures from 2 different manufacturers were installed interchangeably and often mixed within a single stop-bar location. Both types of fixtures met the minimum TP 312 specifications by design; however, the minimum average main-

beam intensity of one unit type was 417 cd, with a beam spread of 48°, while that of the other was 247 cd, with a beam spread of 20°.

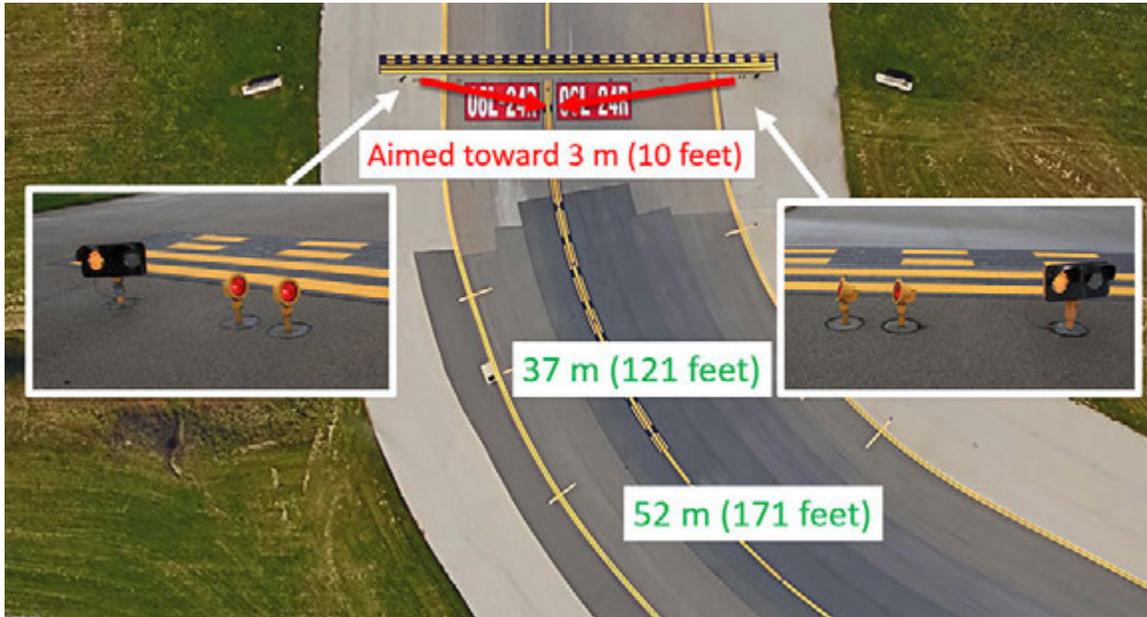
Figure 15. Current aim point of elevated stop-bar lights at rapid exit taxiways of Runway 06L/24R (Source: Google Earth, with TSB annotations)

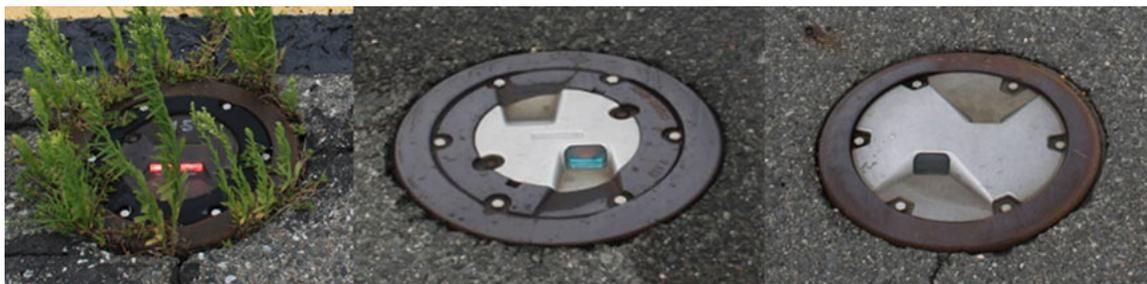
Figure 16. Composite image showing obscured lights, incorrect lenses, and non-functioning bulbs at Runway 06L/24R

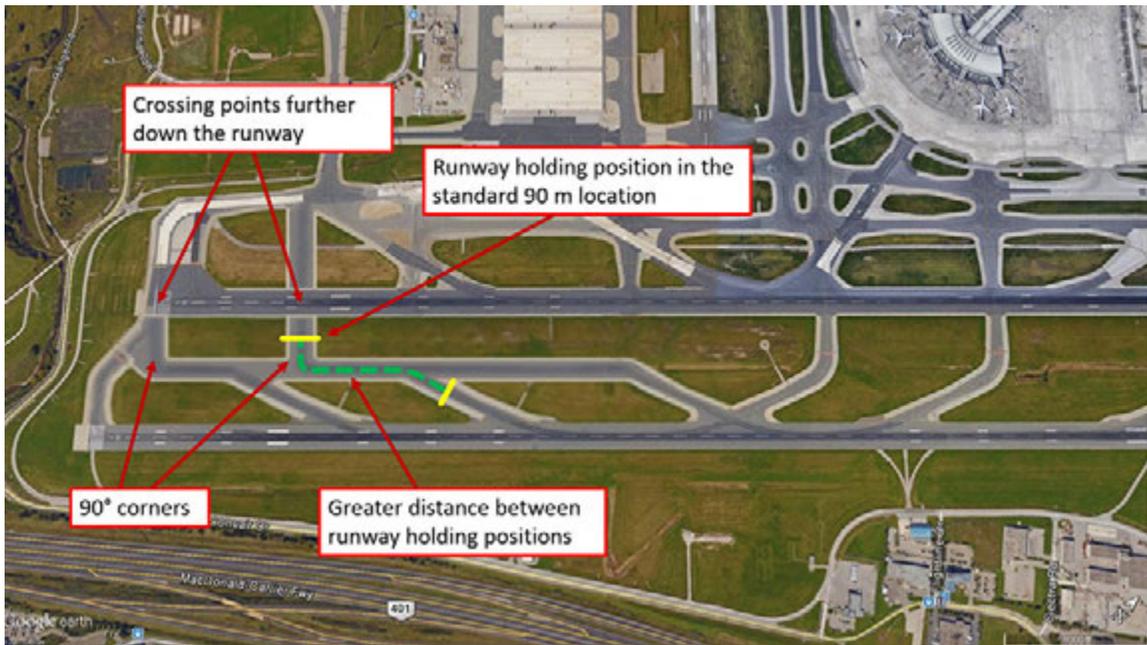
Figure 28. Hypothetical configuration of the south complex at CYYZ (Source: Google Earth, with TSB annotations)

the taxiway layout. A change of this scale may be required to increase the distance and taxiing time between runway holding positions, reduce the taxiing speeds of aircraft approaching hold-short locations, and prevent direct access to adjacent runways from RETs. Among the possible reconfigurations for achieving these objectives is the addition of an intermediate taxiway between the runways and parallel to them, as found at numerous airports with parallel runways, and the re-situating of visual cues in common locations.
