AVIATION INVESTIGATION REPORT A17P0007

Collision with trees and power lines after rejected landing

Victoria Flying Club
Cessna 172, C-GZXB
Duncan Aerodrome, British Columbia
19 January 2017

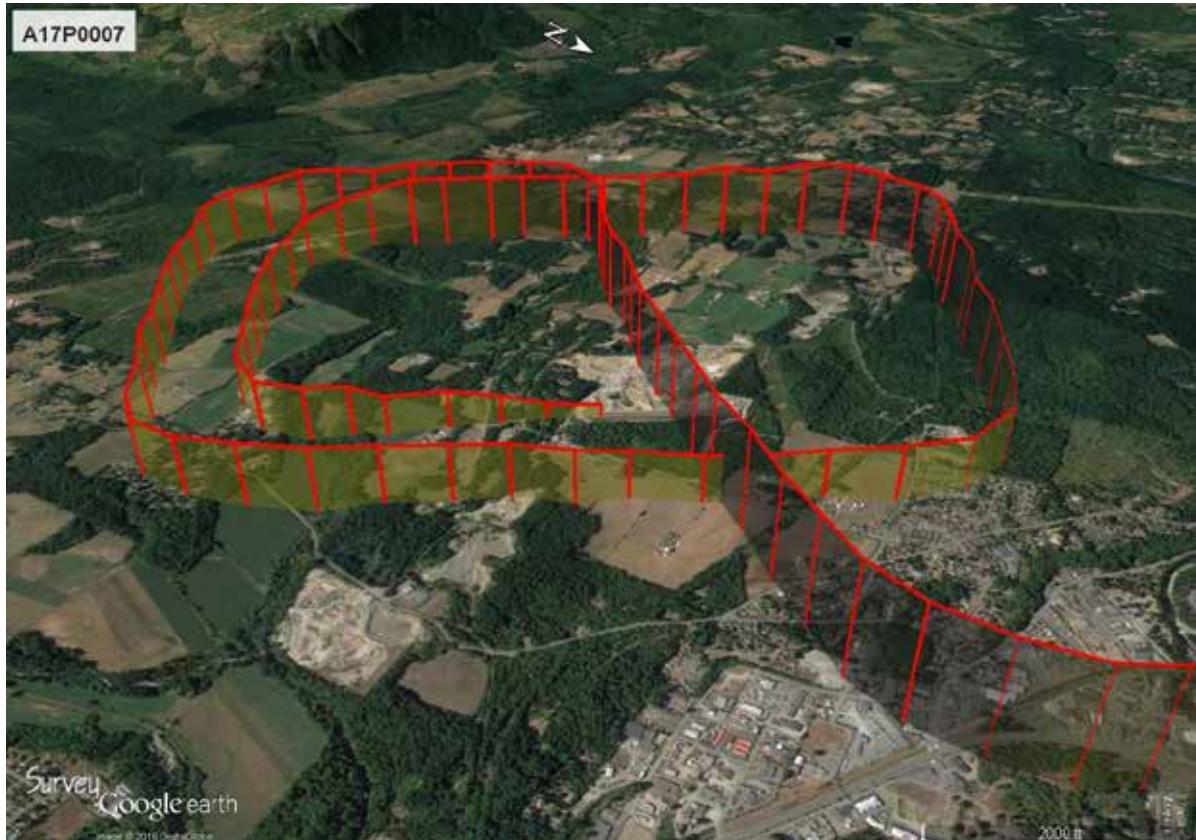
approach for short-field landings in smooth air conditions, and states that “slightly higher approach speeds should be used in turbulent air conditions.”⁵ The descent angle to the runway threshold was about 7°, placing the aircraft significantly above the commonly used 3° flight path with which the student pilot was familiar. However, steeper approaches are often used for short-field landings. The investigation later determined that a rate of descent of about 1000 feet per minute had been required.

Figure 1. Radar track of C-GZXB’s flight path at CAM3, as seen from the northeast (Source: Google Earth, with TSB annotations)

The aircraft was high on final approach, and the approach was steeper than commonly used and faster than was prescribed. With idle power and the flaps fully extended, a slip was subsequently necessary for the aircraft to descend steeply enough to land on the runway. As a result, the aircraft crossed the runway threshold above the intended touchdown speed and remained airborne in ground effect for at least one-third of the runway length before touching down.
