Air Transportation Safety Investigation Report A17P0170

VISUAL FLIGHT RULES FLIGHT INTO DETERIORATING WEATHER AND COLLISION WITH TERRAIN

Mooney M20D, C-FESN
Revelstoke, British Columbia, 26 nm NE
25 November 2017

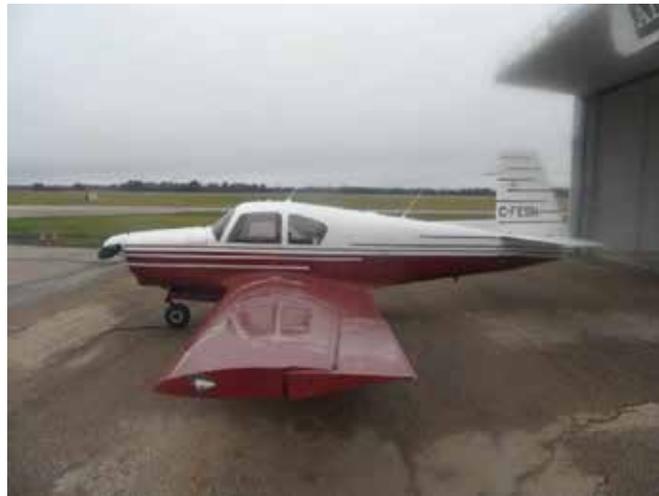
Figure 1. The occurrence aircraft (Source: R. Friesen)

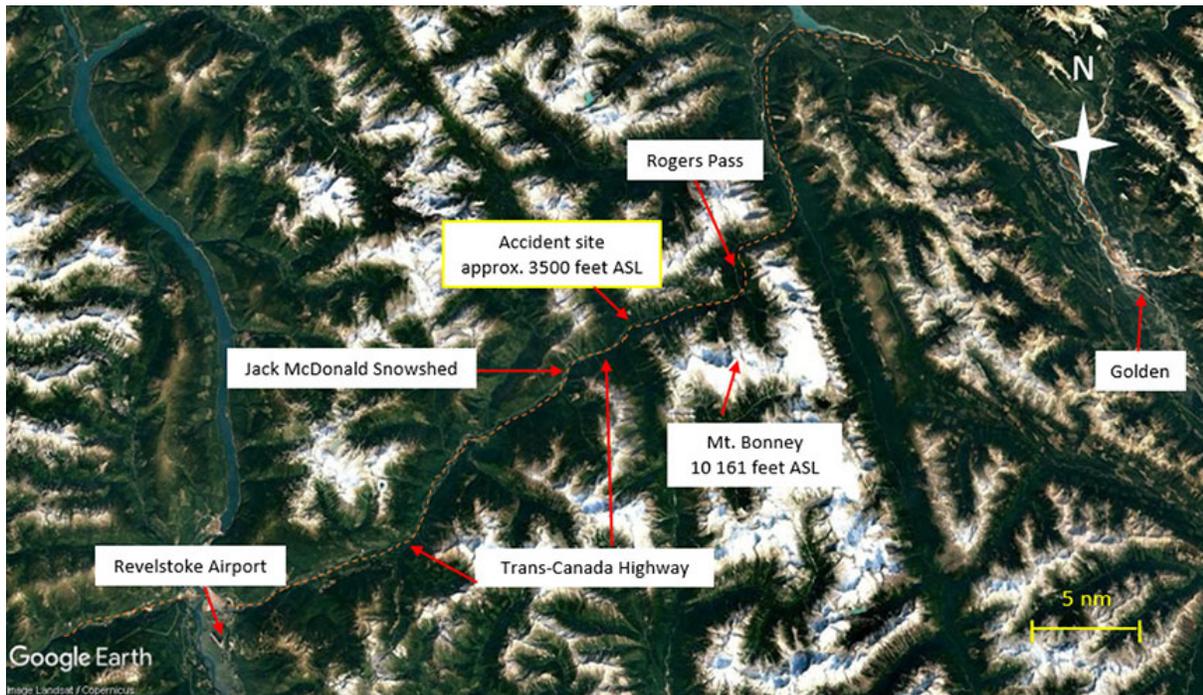
Figure 2. Aircraft's last known position and the accident site (Source: Google Earth, with TSB annotations)

On 10 September 2018, a helicopter heading to Kamloops Airport (CYKA), British Columbia, found the accident site approximately 26 nautical miles (nm) northeast of CYRV (Figure 2). The wreckage was located in Glacier National Park, approximately 500 feet north of the Trans-Canada Highway at approximately 3500 feet ASL, in a heavily forested area.

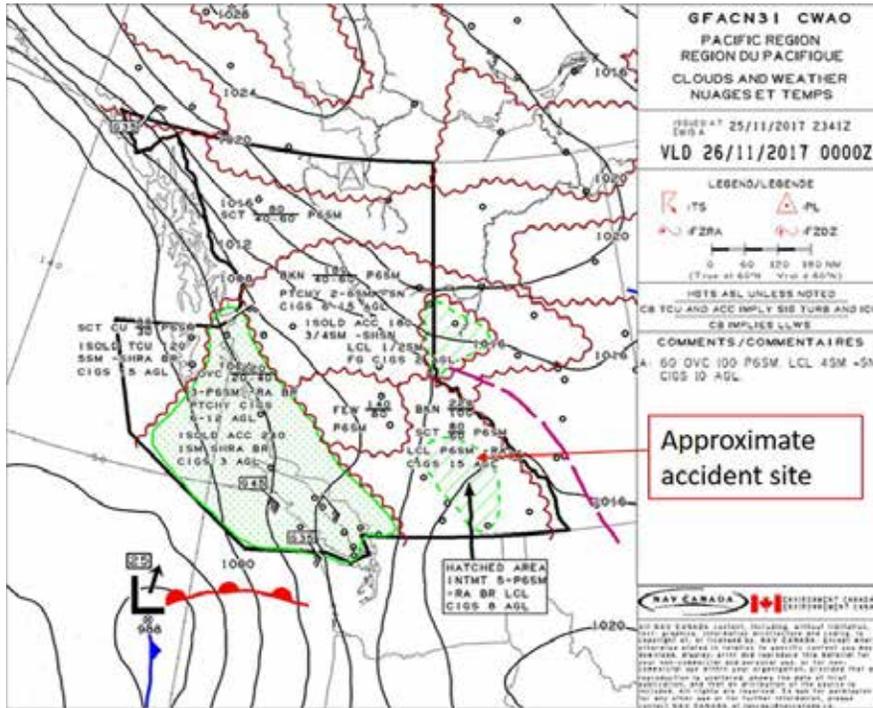
According to the graphical area forecast (GFA) (Figure 3), the forecast for the eastern part of British Columbia—within the Rocky Mountains and along the route to CZVL—was as follows: scattered clouds

based at 6000 feet ASL with tops at 8000 feet ASL; a broken layer of clouds based at 10 000 feet ASL with tops at 22 000 feet ASL; and visibility greater than 6 sm. Also, localized ceilings were forecast at 1500 feet AGL with light rain. An area near Glacier National Park and Rogers Pass was forecast to have intermittent ceilings at 800 feet AGL with mist and light rain, and the visibility was forecast to vary between 5 sm and greater than 6 sm. Sunset for Revelstoke on 25 November 2017 was at 1554.

Figure 3. Graphical area forecast (Source NAV CANADA, with TSB annotations)

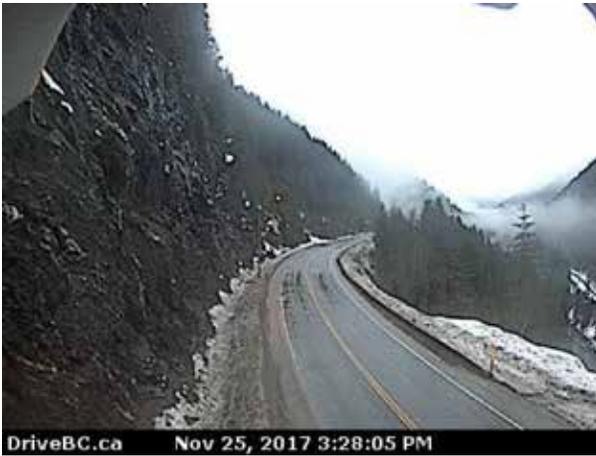
At 1528 on 25 November 2017, local webcam photos depicted low ceilings, fog, and limited visibility due to snow near the occurrence site (Figure 4 and Figure 5).

Figure 4. Northeast view taken at Jack McDonald Snowshed (3050 feet ASL), 22 nm northeast of CYRV at 1528 on the day of the occurrence (Source: DriveBC.ca)

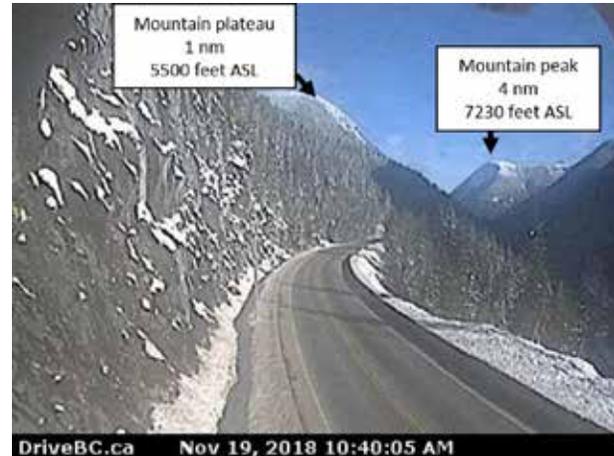
Figure 5. Northeast view taken at Jack McDonald Snowshed (3050 feet ASL), 22 nm northeast of CYRV at 1040 on 19 November 2018 (right) (Source: DriveBC.ca, with TSB annotations)

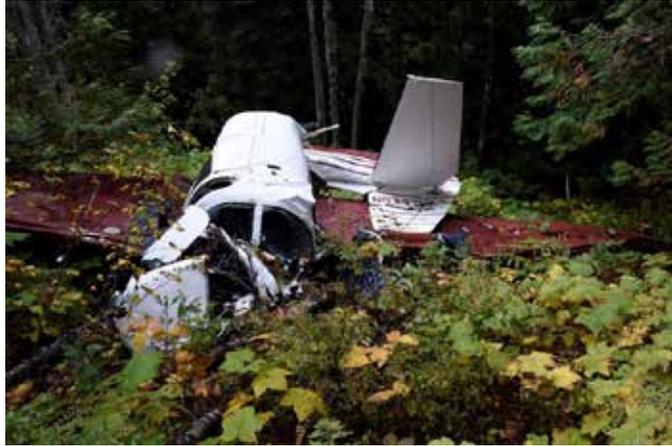
The aircraft was found at approximately 3500 feet ASL, 500 feet north of the Trans-Canada Highway in a heavily forested area (Figure 6). Most of the wreckage was found at the impact location. Examination of the wreckage indicated that the aircraft struck the terrain in a steep, nose-down attitude. The slope of the hillside was approximately 25°. The flaps were found in the fully retracted (up) position. The landing gear

was found in the partially extended position; however, the investigation was unable to determine if the landing gear had been selected down or if it had been extended a result of the impact forces.

All flight control surfaces were accounted for. Damage to the propeller was consistent with power being produced at the time of impact.

Figure 6. Accident site, view looking downhill (Source: Royal Canadian Mounted Police)
