AIR TRANSPORTATION SAFETY INVESTIGATION REPORT A18P0031

LOSS OF CONTROL AND COLLISION WITH TERRAIN

Island Express Air Inc.
Beechcraft King Air B100, C-GIAE
Abbotsford Airport, British Columbia
23 February 2018

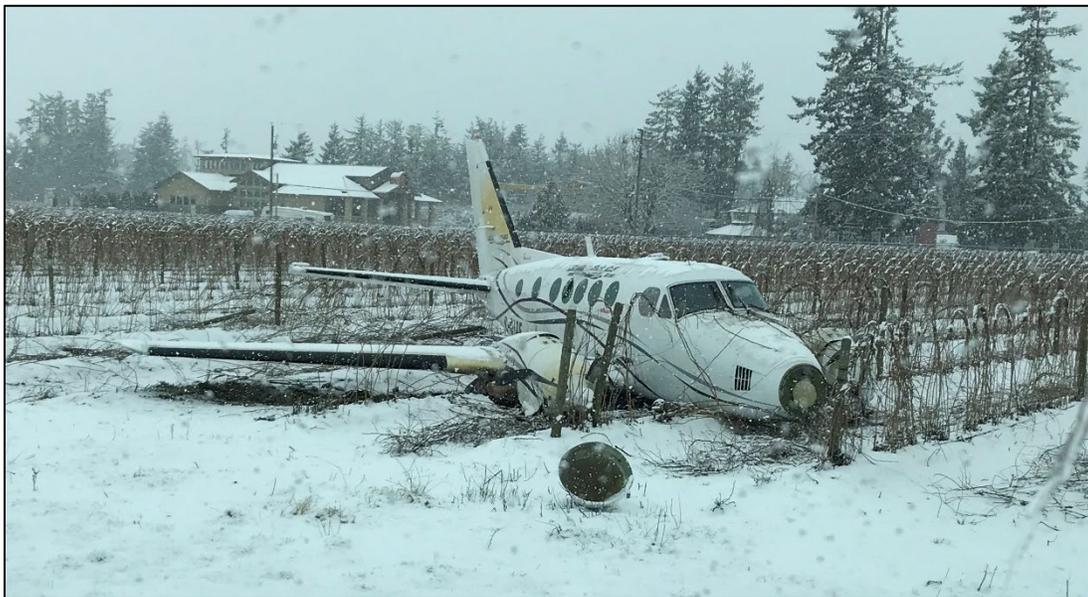
The impact point was between Runway 07 and Taxiway C. The terrain at the initial point of collision was flat and not frozen at the time of the occurrence; however, it was covered by approximately 3 cm of snow. After the initial collision with terrain, the aircraft skidded about 760 feet across the ground and Taxiway C before it came to rest in a raspberry patch about 800 feet left of the runway centreline and about 7500 feet from the runway threshold (Figure 1). The left wing broke off, just outboard of the left engine nacelle during the impact sequence.

Figure 1. Occurrence aircraft where it came to rest (Source: Transport Canada)

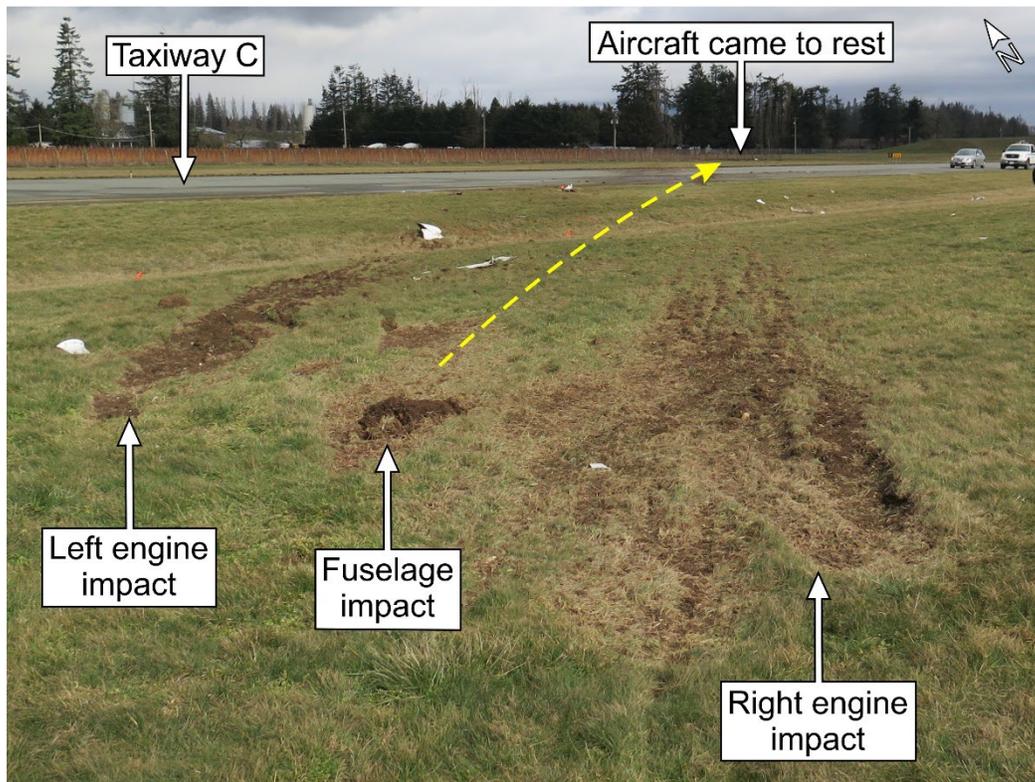
Examination of the initial point of collision on the terrain showed 3 distinguishable ground scars (Figure 2). The 2 long ground scars consistent with impact by the bottoms of the engine nacelles were on each side of a ground scar consistent with impact by the bottom of the fuselage. The maximum depth of this ground scar was estimated to be greater than 1 inch (2.5 cm). Crushing to the bottom of the fuselage and both engine nacelles, as well as the absence of signs of interaction between the right wingtip and the ground, indicated the aircraft had been nearly level in pitch and roll when it collided with the terrain. Signs of vertical shear on both sides of the fuselage were consistent with a large upward impact force transmitted from the wing spars when the bottoms of the engine nacelles struck the ground.

Performance calculations carried out at the TSB Engineering Laboratory determined that the vertical descent velocity of the aircraft at the time of the crash (at the beginning of the impact) was estimated to be at least 20 fps.

Figure 2. The aircraft's initial point of collision with terrain and the direction of travel (photograph taken 27 February 2018) (Source: TSB)

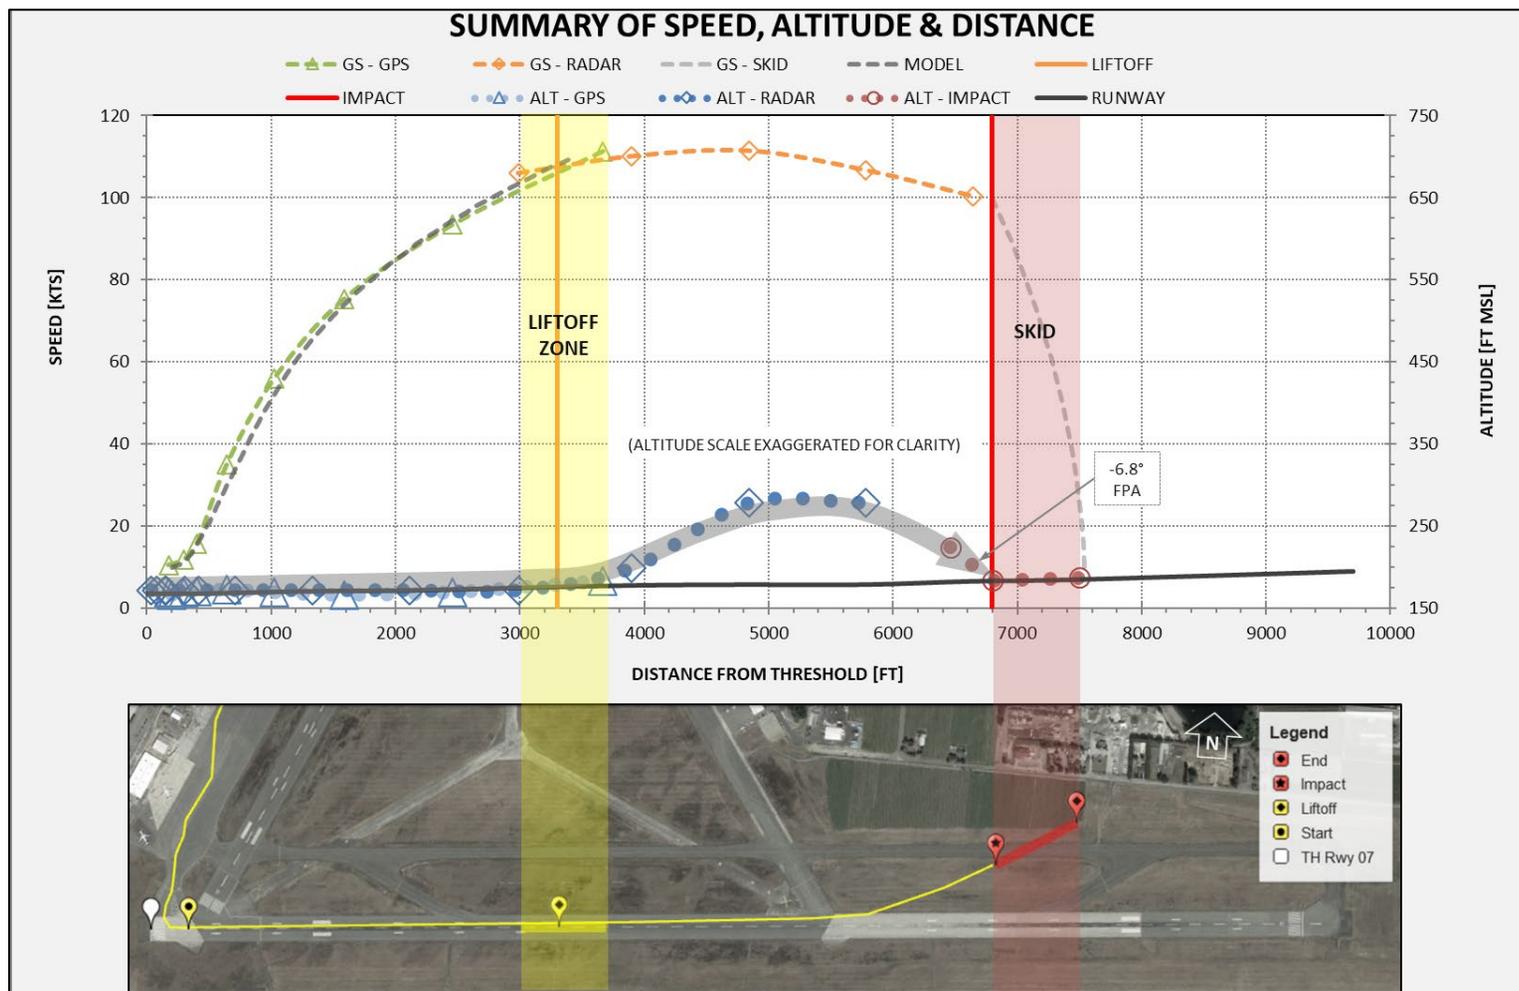
Appendix C – Reconstruction of the path taken by the occurrence aircraft

Note: The "Model" line represents the predicted runway performance based on the aircraft flight manual, aircraft loading, and environmental considerations. (Source: TSB)

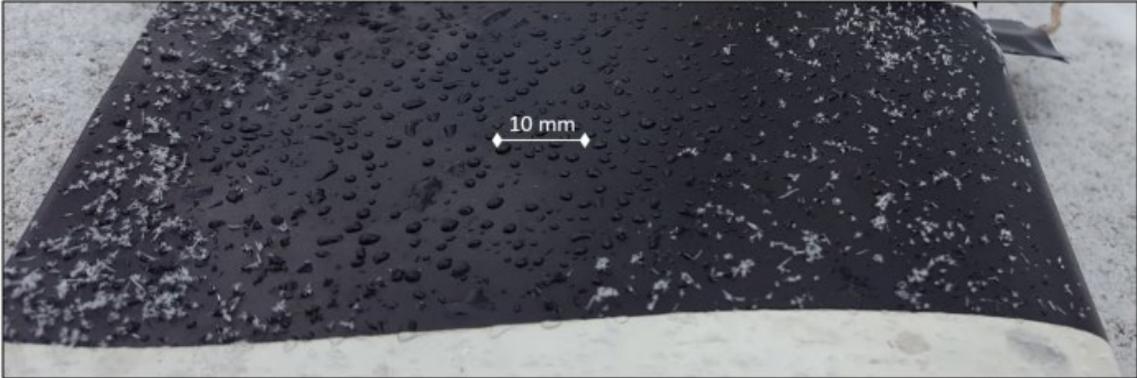
In the cooling tests, the first snowflakes that fell on the warm component melted into small water drops about 1 to 2 mm in size. As the surface quickly cooled, the melt rate decreased, and a mixture of water drops and partially melted flakes was observed (Appendix D, Figure D1). As the surface reached 0°C , ice crystals began to grow from the water drops (Appendix D, Figure D2). As snowfall continued, the falling flakes bonded with the partially melted and re-frozen precipitation layer, creating a very rough surface that protruded up to

Figure D1. Cooling test showing melted flakes and ice crystals

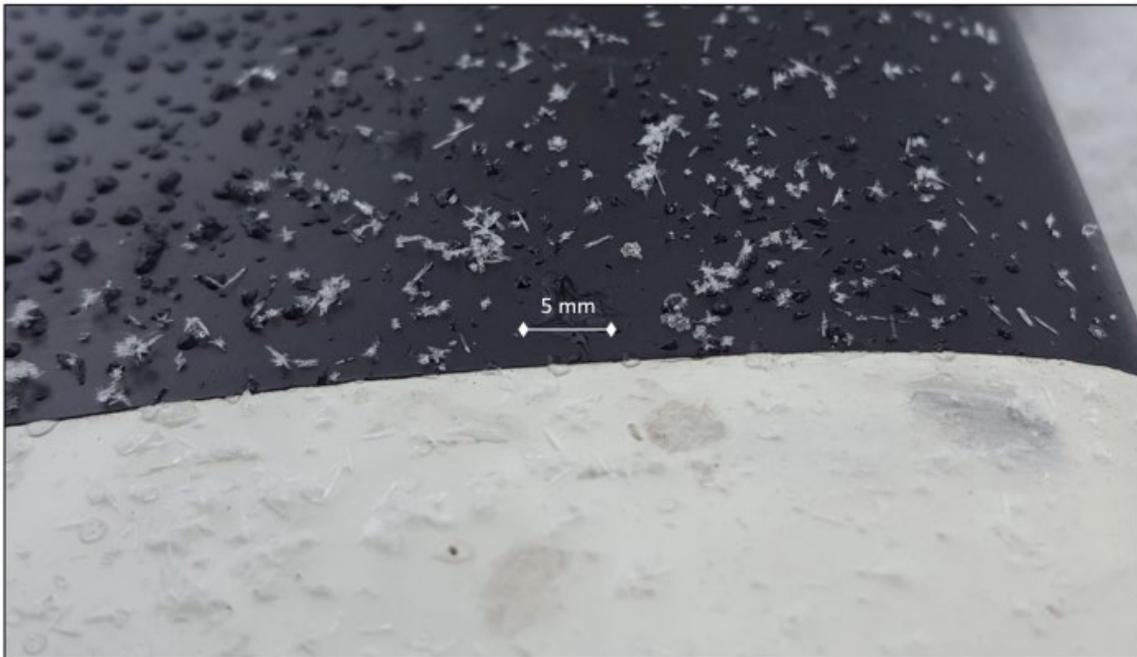
Figure D2. Cooling test (close-up)

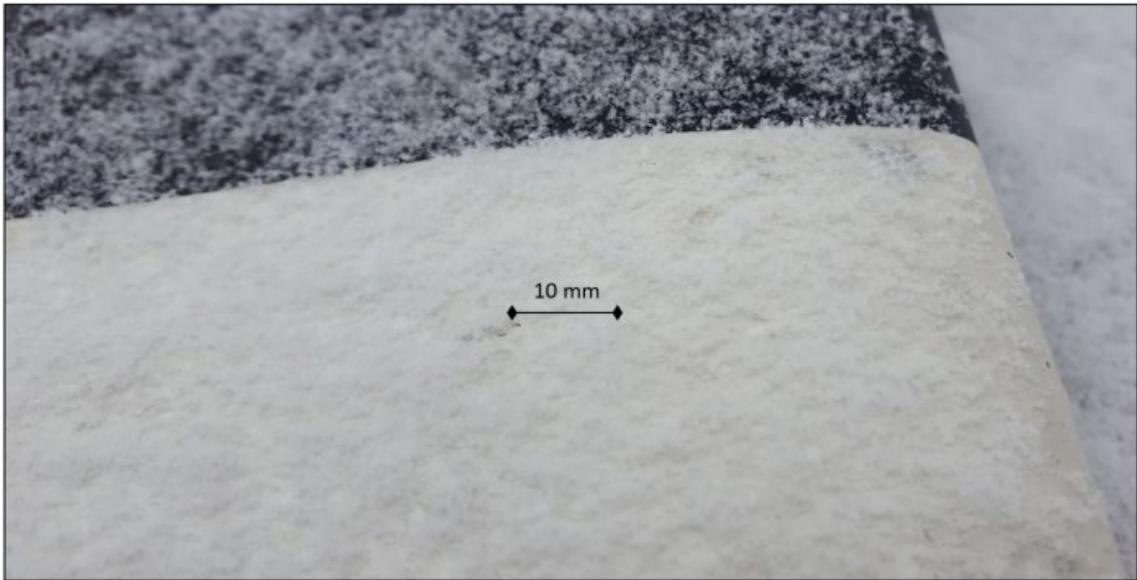
Figure D3. Cooling test after additional snowfall

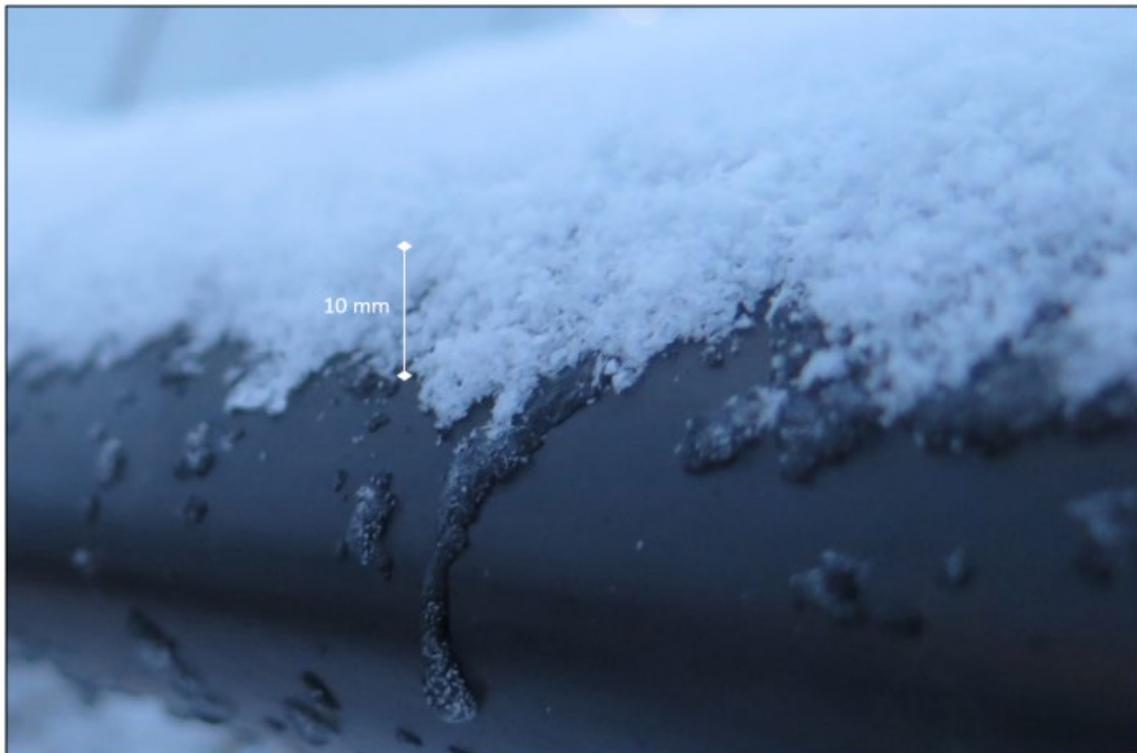
Figure D4. Occurrence wreckage demonstrating the melt/refreeze process approximately 8 hours after the occurrence
