Air Transportation Safety Investigation Report A18P0091

COLLISION WITH TREES AFTER TAKEOFF

Piper PA-28-140, C-GVZP
Sechelt Aerodrome, British Columbia
05 July 2018

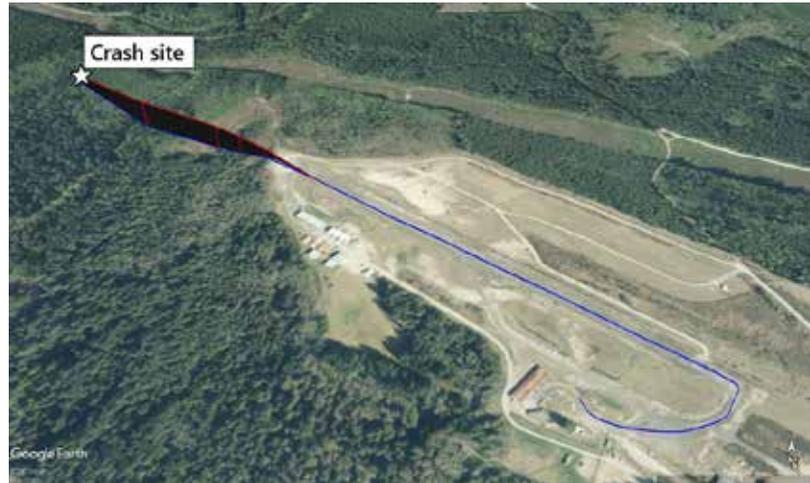
up attitude and slowly decelerated as it crossed the Chapman Creek ravine. It was airborne for less than 30 seconds before it collided with trees and crashed on the far side of the ravine, about 0.35 nm from the departure end of the runway (Figure 1).

Figure 1. Global positioning system track of the occurrence aircraft's flight path, as seen from the south (Source: Google Earth, with TSB annotations)

Global positioning system data shows differences in aircraft performance on the first flight compared to the accident flight. Both flights became airborne at about 73 mph (ground speed¹²), but on the accident flight, the ground run (1700 feet) to reach that speed was longer than on the previous flight (1300 feet). Both ground runs were longer than the minimum indicated in the Owner's Handbook (1000 feet) for the density altitude. On the earlier flight, the aircraft continued to accelerate while climbing after takeoff. However, on the accident flight, the highest speed the aircraft reached was at liftoff. After this point, the ground speed steadily decreased to 59 mph—even though the aircraft was descending for about the last 15 seconds of the flight—and the aircraft collided with trees.

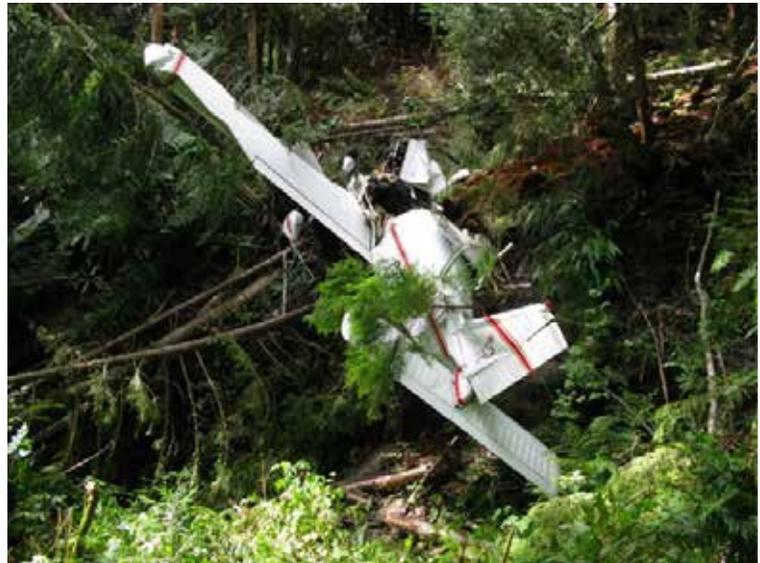
The aircraft was destroyed (Figure 2). The pilot was fatally injured. The 3 passengers received minor injuries and were able to exit the aircraft and walk to nearby houses. The emergency locator transmitter did not activate during the crash. There was no post-impact fire.

Figure 2. Accident site
