# Air Transportation Safety Investigation Report A18W0054

## ENGINE POWER LOSS AND FORCED LANDING

Super T Aviation  
Piper PA-31-350 Navajo Chieftain, C-FCWW  
Calgary, Alberta  
25 April 2018

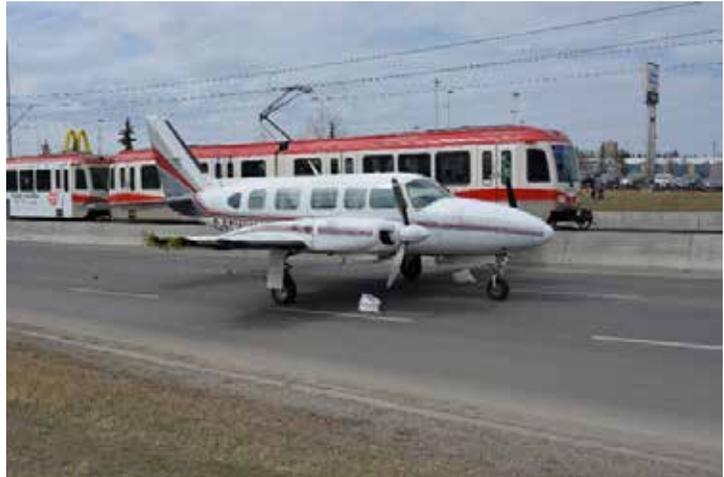
The aircraft touched down in the northbound lanes of 36 Street N.E., just north of the intersection with Marlborough Drive N.E. Shortly after the aircraft touched down, its right wing contacted a light standard on the right side of the road, shearing off the outer 4 feet of the wing. The aircraft continued north, through the intersection with Marbank Drive N.E., and came to a stop just south of the on-ramp for eastbound 16 Avenue N.E., which is part of the Trans-Canada Highway (Figure 1).

**Figure 1. The occurrence aircraft after coming to a stop on 36 Street N.E., Calgary, Alberta**
