## Marine Occurrence Report

### Swamping and Sinking

of the Small Fishing Vessel "E.L.M."  
in the Minas Basin, Nova Scotia  
05 July 1993

Report Number M93M4022

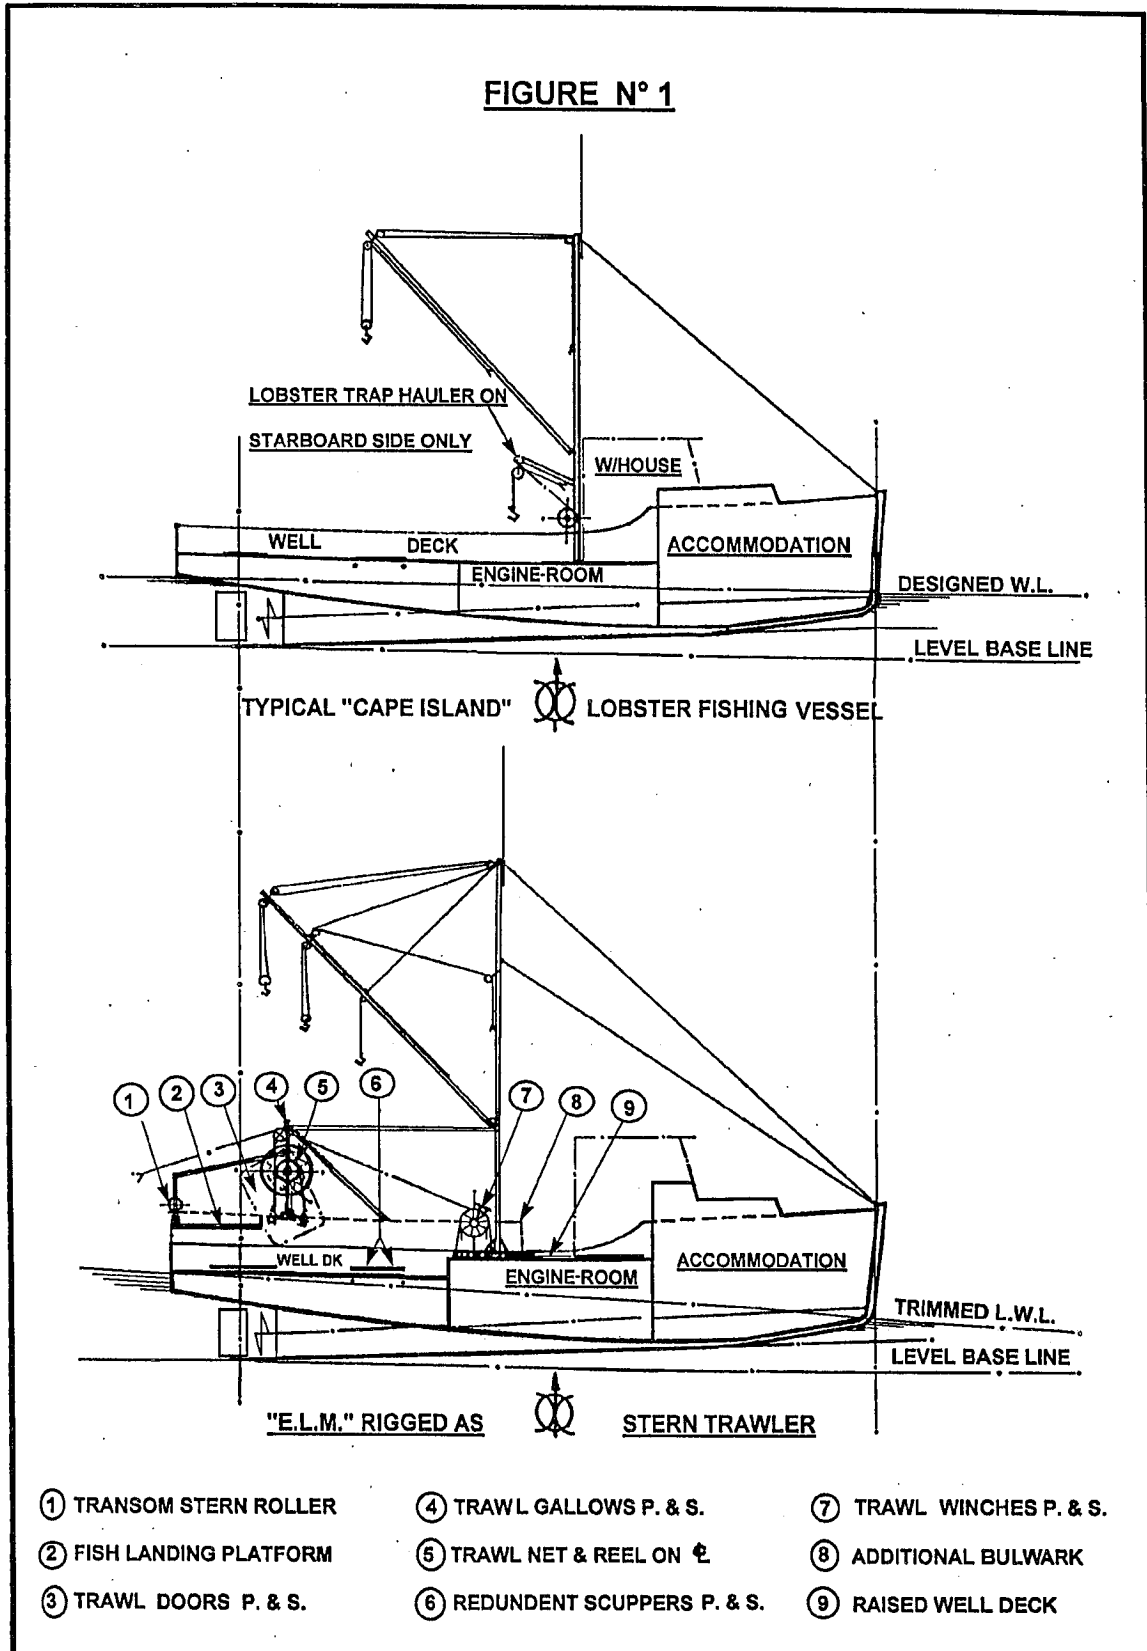
Appendix B - Conversion Diagram

hydraulically driven trawl winches, net reel, trawl doors, fishing warps and a net. The original non-watertight well deck was raised 0.35 m in way of the engine compartment and a fish landing platform was fitted at the stern. Additional 0.46 m-high bulwarks were constructed on top of the existing gunwales on the port and starboard sides, extending from midships to the stern and across the transom.

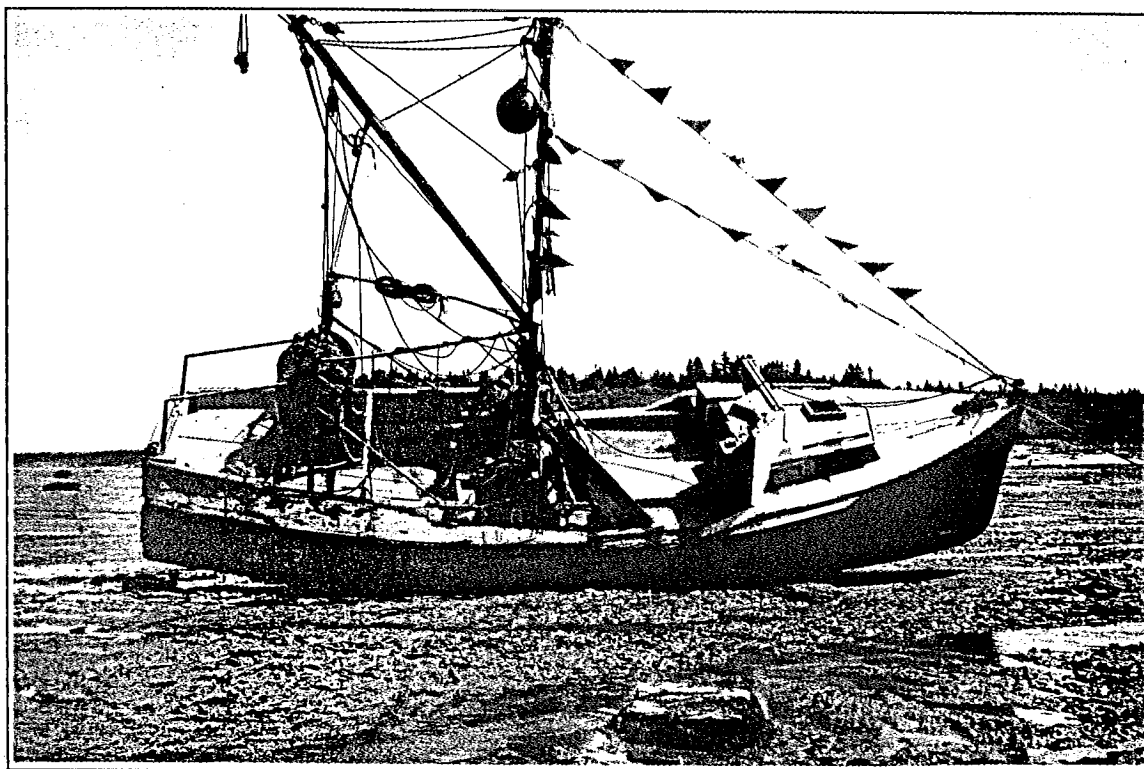
The "E.L.M." at low tide in position of sinking.

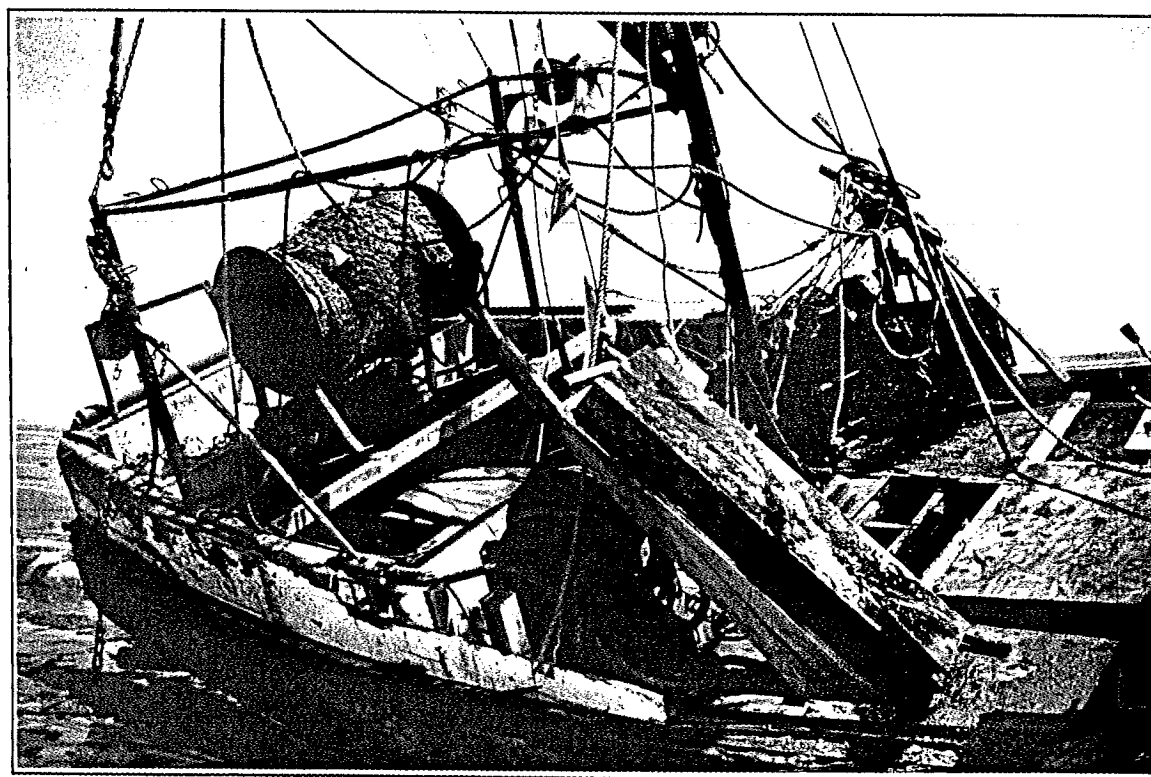
View of stern showing modifications and additional gear fitted for trawling.
