MARINE INVESTIGATION REPORT

M98C0082

STRIKING OF A LIGHT STRUCTURE

THE BULK CARRIER "FEDERAL BERGEN"

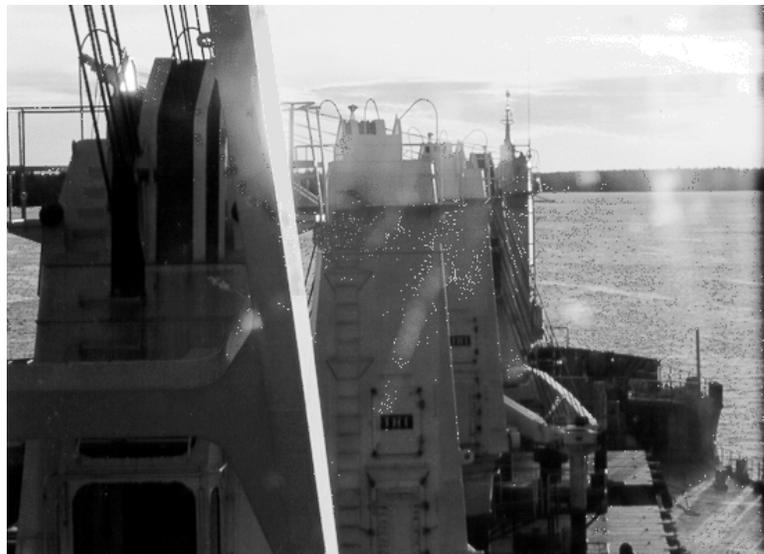
The vessel has five cranes forward, which were in the housed position. These cranes partially restricted the view forward such that a person stationed on the starboard side of the bridge could not see across the bow to the port side.

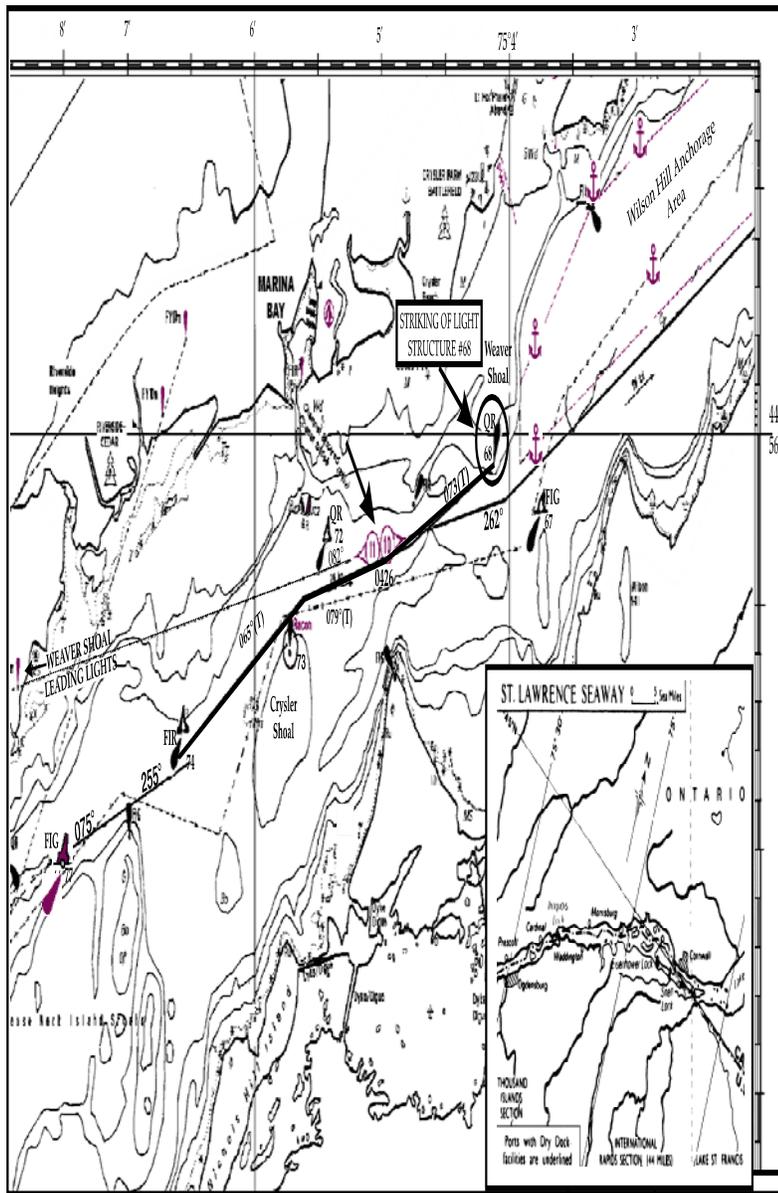
Appendix A - Sketch of the Occurrence Area

By this time, striking of light structure "68" was imminent and the pilot ordered hard-a-starboard helm. However, this action was initiated too late and about the time the "FEDERAL BERGEN" started responding to the helm, the port bow of the vessel came in contact with light structure "68", some 5 m from the stem at approximately 0430.

If it is accepted that the vessel’s position was on the recommended track and, had the vessel’s course of 077° been maintained, she would have cleared light “68” by some 120 m; the distance according to the recommended track on the chart is 150 m. An alteration to 080° would have placed the vessel some 30 m further south and at the recommended distance for normal downbound transits.
