MARINE INVESTIGATION REPORT

M99W0116

STRIKING

CANADIAN COAST GUARD HOVERCRAFT "SIYAY"  
STEVESTON JETTY, SOUTH ARM OF THE FRASER RIVER, BRITISH  
COLUMBIA  
15 JULY 1999

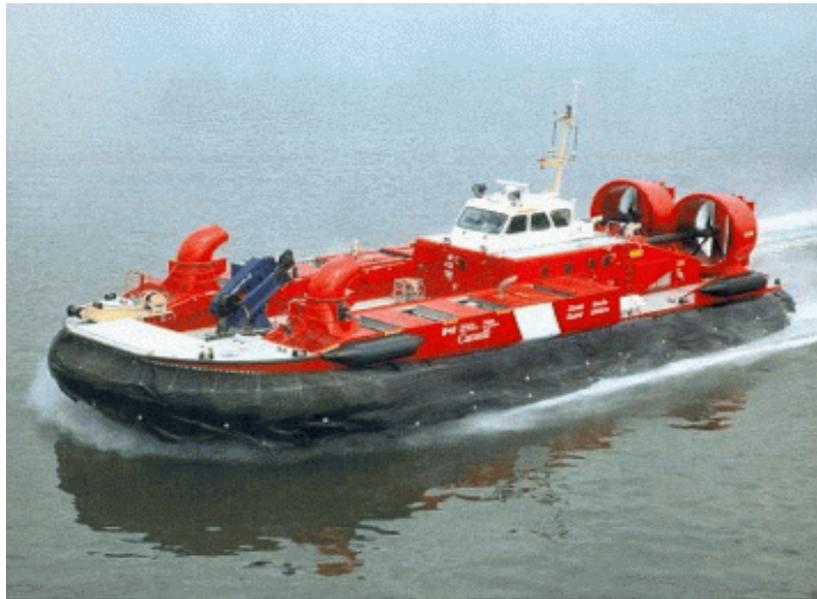
The control cabin of the “SIYAY”, similar in design to that of an aircraft, is near the after end of the craft (see Figure 1). The design allows for an excellent view forward, with the exception of the bow thruster vents to port and starboard at the forward end of the craft, which cause blind sectors. Operationally these blind sectors are overcome by the craft captain and port seat occupant exchanging information as targets move from one sector to the other.

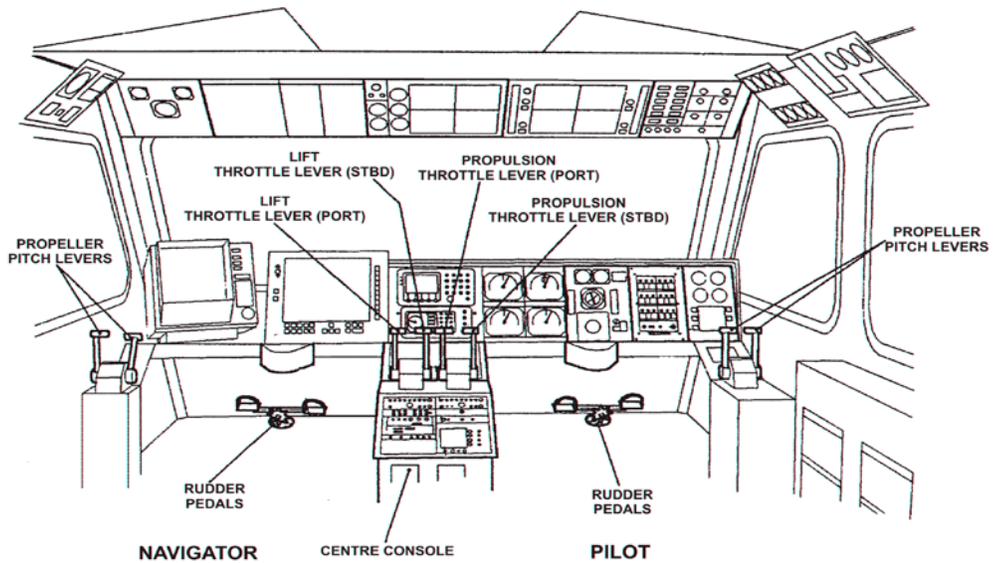
**CONTROL CABIN LAYOUT (SEAT NOT SHOWN)**

The control cabin consists of four seats, two forward and two aft. Manoeuvring- and navigation-related instrumentation is arrayed across the fore part of the control cabin, below the windows (see Figure 2). Dual control levers for the propulsion system are in a centre console between the two forward seats. Dual controls for the bow thrusters are immediately in front of each forward seat. The very high frequency radios are on the centre console, and communication is via headsets. Navigation instrumentation consists of a radar, gyro, global positioning system, and depth finder. An additional radar is in the after part of the control cabin in a position accessible to the port side seat occupant.

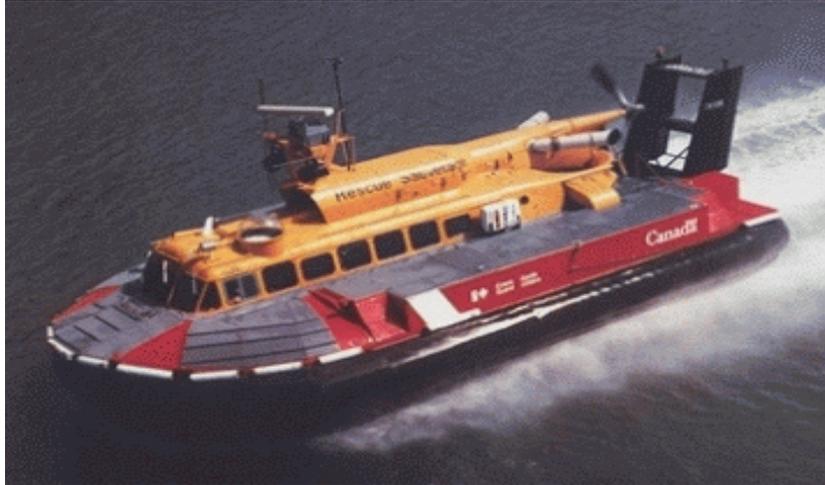
The CCG Sea Island Base in Richmond, British Columbia, had been operating two SRN-6 hovercrafts in continuous SAR service since August 1968 (see Figure 3). In 1993, the CCG identified the need for a hovercraft replacement program for the two SRN-6s at Sea Island Base and recommended the AP1-88, in part because of its multi-mission capabilities.
