MARINE INVESTIGATION REPORT
M03W0265

COLLISION

BARGE *PACKMORE 4000* UNDER TOW BY TUG *TIGER SHAMAN*

FRASER RIVER NEAR MISSION, BRITISH COLUMBIA

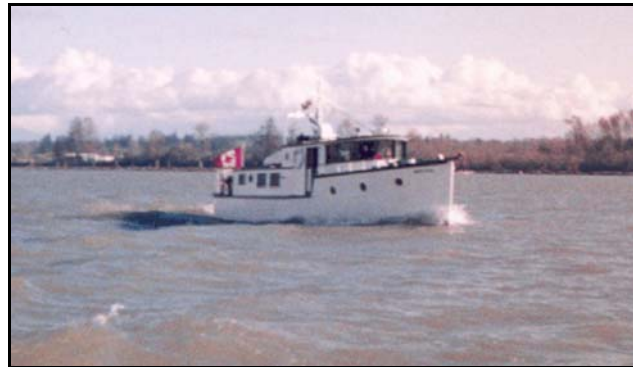
Photo 1. Pleasure craft *Mistral*

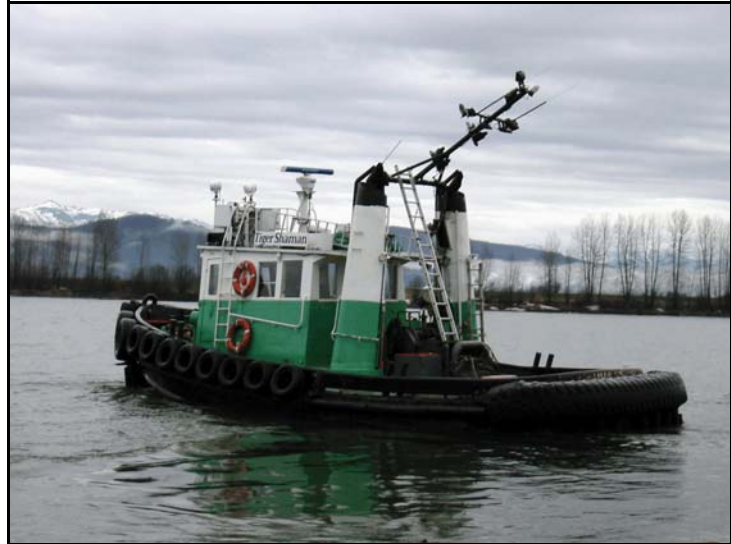
Photo 2. Tug *Tiger Shaman* with mast lowered 45 degrees

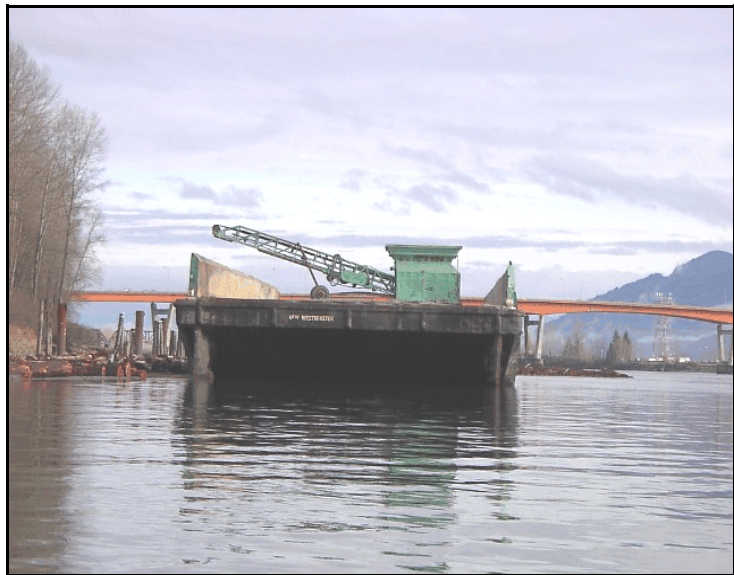
Photo 3. End view of barge *Packmore 4000*

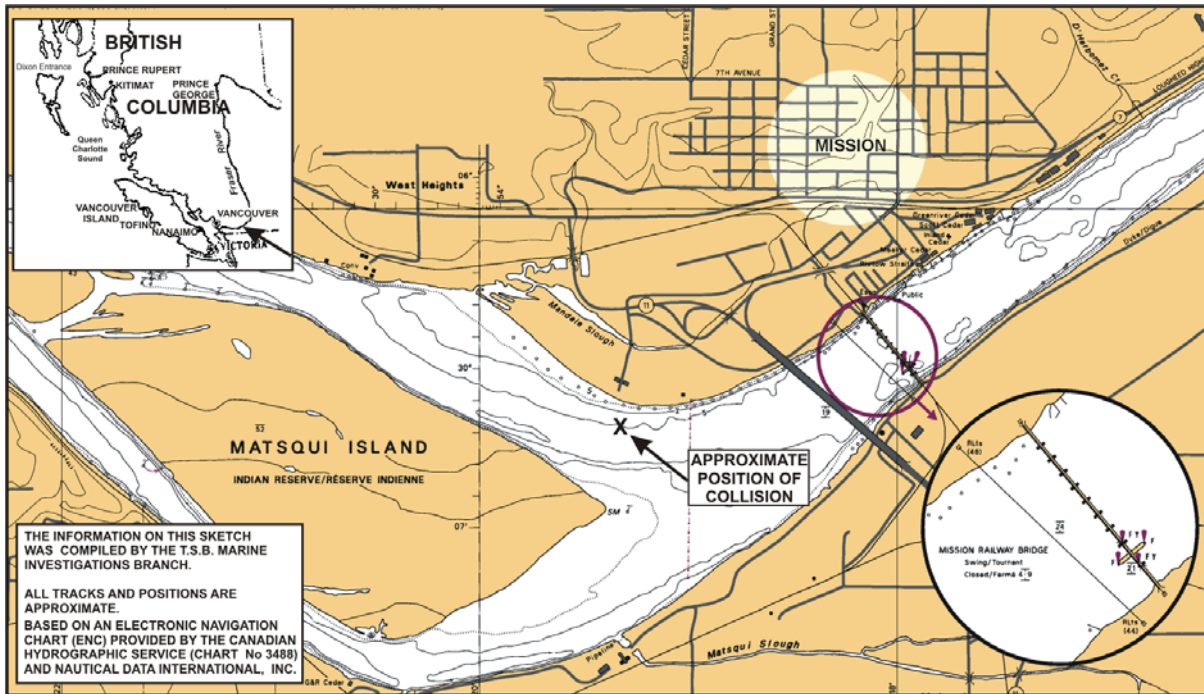
Figure 1. Fraser River, north of Matsqui Island, where collision occurred

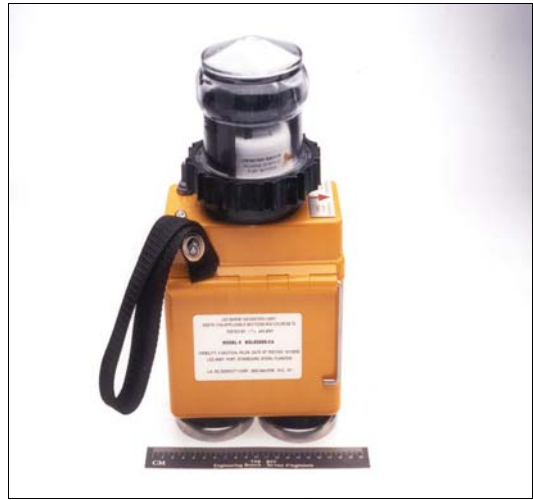
Photo 4. LED barge navigation lamp

The investigation by the TSB into the 1999 collision between the pleasure craft *Sunboy* and the tug *Jose Narvaez* towing the barge *Texada B.C.* (M99W0133) determined that the portable lamp in use on the barge did not meet the minimum range requirements. With this knowledge, the towing industry and Transport Canada sought an alternative. Barge navigation lamps manufactured in the USA that meet relevant USCG regulations were subsequently further tested and found by Transport Canada to meet the requirements of the *Collision Regulations and Standards for Navigation Lights, Shapes, Sound Signal Appliances, and Radar Reflectors*, TP 1861, for use on unmanned barges in Canadian waters. These approved lamps make use of LED technology (see Photo 4).

- A potential exists to misalign the head and base assemblies of these lamps. This may result in a lamp's failure to meet the horizontal luminous intensity requirement. The manufacturer does not provide alignment documentation.

1. The misalignment of a Light Emitting Diode (LED) barge navigation lamp could significantly reduce its visible range, due to the narrow vertical sector of emitted light, and as the manufacturer does not provide alignment documentation.
2. The exemption of unmanned barges lamps from the vertical sector component requirements applicable to other commercial vessels makes any misalignment safety-critical and may deprive navigators on the approaching vessel from sighting the light in sufficient time to take collision-avoidance action.

Following the occurrence, the TSB met with the Council of Marine Carriers (CMC) and expressed concerns about the Light Emitting Diode (LED) navigation lamps.
