MARINE INVESTIGATION REPORT M04L0092

GROUNDING

CONTAINER SHIP *HORIZON*
SAINTE-ANNE-DE-SOREL, QUEBEC
24 JULY 2004

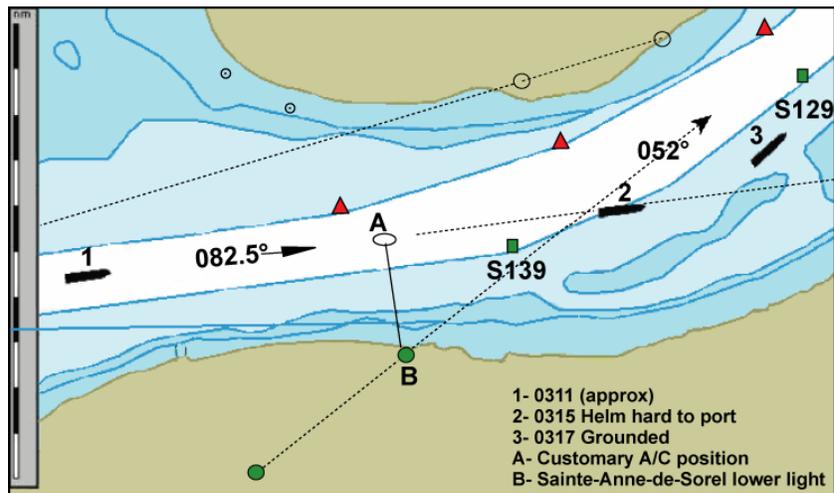
Figure 1. Area in the vicinity of alter-course (A/C) position

Soon after the vessel passed buoy S-139 on the starboard side, the helmsman noticed a tendency for the vessel to swing to port. He applied 5 and then 10 degrees of starboard helm to maintain the ordered course, but the vessel continued the trend to port. The helmsman read aloud the descending ship's heading, zero, eight, three - zero, eight, two - zero, eight, one. At this point, the pilot stood up and ordered hard-a-port. The helm was applied accordingly, and the vessel began to swing in that direction. As the vessel turned to port, it also slowed down and made

contact with the muddy channel bottom. At 0317, the vessel grounded on the 056° G heading, in position 46°03' 57" N latitude, 073° 02' 13" W longitude, approximately one cable to the southeast of the channel limit (see Figure 1). The Marine Communications and Traffic Services (MCTS) centre at Montréal was contacted and made aware of the situation. Damage to the vessel was minor.

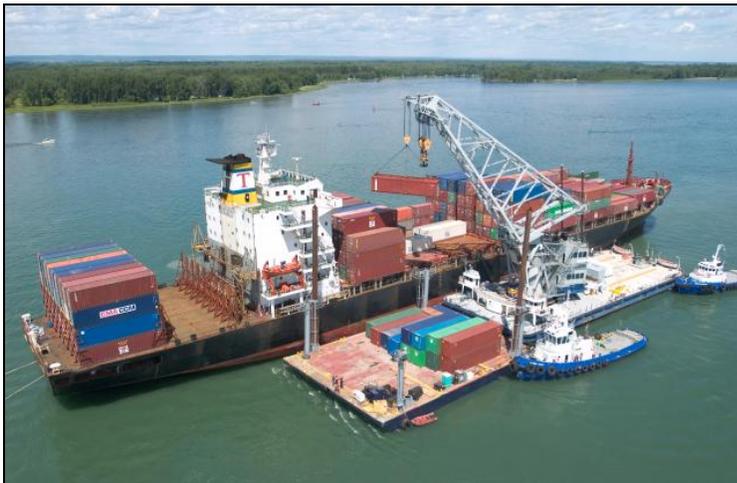
Photo 2. Lightering operations

By 26 July 2004, plans to lighten the *Horizon* were now being considered. On July 30, Ocean Group was awarded the salvage contract. The salvor in turn contracted a barge and a self-propelled floating crane in order to discharge 112 containers weighing approximately 2400 tonnes.

Lightering commenced on 01 August 2004, and by August 3, some 71 containers had been discharged, for a total mass of approximately 1320 tonnes. As abundant rainfall on July 28, 30, and 31 had returned the river level to essentially the same height as on the morning of the grounding, it was decided to refloat the vessel using five tugs. This attempt, too, was unsuccessful, and on August 4, another 38 containers were discharged, bringing the total to 109 removed containers, for a combined weight of 2240 tonnes. At 1650, now with the additional help of a sixth tug, the *Horizon* began moving. By 1700, it was afloat in the channel, with fore and aft draughts of 7.05 m and 7.81 m, respectively.

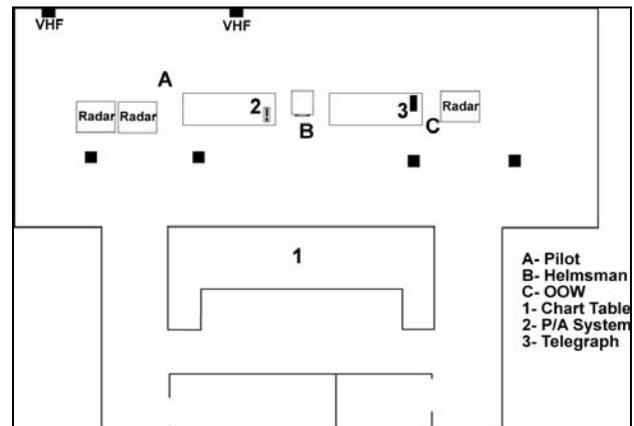
Figure 2. Bridge layout

The *Horizon's* bridge layout is typical of the majority of ocean-going cargo vessels. The arrangement can be seen in Figure 2, which shows the position of the bridge team members just before the grounding. The four black squares just aft of the instruments and forward of the chart table are structural pillars that extend from deck to deckhead.

During the night-time trip downriver, the bridge team was spread throughout the darkened wheelhouse, with the various members attending to their respective duties. Communication among team members was limited. The pilot voiced headings to steer, and the helmsman repeated these headings as each manoeuvre was executed. Just before the grounding, the pilot, who was seated to port, was 3.3 m from the helmsman at the steering stand and approximately 6.7 m from the OOW, who was standing near the engine room telegraph.

The bridge of the *Horizon*, for example, as well as many other vessels of even more recent construction, is essentially the same as those constructed in the 1950s or even earlier – only with more buttons, controls, and alarms to consider. Such a layout, which has not kept pace with advances in ergonomics and technology, is not conducive to BRM techniques and precise vessel control.
