## MARINE INVESTIGATION REPORT

M04W0235

**SINKING AND LOSS OF LIFE**

**THE TUG *MANSON* TOWING THE  
CRANE BARGE *MCKENZIE* AND DECK BARGE *M.B.D. 32***

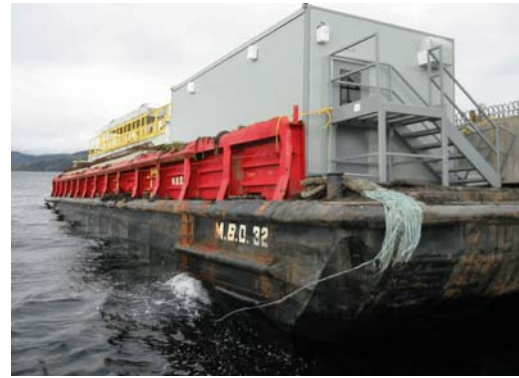
**Photo 3.** *M.B.D. 32* (note the parted rope coupler at bow)

In this occurrence, when connecting the *M.B.D. 32* to the *McKenzie* for the tow across the Strait of Georgia in November – a time when rough weather and sea conditions are to be expected – short, synthetic-rope couplers were used instead of a longer, more robust wire arrangement that would have been better suited to the conditions. The towing arrangement of the *Manson* was configured with a wire pendant so that an all-wire option was available to the crew; it is not known why the crew members chose to use shorter, synthetic-rope couplers.
