MARINE INVESTIGATION REPORT
M05C0063

GROUNDING

BULK CARRIER *MICHIPICOTEN*
BRUSH POINT LIGHTED BUOY G17
ST. MARY'S RIVER, ONTARIO
28 OCTOBER 2005

Report Number M05C0063

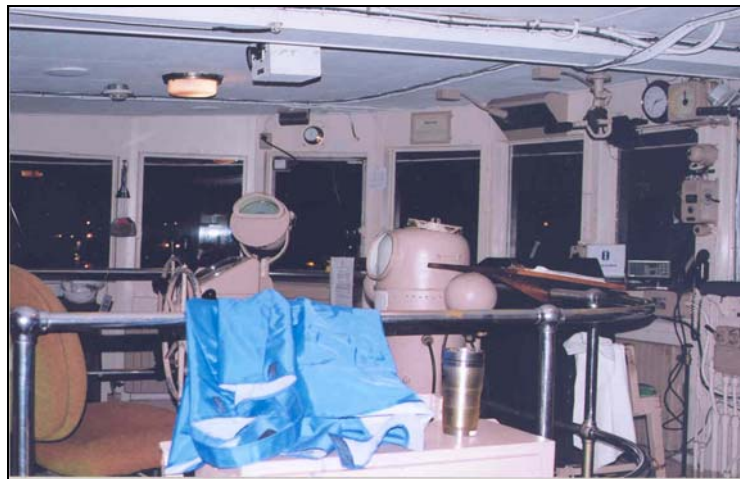
The steering station is located on a raised platform in the middle of the wheelhouse providing the wheelsman with a good view ahead while in close proximity to the course and rudder angle indicators.

Photo 2. View of the raised platform in the middle of the wheelhouse, looking to port.

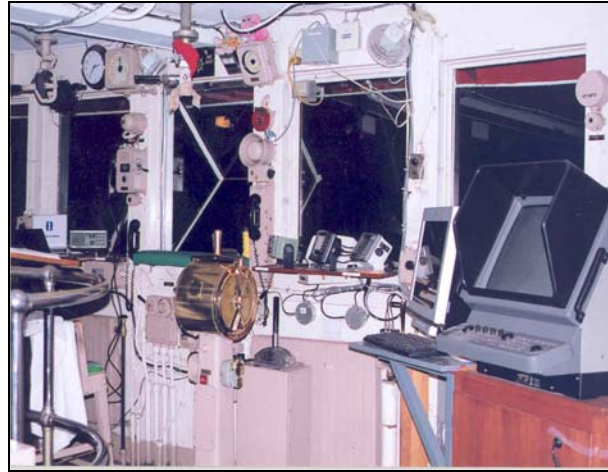
The master was conning the vessel mainly from the pilot's chair, which is forward and starboard of centre. From this position, he had to lean back and look over his right shoulder to see the ECS unit. The light level of the unit's screen was set to monochrome night display, which coloured the entire screen in red. The screen had also been covered with a red transparency to further lower the brightness of the screen. This reduced the clarity of information displayed, including the vessel's position icon.

Photo 3. The pilot's seat is located between the controls on the left and the ECS on the right.

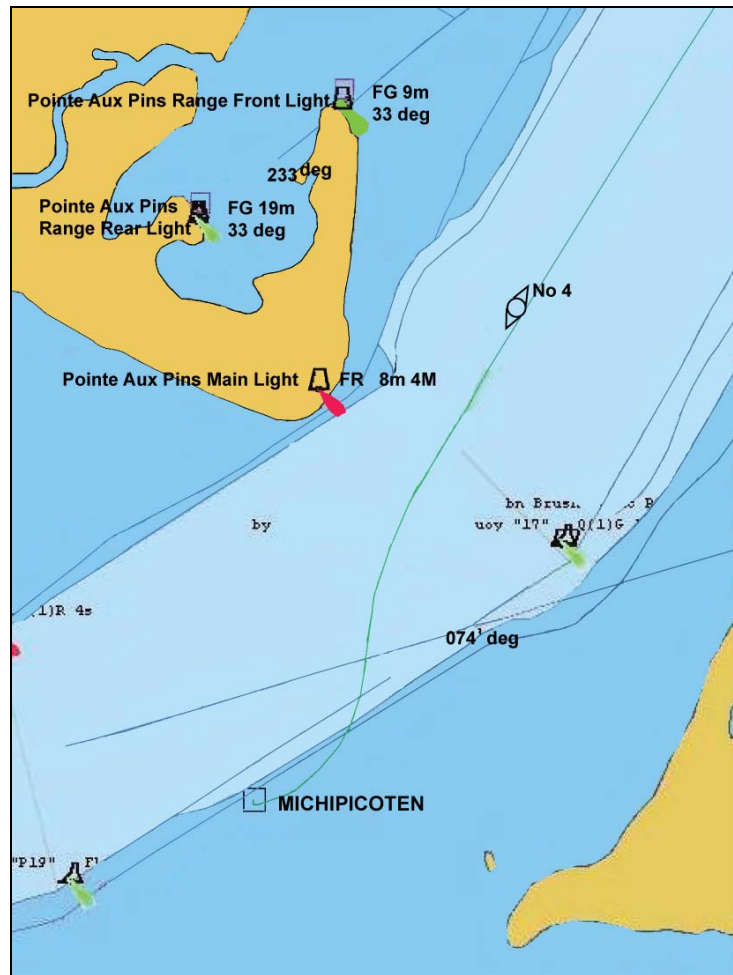
At this time, he reportedly gave the wheelsman the order "20 degrees starboard" with the intention of settling on the new course of 238° T. The wheelsman, however, heard the order as "20 degrees port." As a result, he turned the wheel until the rudder angle indicated 20 degrees to port. He then repeated the order, although the master has no recollection of the order being repeated.

As the *Michipicoten* began turning to port, the master did not observe the movement of the rudder angle indicator from his forward seated position. At approximately 0725, the master saw the image of what appeared to be the ranges at Brush Point reflected in one of the wheelhouse windows. He interpreted this image to mean that the vessel was turning to starboard.

At 0727, the *Michipicoten* was continuing to turn to port. Meanwhile, the wheelsman was able to see the electronic chart display from the steering position. Although untrained in its use, he deduced that the *Michipicoten* was southbound, out of the channel, and informed the master that the last manoeuvring instruction to port may have been a mistake.

The master immediately ordered “hard to starboard.” The *Michipicoten* reduced its turning rate to port and started turning to starboard. However, the vessel was too close to the channel’s southeasterly side and at 0733 the vessel grounded in soft mud, just inside the Canadian border between Brush Point buoys G17 and P19 in position 46°27'34" N, 084°28'23" W (see Figure 2). Following the grounding, all tanks were sounded, and no ingress of water or apparent damage was found. In its grounded position, the vessel did not obstruct either upbound or downbound traffic. The vessel remained grounded until tug assistance was provided several hours later.

Figure 2. Vessel track before the grounding

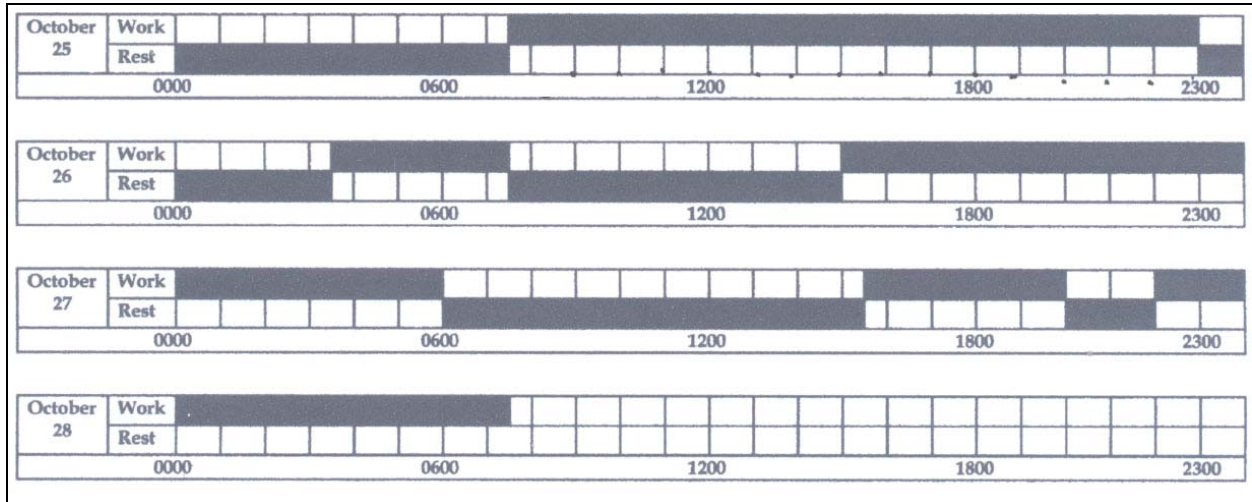
The master piloted the bulk carrier *Saginaw* for 15.5 consecutive hours from 0730 until 2300 on October 25. Commencing at 1500 the following day, he piloted the vessel single-handedly for another 15 consecutive hours until 0600 on October 27. Finally, commencing at 2200, he piloted the *Saginaw* for seven and a half hours until it arrived at the Algoma Steel docks, Sault Ste. Marie, at 0520 on October 28. Minutes later, he boarded the *Michipicoten* at about 0545 and piloted it until it grounded less than two hours later at 0730.⁵

The master rested for a total of four and a half continuous hours during the 24-hour period beginning at 0730 on October 25. Later on October 26, he rested for seven and a half continuous hours and, on October 27, he rested for nine and a half continuous hours.⁶

He obtained a total of 13.5 hours of rest during the 48-hour period commencing at 0730, October 25, and the same time on October 27. During a second 48-hour period between 0730, October 26, and 0730, October 28, he obtained a total of 19 hours.⁷

Figure 3. Master's work/rest history

In this occurrence, some features of the master's work/rest schedule fall short of the minimum acceptable levels identified in the requirements. For example, a minimum of six consecutive hours of rest in a 24-hour period¹² is considered necessary, whereas the master had only four and a half hours of rest between 2300 on October 25 and 0330 the next morning. In addition, a total of at least 16 hours of rest during any 48-hour period is a minimum requirement and the master had rested for a total of 13.5 hours in one of the two 48-hour periods under review.¹³

On 25 October 2005, the master was on duty for 15.5 consecutive hours and overnight between 26 and 27 October, he worked another 15 consecutive hours. At the time of the accident, he had been on duty for nine consecutive hours. Although he had 19 hours of rest in the 48 hours immediately before the occurrence, it is unclear how many of those hours were spent in sleep.

Taking into account the master's 15.5-, 15-, and 9-hour periods over three days and one instance of having rested for fewer hours than the minimum set out in the established guidelines, this schedule may have predisposed him to fatigue-related performance issues.
