**MARINE INVESTIGATION REPORT**  
**M05L0205**

**COLLISION**

**BETWEEN THE CONTAINER VESSEL *CAST PROSPERITY***  
**AND THE TANKER *HYDE PARK***  
**LAC SAINT-PIERRE, QUEBEC**  
**26 SEPTEMBER 2005**

Report Number M05L0205

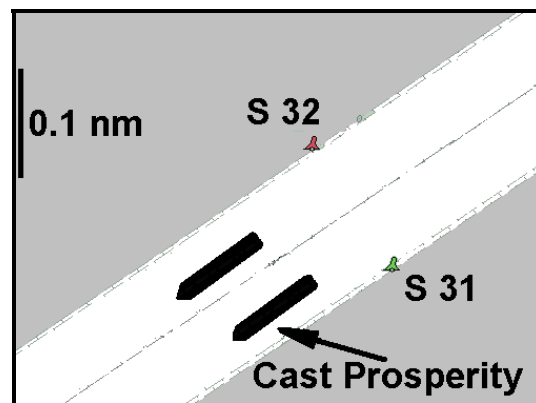
Ten minutes later, at 1851, the helmsman on the *Cast Prosperity* found it necessary to use a considerable amount of port helm (up to 23°) to maintain the desired heading of 235° Gyro (G). However, this information was not relayed to the pilot, nor did the pilot detect it from monitoring the rudder angle indicator. About one minute later, the vessels were beginning to draw parallel to each other about 75 m apart. At 1853, they had passed buoys S-31 and S-32; the *Hyde Park* had reduced speed and was making 7.3 knots, and the *Cast Prosperity* was proceeding at 10.7 knots (see Figure 1).

Figure 1. Relative position of vessels in channel at 1853 (to scale)

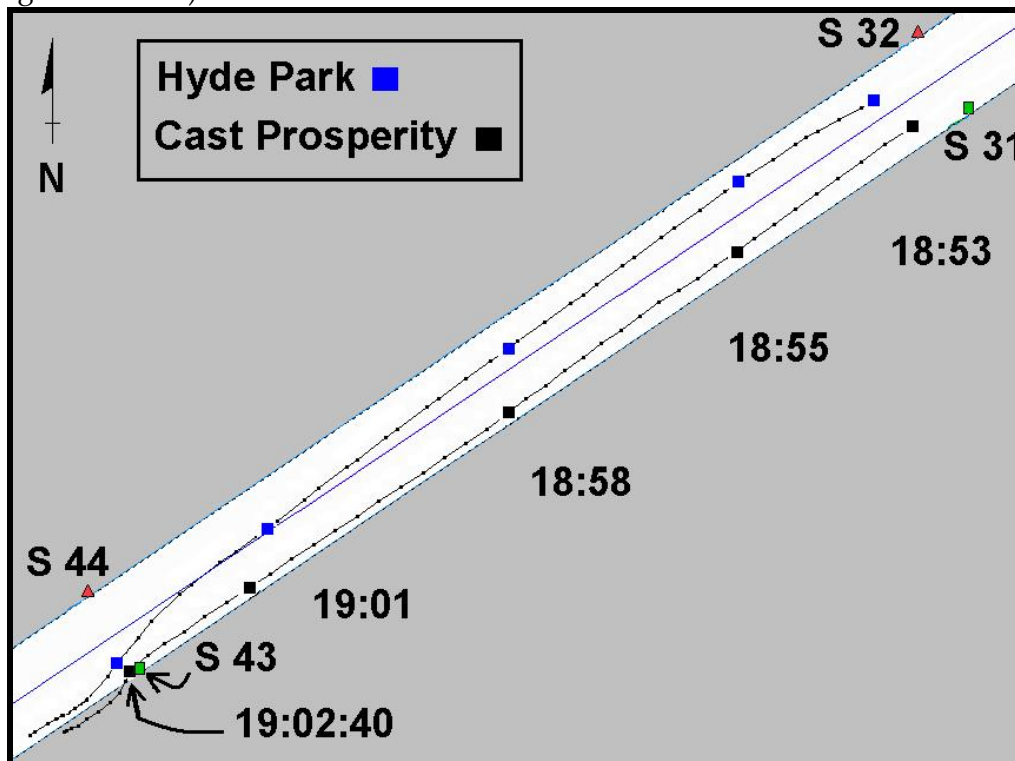
On the *Hyde Park*, the engine telegraph was set to stop and then to full astern; despite this, the tanker continued advancing along the starboard side of the *Cast Prosperity* before coming to a stop (see Figure 2 for positions of vessels between buoy sets S-31/S-32 and S-43/S-44 during the overtaking manoeuvre).

Figure 2. Vessel tracks during overtaking manoeuvre. Information derived from VDR and AIS inputs.

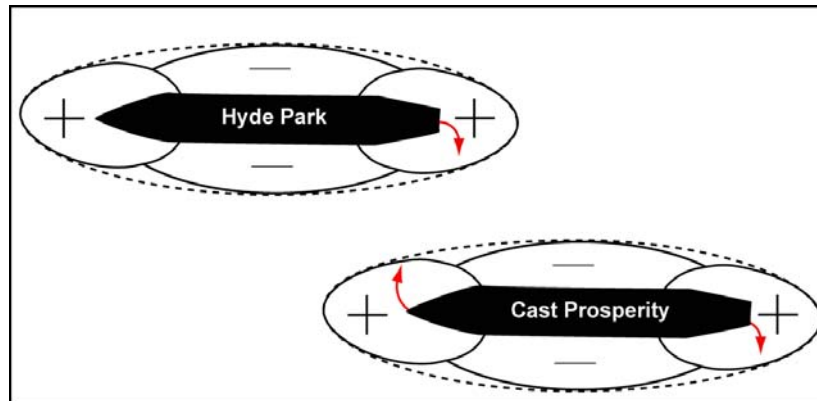
- As a vessel moves forward, hydrodynamic pressure cells are created around the ship and can best be characterized by high (+) and low (-) pressure areas, as seen in Figure 3;<sup>4</sup>

**Figure 3.** Vessel interactions during overtaking manoeuvre (pressure areas not to scale)

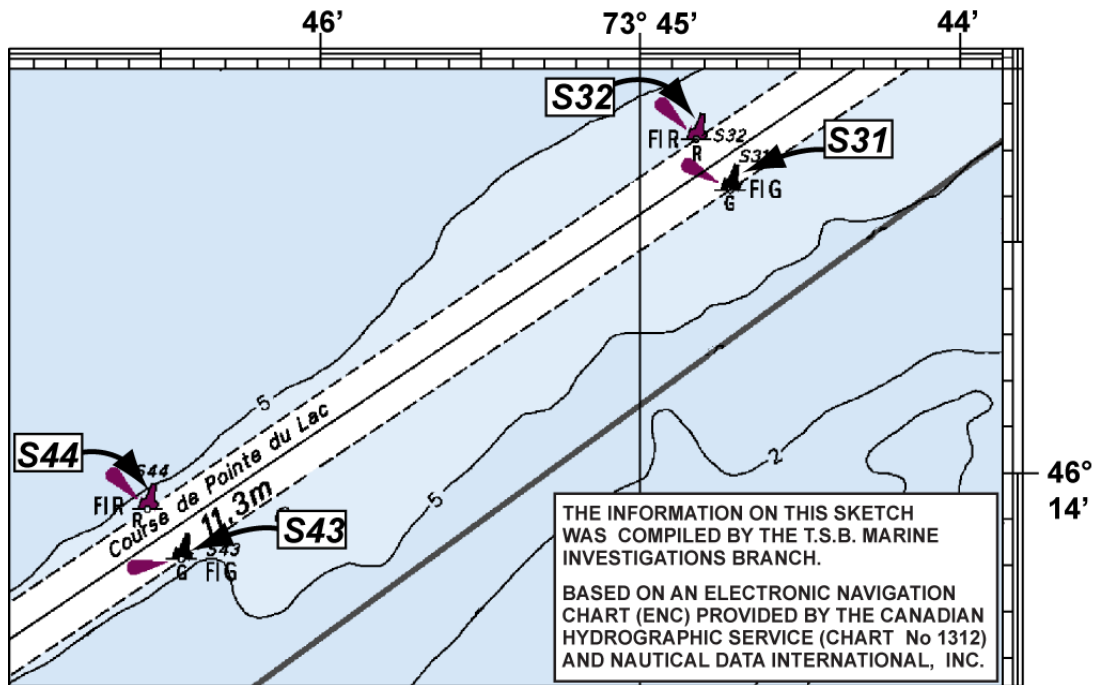
The *Cast Prosperity* attempted to overtake the *Hyde Park* between buoys S-31/S-32 and S-43/S-44; in this area, the navigable channel is 11.3 m deep and 245 m wide. Outside the channel, there is very shallow water, with the 5 m bathymetric line closing to the channel edge at buoys S-43/S-44 (see Figure 4).

Figure 4. Area of occurrence: Blue shaded area indicates shallow water

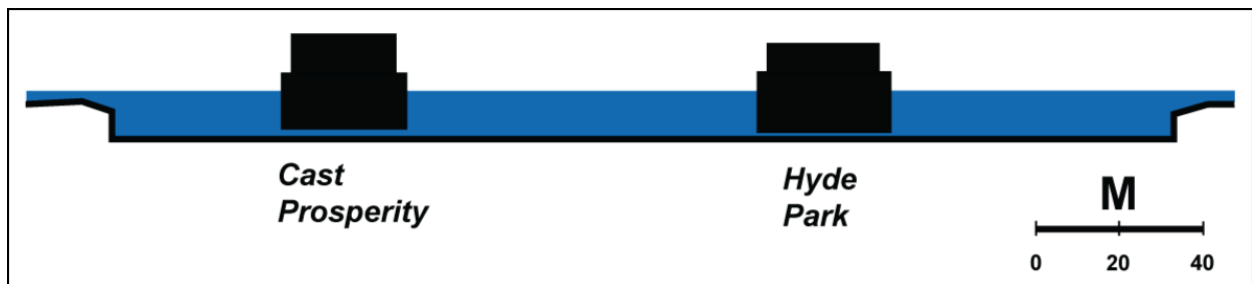
Figure 5. Outline of vessels, dredged channel, channel banking, and water depth on Lac Saint-Pierre, as seen from the stern

In the two and a half minutes before the vessels collided, the *Cast Prosperity* failed to achieve a speed of greater than 9.1 knots—despite a propeller-pitch setting that should have produced a higher speed.<sup>15</sup> This is a demonstration of the classic trapping phenomenon while overtaking in confined waters.<sup>16</sup> The *Hyde Park*, meanwhile, continued to accelerate forward, being drawn towards the *Cast Prosperity* despite the engine telegraph set at dead slow ahead and the helm set hard to starboard (see Figure 5).

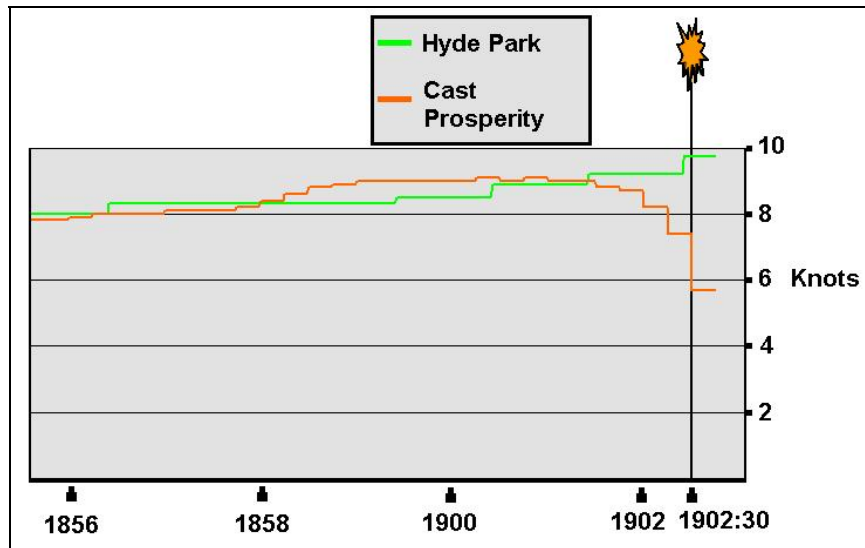
Figure 6. Vessel speeds over ground<sup>17</sup>
