**MARINE INVESTIGATION REPORT**  
**M06C0058**

**STRIKING OF LOCK ARRESTER CABLE**

**PUSHER TUG *PETITE FORTE* AND BARGE *ST. MARYS CEMENT***  
**LOCK 4, WELLAND CANAL**  
**ST. CATHARINES, ONTARIO**  
**02 OCTOBER 2006**

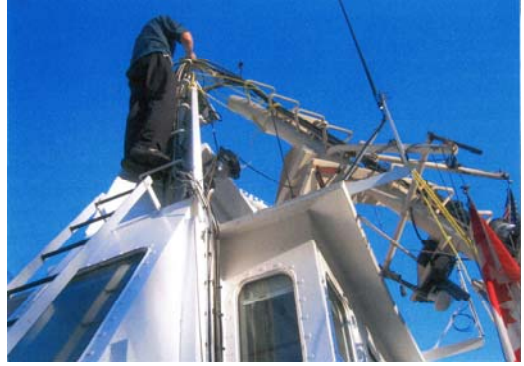
The *Petite Forte* suffered damage to its main mast, which was sheared-off at the deck. All the electronic navigation and communication equipment was rendered non-operational including the following: radars, DGPS unit, navigational lights, anchor release antennae, and radio antennae (see Photo 6).

**Photo 6.** Damaged mast and radar assembly on *Petite Forte*
