**MARINE INVESTIGATION REPORT**  
**M07M0088**

**CAPSIZING WITH LOSS OF LIFE**

**SMALL FISHING VESSEL *BIG SISTER***  
**BAY OF FUNDY, NEW BRUNSWICK**  
**13 NOVEMBER 2007**

Report Number M07M0088

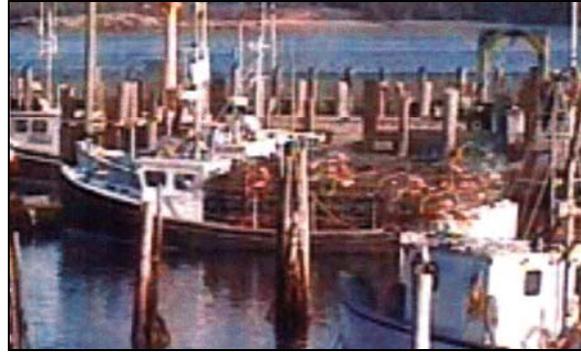
**Photo 1.** The *Big Sister*

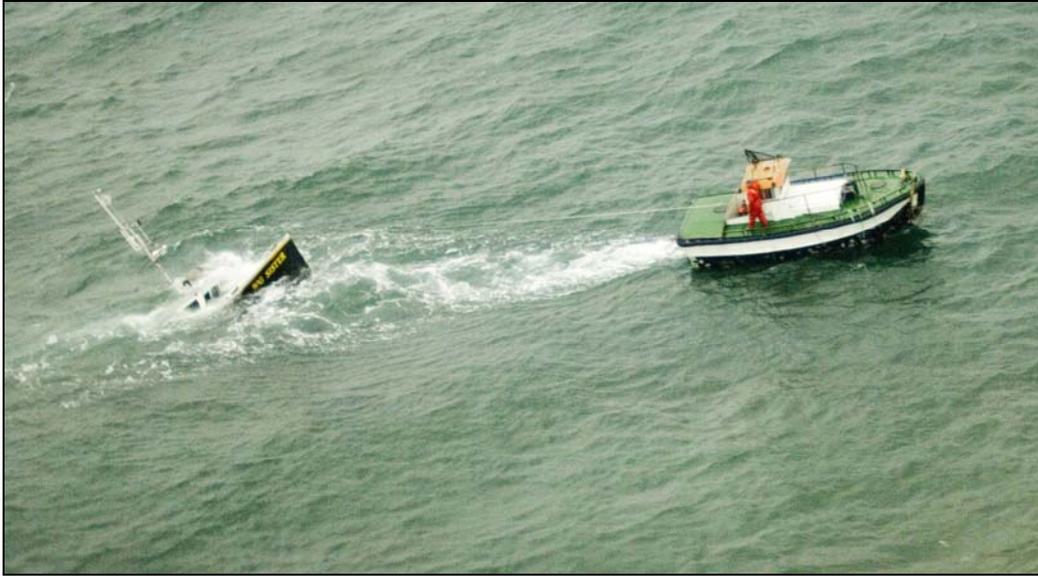
<sup>3</sup> Although the vessel was initially towed toward shallow water, it was broken up by wind and waves, and subsequently sank before a recovery attempt could be made.

**Photo 2.** The partially submerged *Big Sister* under tow

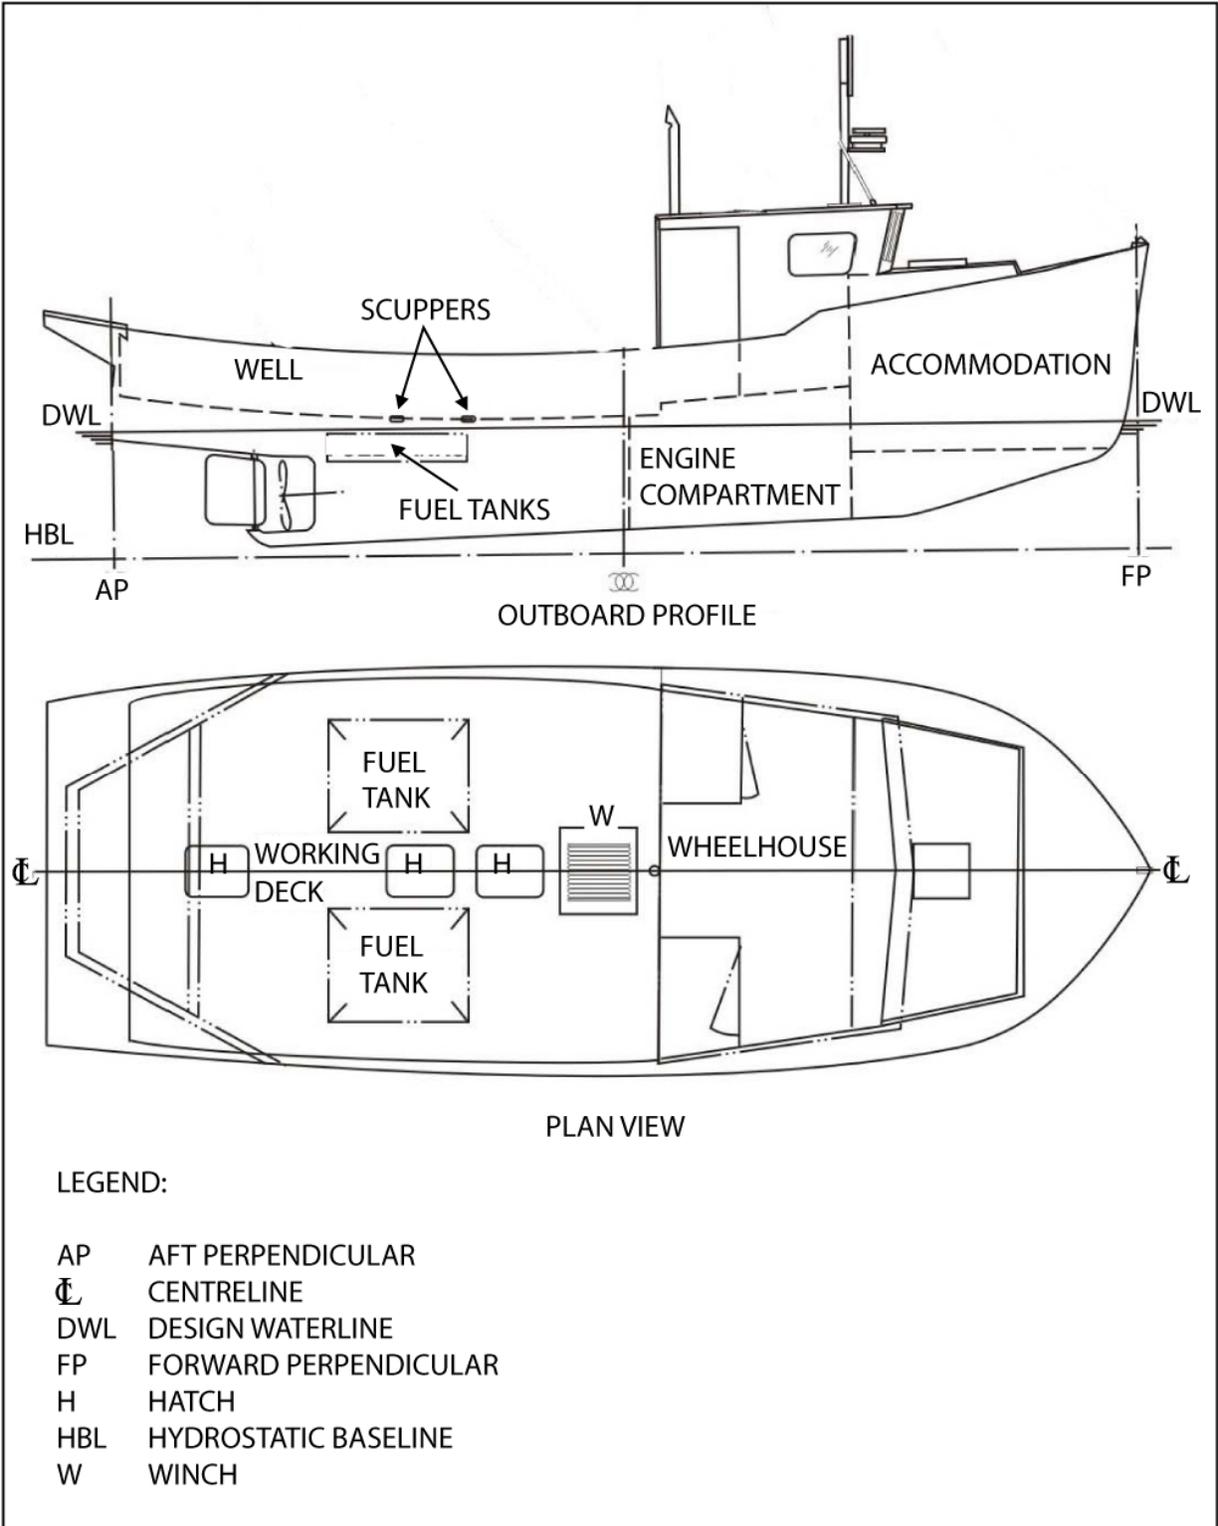
# Appendix A – Outline Arrangement of the Vessel

The *Big Sister* was a small fishing vessel of the Cape Island design of open construction, built in moulded, glass-reinforced plastic, with the wheelhouse and accommodation forward, and the engine compartment beneath the wheelhouse. The working deck was aft, surrounded by a solid bulwark forming a well. An extension placed beyond the limits of the stern and flush with the top of the bulwarks was used to store fishing gear. Entry to the wheelhouse was through a hinged door on the starboard side, and access to the engine compartment was through a large hatch cover located in the wheelhouse. No watertight bulkhead was fitted below deck, nor was one required (see Appendix A).

The vessel did not have a bilge high level detection system, nor was one required. The only mechanical equipment on deck was a trap hauler. The working deck had three flush non-watertight hatches located along the centreline; these provided access to the below-deck space in way of the steering gear, the fuel oil tanks, and the manual bilge pump. Two scuppers were located in the bulwark at deck level on each side.
