## MARINE INVESTIGATION REPORT M08C0024

### GROUNDING

**BULK CARRIER *ALGOMARINE*  
BRUCE MINES, NORTH CHANNEL  
LAKE HURON, ONTARIO  
28 MAY 2008**

Report Number M08C0024

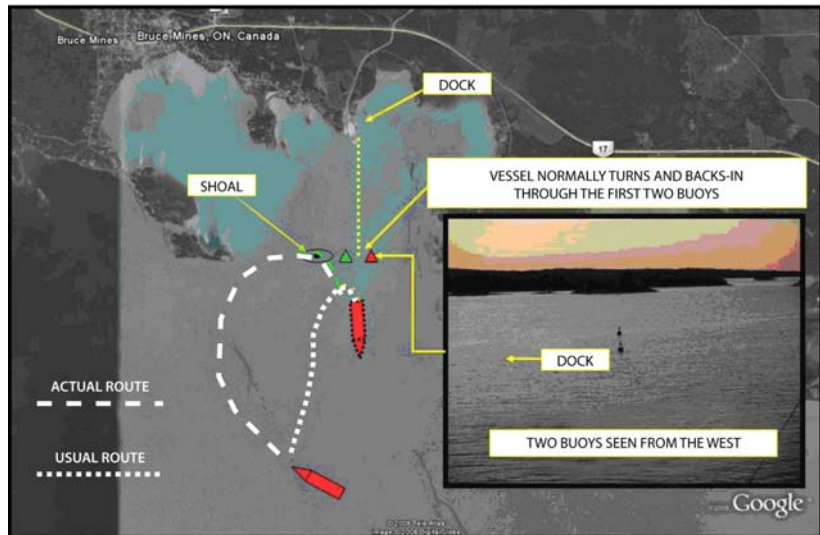
At 0545, the master sighted the channel entrance buoys to the east and, using them as a visual reference, ordered 35° starboard helm. Vessel speed was between 6.5 and 7 knots. At 0546, the master asked the OOW to keep the vessel turning to starboard. He then left the bridge to conduct ship's business. There was no formal handover of the con. Moments later, the wheelsman indicated that the vessel was slowing in its turn to starboard. The OOW responded by giving the engine/pitch a "kick" ahead.

At 0548, the alarm went off on the vessel's depth sounder for approximately 30 seconds. The bridge team, however, was unfamiliar with the sound of the alarm and took no action before 0549, when the vessel ran aground on a charted but unmarked shoal on a heading of 090° True (T).

Photo 3. Approximate track of the vessel with photo of buoys (inset)
