## MARINE INVESTIGATION REPORT

M08W0236

NEAR CAPSIZING WITH LOSS OF LIFE

SEALANDER 37 LANDING CRAFT *JUMBO B*  
BURKE CHANNEL, RESTORATION BAY, BRITISH COLUMBIA  
30 OCTOBER 2008

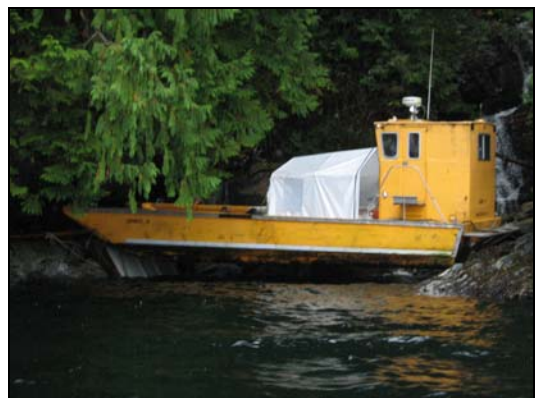
**Photo 1.** The *Jumbo B* beached after the occurrence

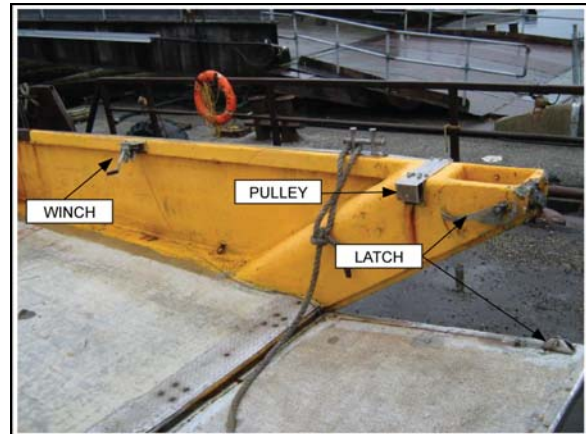
The bow ramp is hinged along the bottom edge (see Photo 2). The two winches, each with a capacity of 682 kg, were installed on either side of the vessel in 2007. They are used in conjunction with wires and steel pulleys to open and close the bow ramp, but are not designed to hold the door shut.

Each wire is 5 mm of 7 x 19 of galvanized carbon steel with a breaking strength of 1987 kg. The TSB Laboratory<sup>9</sup> analysis found that both wires had parted where they passed over the pulleys<sup>10</sup> and that the region around the fractured wires was visibly corroded.

**Photo 2.** Bow ramp and winching arrangement

The port pulley was corroded and did not rotate freely. The pulley had a diameter of 5 cm, approximately 13 times the diameter of the 5 mm wire. The pulley-to-cable ratio recommended in most literature is at least 30:1.<sup>11</sup>

In this occurrence, although the winching system and its components had been modified only the previous year, the port pulley was corroded such that it did not rotate freely. The wire was also corroded where it passed over the pulley. Sections of the rubber gasket that sealed the bow ramp door to the landing craft were also missing, and the holes in the latch bracket were found ovalized, indicating that the bracket had been subject to strain.

The wire was weakened by a combination of fatigue, corrosion, and the abrasion from being in constant stress against the incorrectly sized pulley.<sup>20</sup> The resulting localized weak point<sup>21</sup> fractured. The other wire then failed, leaving the ramp held closed only by the two non-locking latches. However, because the absence of portions of the watertight gasket meant the latches contained a great deal of freeplay, these were able to work their way open. This allowed the ramp to fall completely open and permitted water to flood the well deck.

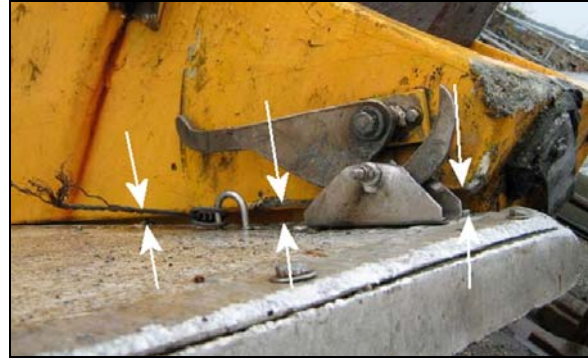
A latch on each side of the vessel was designed to keep the bow ramp secured when closed. Both latches were worn, the bearing surface of the latch hook having been polished smooth by wear. The hinge pin of the latch hook also had considerable freeplay within the bushing.

The pin, against which the latch engages to complete the locking process, is mounted within a bracket on the bow door. This bracket's holes were found ovalized by wear. The latch design does not include any locking mechanism to keep the latch handle in the closed position.

**Photo 3.** Bow ramp latch, port side

Additionally, the ramp's design was such that there was no locking mechanism to keep the latch closed once the ramp was up; instead, this was accomplished by maintaining continuous tension on the winch wire. This wire, which had originally been intended only to raise and lower the ramp, was further subjected to a cyclical loading component from wave action pushing against the door.

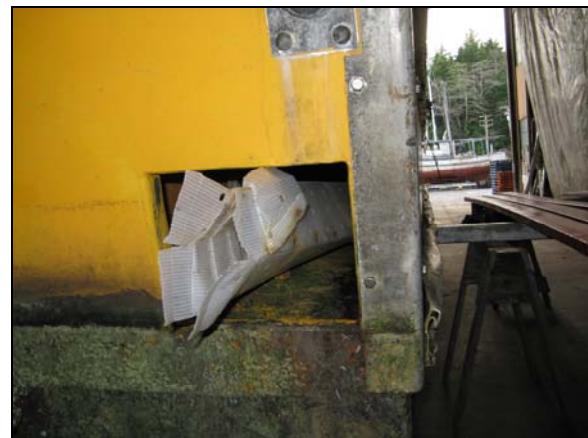
The vessel was originally fitted with two hinged freeing ports on either side of the transom. Examination revealed that the cover of the starboard freeing port was missing.

The vessel was normally trimmed by the stern to the extent that the waterline was approximately 50 mm above the lower edge of the freeing ports and the main deck. Algae and marine growth were noted above the lower edge of the freeing ports and onto the after part of the main deck (see Photo 4).

**Photo 4.** Starboard freeing port with protruding cone

Once the bow ramp opened, water was shipped aboard. The blocked freeing ports restricted the vessel's ability to shed this water, and the accumulated weight caused a starboard list until the vessel slowed down, water was shed, and it righted itself.

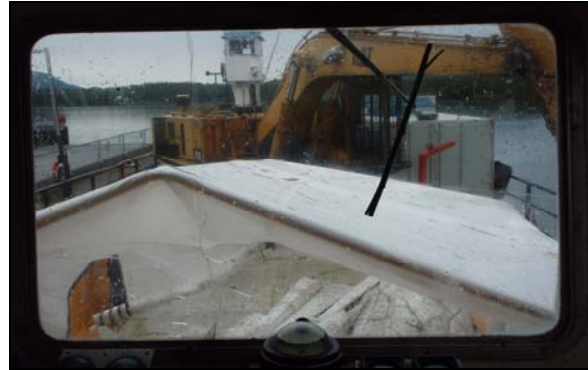
However, the canopy restricted the view forward. As a result, when the operator and the passengers inside the wheelhouse heard the banging from forward and observed water on deck, they were unable to determine the immediate cause – that the bow ramp door had failed.

**Photo 5.** View of bow from operator's position in wheelhouse
