MARINE INVESTIGATION REPORT
M09W0193

STRIKING

BULK CARRIER *PETERSFIELD*
DOUGLAS CHANNEL, BRITISH COLUMBIA
25 SEPTEMBER 2009

Report Number M09W0193

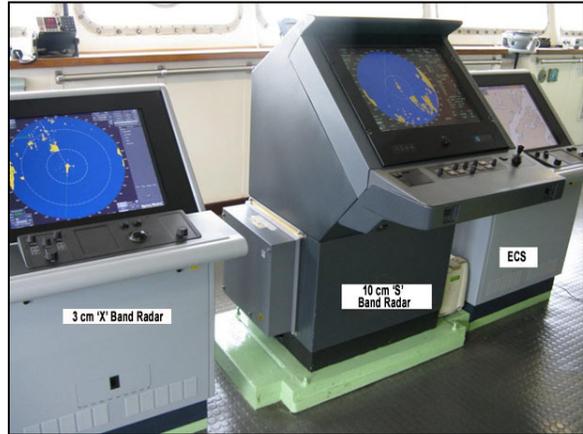
Photo 3. 3 cm radar, 10 cm radar and ECS.

At 2048:48,⁷ the 10 cm radar lost its heading input from the gyro compass and the OOW realigned it,⁸ returning it to normal function. A similar event occurred again at 2054:18 and at 2058:33. Each time the heading was re-aligned.

At 2156:49 and again at 2208:18, the 10 cm radar lost its heading input from the gyro compass. In both instances, the OOW realigned the radar heading.

At 2240:34, with the vessel still on a steady course, the image on the 10 cm radar screen began to rotate randomly and the visual compass alarm appeared. Moments later, the pilot stepped outside onto the port bridge wing in order to use his portable VHF to obtain weather information.¹⁰ Meanwhile, the OOW informed the master of the jumping radar and following a brief discussion, the master left the bridge. At this moment the vessel's heading had started swinging to starboard unobserved and had changed from approximately 218° G to 231° G.

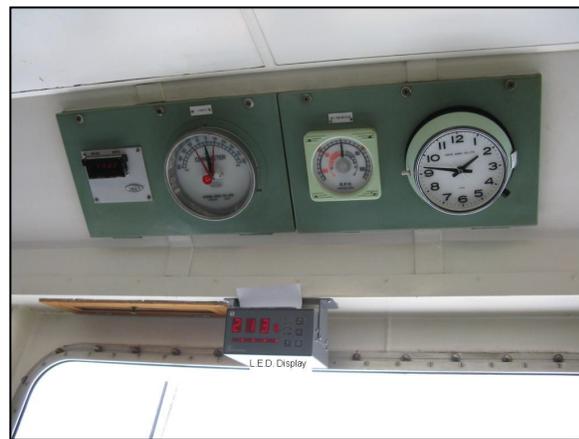
Photo 4. LED analogue repeater and rudder angle indicator.

The pilot then noticed a flashing white light abeam on the starboard side ¹⁴ and he was also able to distinguish the tops of the mountains ahead of the vessel. He immediately ordered the OOW to call the master and requested that a searchlight be turned on. The pilot ordered hard-a-port at 2244:05. Once the vessel started swinging to port, both the LED repeater and the gyro repeater in the steering stand reflected the port swing. However, they were no longer properly aligned with the gyro compass.

In this occurrence, whatever caused the malfunction of the heading feed to the 10 cm radar also likely affected the functioning of the LED analogue repeater and the steering stand repeater used by the quartermaster. This contributed to the vessel deviating from its intended course. Furthermore, a situation was created where some components displayed inaccurate information while others remained accurate. This caused confusion, as the pilot was uncertain which components to trust, adding to the time necessary to determine the vessel's true position and heading.

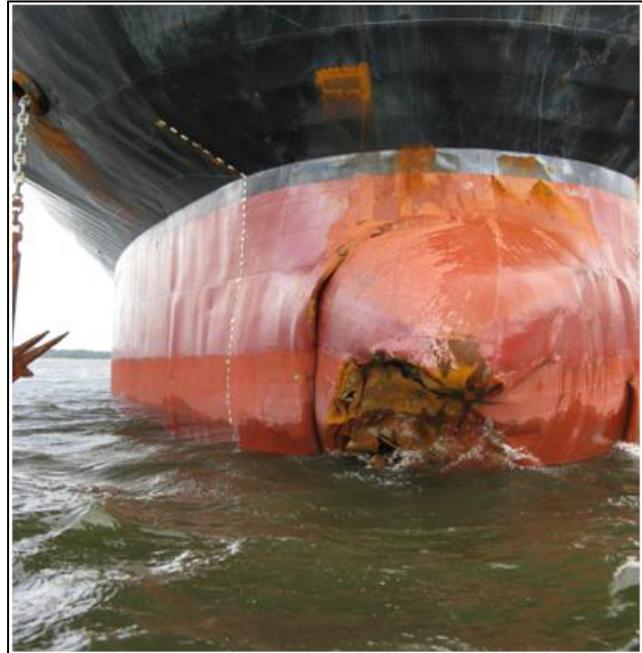
Photo 5. Damage to the bulbous bow.

An underwater inspection ¹⁷ revealed that the vessel was holed in the forepeak and that the bulbous bow was pushed in between frames 227 and 238, from the 8 m draft mark to a depth of 6 m below and predominantly on the starboard side.

Most of the floors, stringers, frames and brackets were found buckled, deformed or ruptured from frames 220-238 in the forepeak tank. Buckling of frames was also observed on the collision bulkhead. The maintenance room deck above the forepeak was deformed and ruptured at 3 locations.

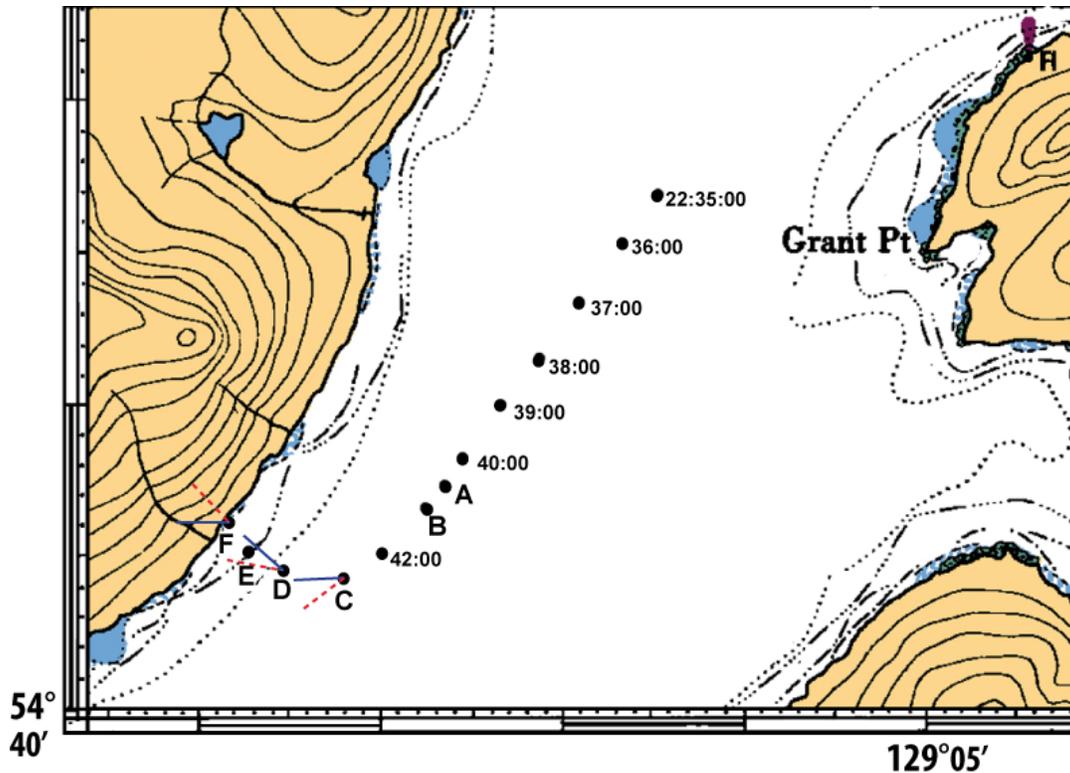
Appendix B

As a result, the vessel's swing to starboard went unnoticed for a period of 2 minutes and 15 seconds until the pilot was alerted by visual cues from navigational aids onshore and a change in apparent wind. At this time, the vessel's rate of turn had increased to almost 40 degrees per minute to starboard, the heading had changed by over 50 degrees, the distance from shore had decreased to approximately 0.4 nm (see Appendix B) and the vessel was standing into danger.

Positions of *Petersfield* 10 minutes prior to striking

Time (UTC)	Letter	Event	Gyro Heading ²³	Course over Ground	Speed over Ground (knots)
5:40:34	A	first radar jump ²⁴	217.9	218	12.5
5:41:00	B	pilot leaves wheelhouse ²⁵	218.0	218	12.5
5:42:49	C	pilot re-enters wheelhouse	271.2	233	11.7
5:44:04	D	hard to port	311.3	280	10.6
5:44:46	E	full astern	302.9	306	10.6
5:45:25	F	striking	270.1	316	10.4

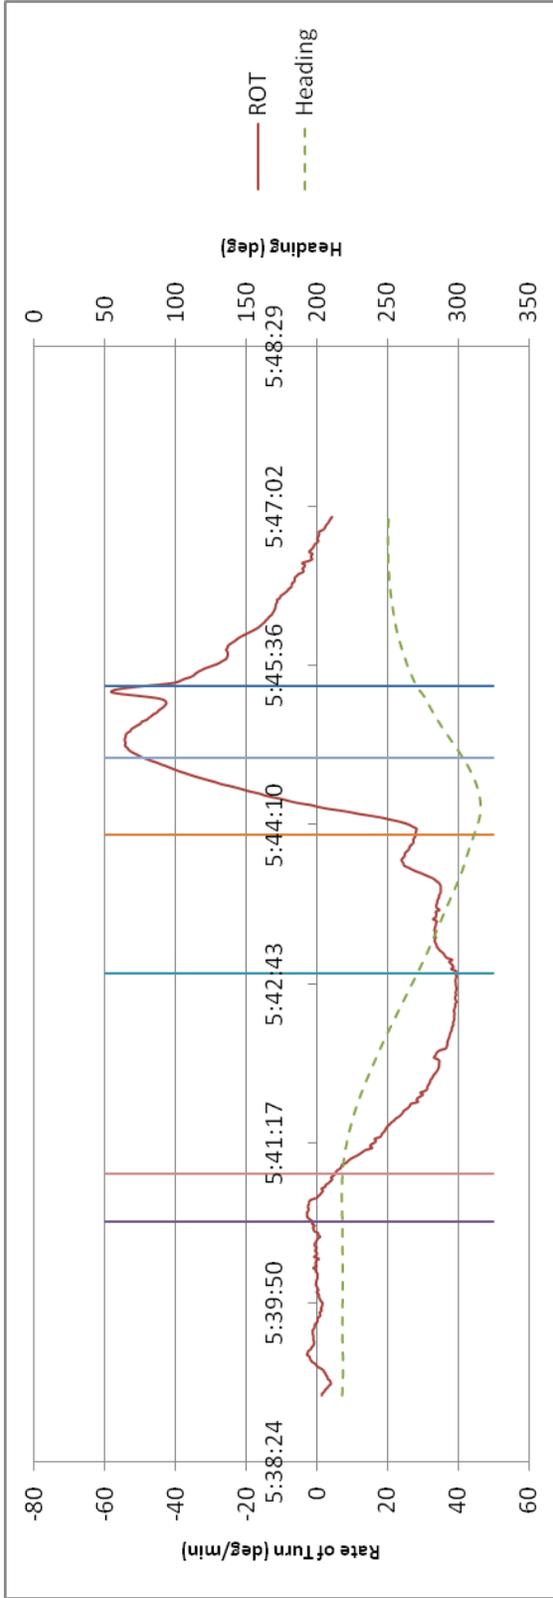
Appendix C – S-VDR Data

The application of starboard helm was examined through a detailed analysis of the S-VDR data. By plotting the vessel's heading and rate of turn against time (see Appendix C) it can be seen that, when the 10 cm radar started experiencing problems, the vessel's rate of turn was to port. In order for the quartermaster to maintain the vessel's desired heading, a small routine helm correction to starboard was necessary.

Nevertheless, S-VDR data indicates that the starboard rate of turn continued until shortly after the pilot re-entered the bridge, as illustrated in Appendix C (between points C and D). It is likely that the quartermaster, having been alerted of a problem, initiated corrective action to port at that time. However, when the pilot ordered hard to port (75 seconds after entering the bridge) the vessel was just over 0.2 nm from shore. Travelling at 12 knots on a heading of 312° G, the vessel had progressed to a point where striking the shore could not be avoided. The vessel had commenced swinging to port when the starboard bow struck the shore at an angle of 30 to 45 degrees relative to the ship's heading, at approximately 10 knots.

Time (UTC)	Letter	Event	Gyro Heading	Course over Ground	Speed over Ground (knots)
5:40:34	A	First radar jump	217.9	218	12.5
5:41:00 *	B	Pilot leaves wheelhouse	218.0	218	12.5
5:42:49	C	Pilot re-enters wheelhouse	271.2	233	11.7
5:44:04	D	Hard to port	311.3	280	10.6
5:44:46	E	Full astern	302.9	306	10.6
5:45:25	F	Striking	270.1	316	10.4
