Transportation Safety Board
of Canada

MARINE INVESTIGATION REPORT

GROUNDING

PASSENGER VESSEL *CLIPPER ADVENTURER*
CORONATION GULF, NUNAVUT

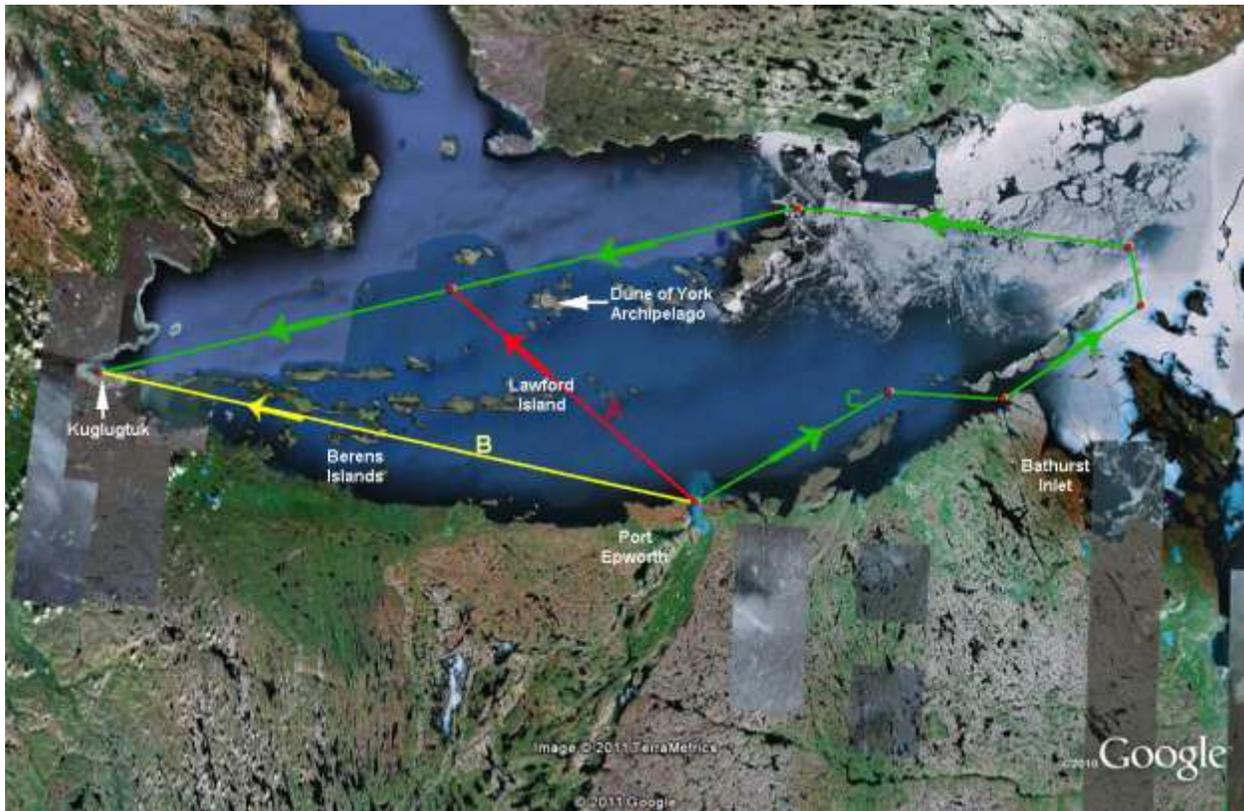
The master and bridge team considered two routes from Port Epworth to Kugluktuk. The first (A) was a course north from Port Epworth, crossing an archipelago on a single line of soundings before proceeding west parallel to the islands, also on a single line of soundings. A second option (B) of proceeding west between the southern shoreline of Coronation Gulf and the archipelago using a single line of soundings was also considered.

Subsequently, in Port Epworth, a third alternative route (C) was available to the bridge team that consisted of using their reciprocal track (which they had already successfully navigated) northeast back to the main east-west surveyed channel. (Figure 1 and accompanying table). The bridge team elected to take the first option (A).

Figure 1. A) Route chosen by the *Clipper Adventurer* - B) Second route option - C) Reciprocal track

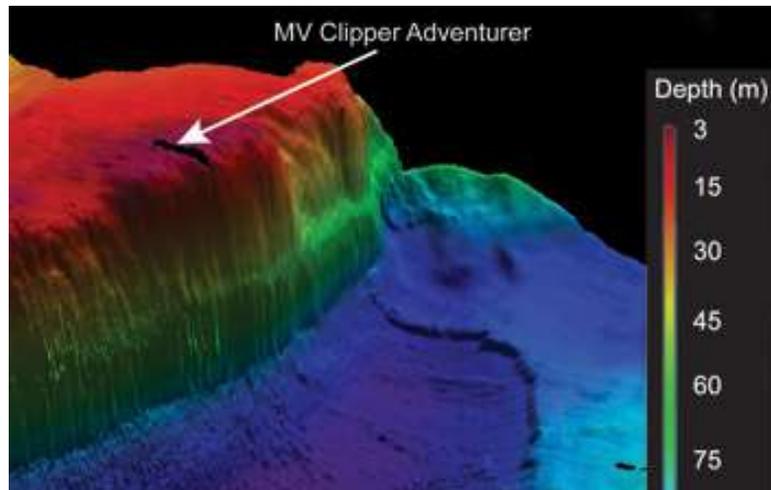
The shoal on which the *Clipper Adventurer* grounded had been previously discovered on 13 September 2007 by the CCGS *Sir Wilfrid Laurier* while conducting scientific research. The CCGS *Sir Wilfrid Laurier* reported the shoal to MCTS Iqaluit, who then broadcast a NOTSHIP ²² for CHS Chart No. 7777 indicating that, "a shoal was discovered between the Lawson Islands and the Home Islands in the Southern Coronation Gulf in position 67° 58.25' N, 112° 40.39' W. Charted depth in area 29 m. Least depth found 3.3 m. Isolated rock. Refer to NAD 83 datum." It was still in effect at the time of the grounding.

Figure 3. Three-dimensional survey image of the shoal in way of the grounded vessel. ²¹

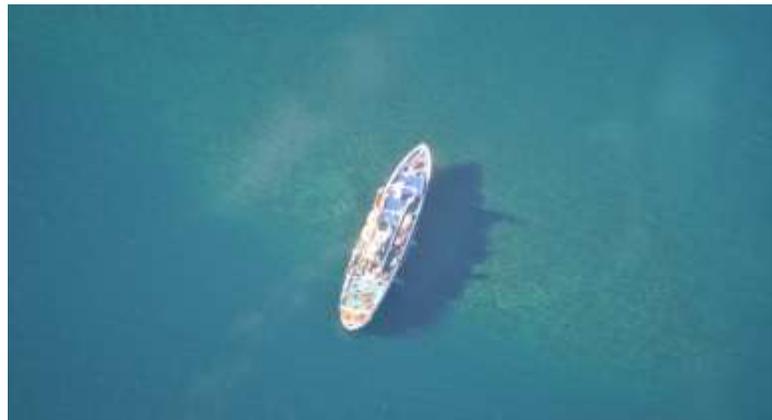
On 01 September 2010, a dive team and a salvage company, engaged by the ship management company to refloat the *Clipper Adventurer*, arrived on site. The dive team discovered that the hull had sustained extensive damage from the forepeak to aft of amidships and that 13 double-bottom tanks and compartments including 4 full diesel oil tanks were holed, as opposed to the 7 originally reported by the crew.

Photo 3. *Clipper Adventurer* aground

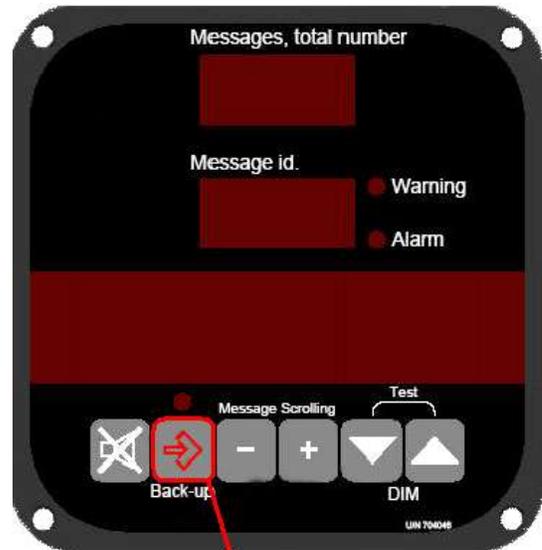
On 03 September 2010, the TSB investigation team attempted to download data from the VDR but no data had been saved. Since the backup procedures had not been followed by the bridge team, the VDR had continued to record data following the grounding, overwriting the data recorded at the time of the grounding.

Red LED placed over the Backup Button

Figure 4. Alarm panel to activate data backup

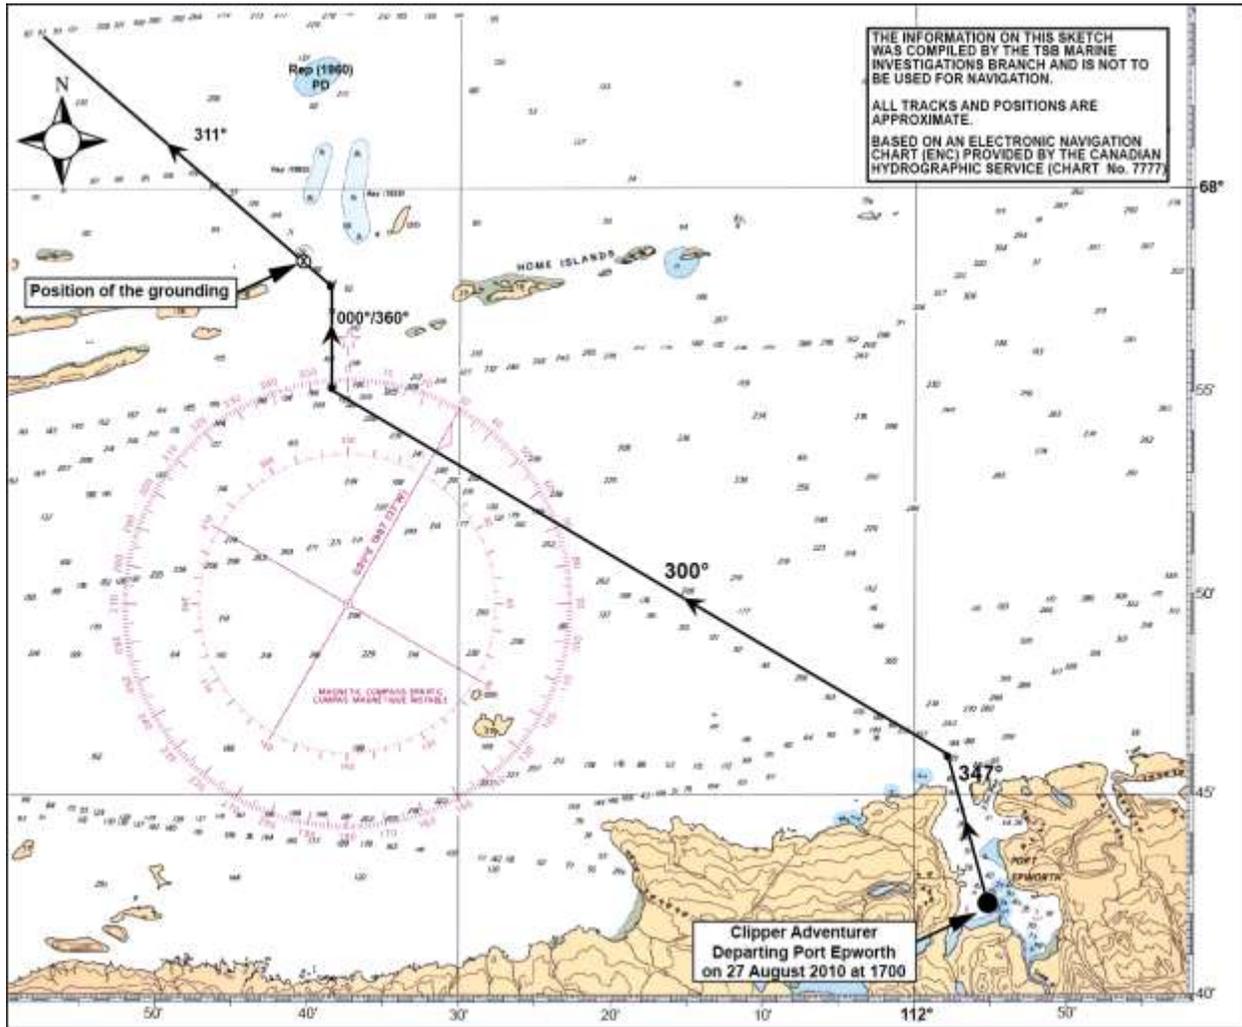
Appendix D- Chart of the Area of the Grounding

PAs can be used to indicate that the position of a shoal, wreck or navigational hazard has not been determined or does not remain fixed. PDs are used to indicate that a wreck, a shoal or other navigational hazard has been reported in various positions but not confirmed in any of them. In 1960, CHS utilized PDs on chart No. 7777 to indicate reported shoals that were not confirmed (Appendix D). These symbols are part of IHO standards.
