**MARINE INVESTIGATION REPORT
M12C0058**

GROUNDING

**ROLL-ON/ROLL-OFF PASSENGER VESSEL *JIIMAAN*
APPROACHING KINGSVILLE HARBOUR, ONTARIO
11 OCTOBER 2012**

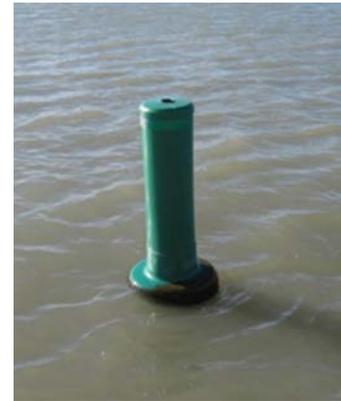
Photo 2. Port-hand buoy

The KNPPMC placed a private port-hand buoy (Photo 2) to mark the eastern extremity of the sandbar that naturally occurs in the southwestern portion of the harbour channel. As the sandbar expanded, the buoy was periodically repositioned. The buoy normally remained in place throughout the winter and, after having been positioned at the beginning of the 2012 operating season, was not moved again prior to the occurrence.

At the time of the grounding, the buoy in use was approximately 1.0 m in height and 30 cm in diameter; it was observed in position 41°01.46' N, 082°43.80' W (Appendix C). The buoy was not marked as private and did not display the owner's identification information as required by regulation. There was no documentation to indicate that TC was informed of the port-hand buoy. Neither CCG nor CHS was aware of the buoy.

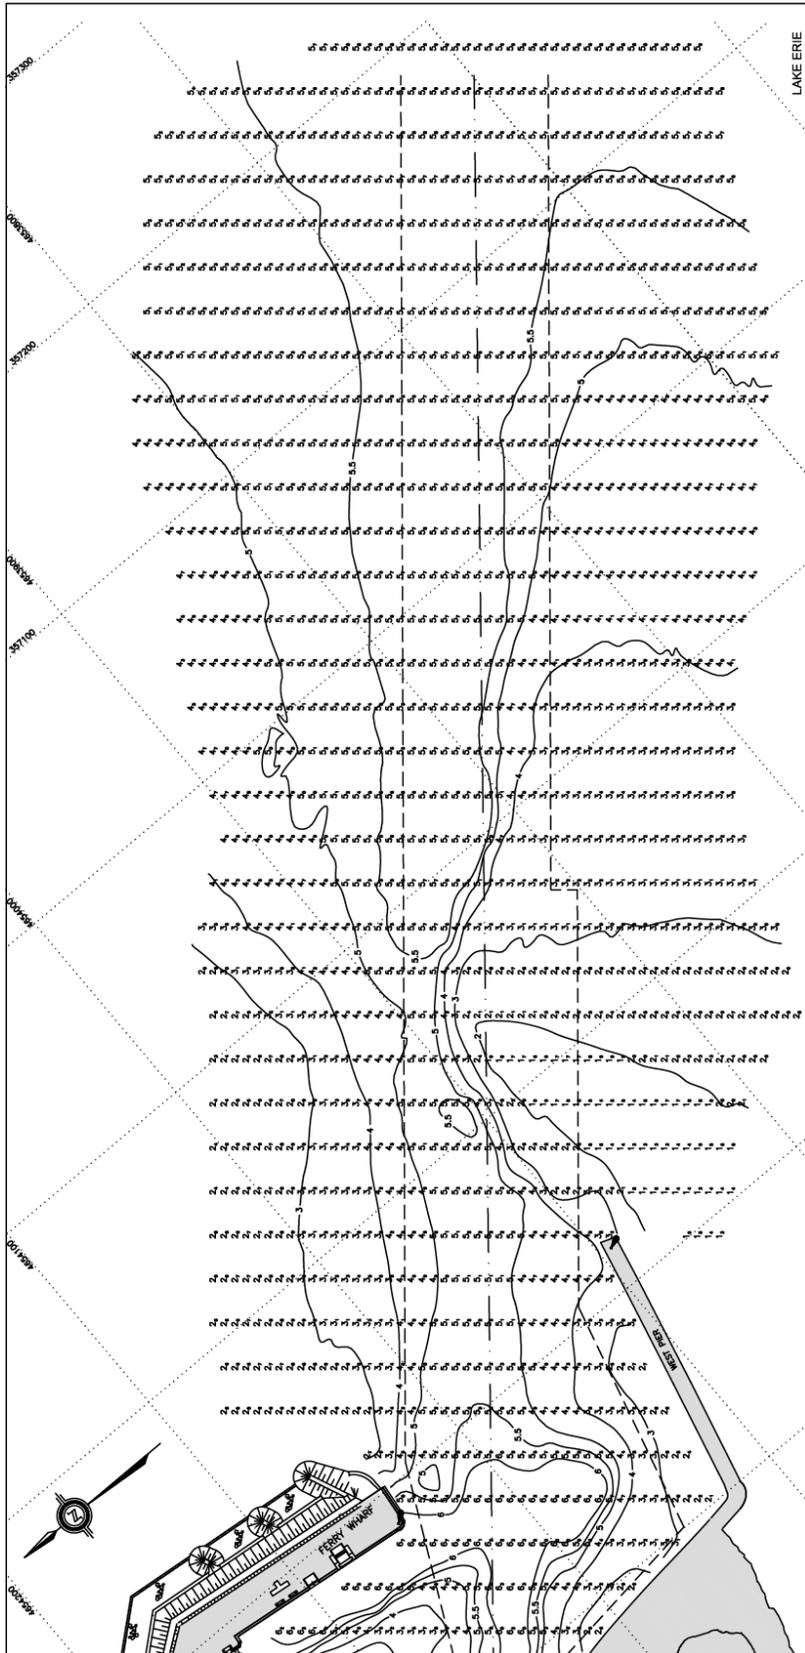
Appendix B – April 2012 sounding survey

² A survey of the harbour channel conducted on 17 April 2012 shows a sandbar extending into the centreline of the channel.

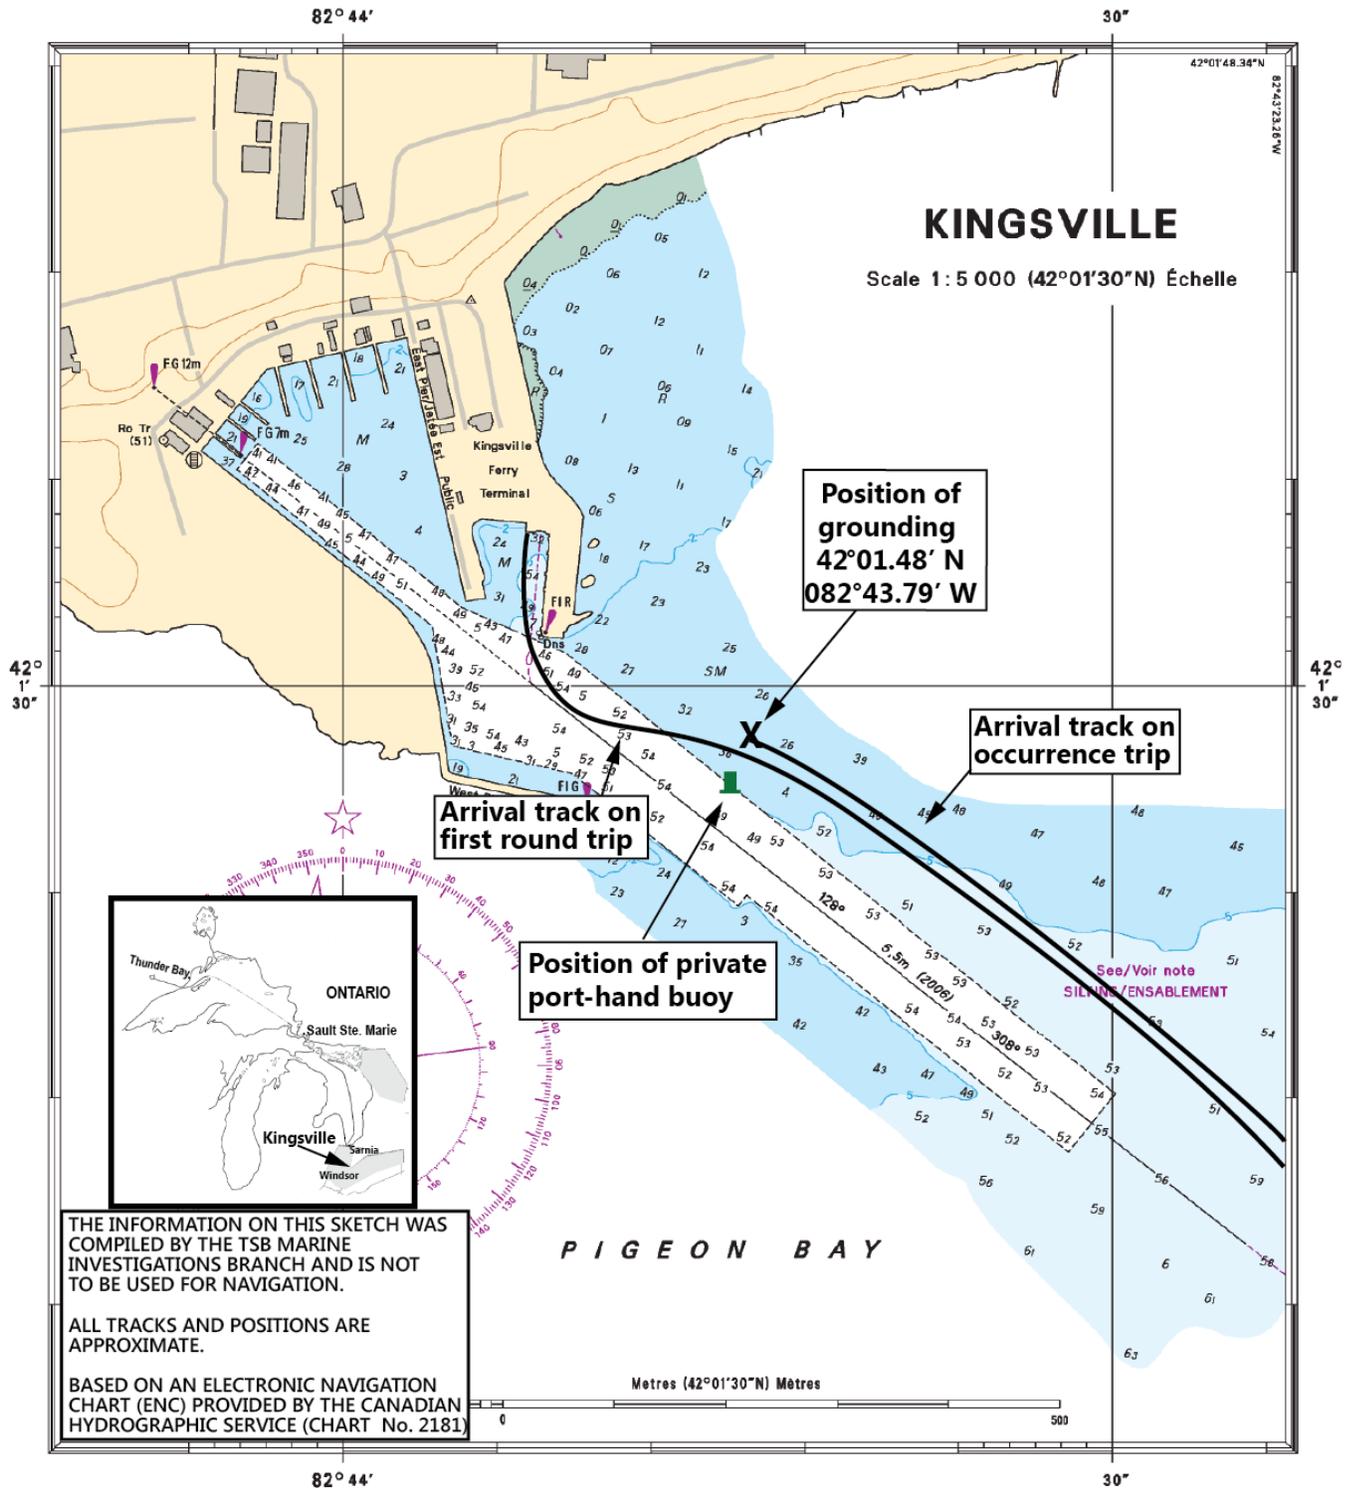
Appendix C – Area of the occurrence

As the *Jiimaan* approached the port-hand buoy, the vessel was being set to starboard due to the prevailing winds. The bridge team estimated that the vessel would pass the port-hand buoy with a clearance of 2 to 3 m. However, when the vessel was almost abeam of the buoy, its position was further east than intended. The *Jiimaan* entered the shallows northeast of the channel and went aground. The master reacted by increasing propulsion and port rudder; however, the vessel's speed continued to drop until all headway was lost. At 1340, the vessel grounded 0.07 nm (130 m) southeast of the Kingsville harbour entrance in position 42°01.48' N, 082°43.79' W. The grounded position of the vessel's stern was approximately 30 m outside of the charted channel.

Track data obtained from the electronic charting system (ECS) on board the *Jiimaan*.

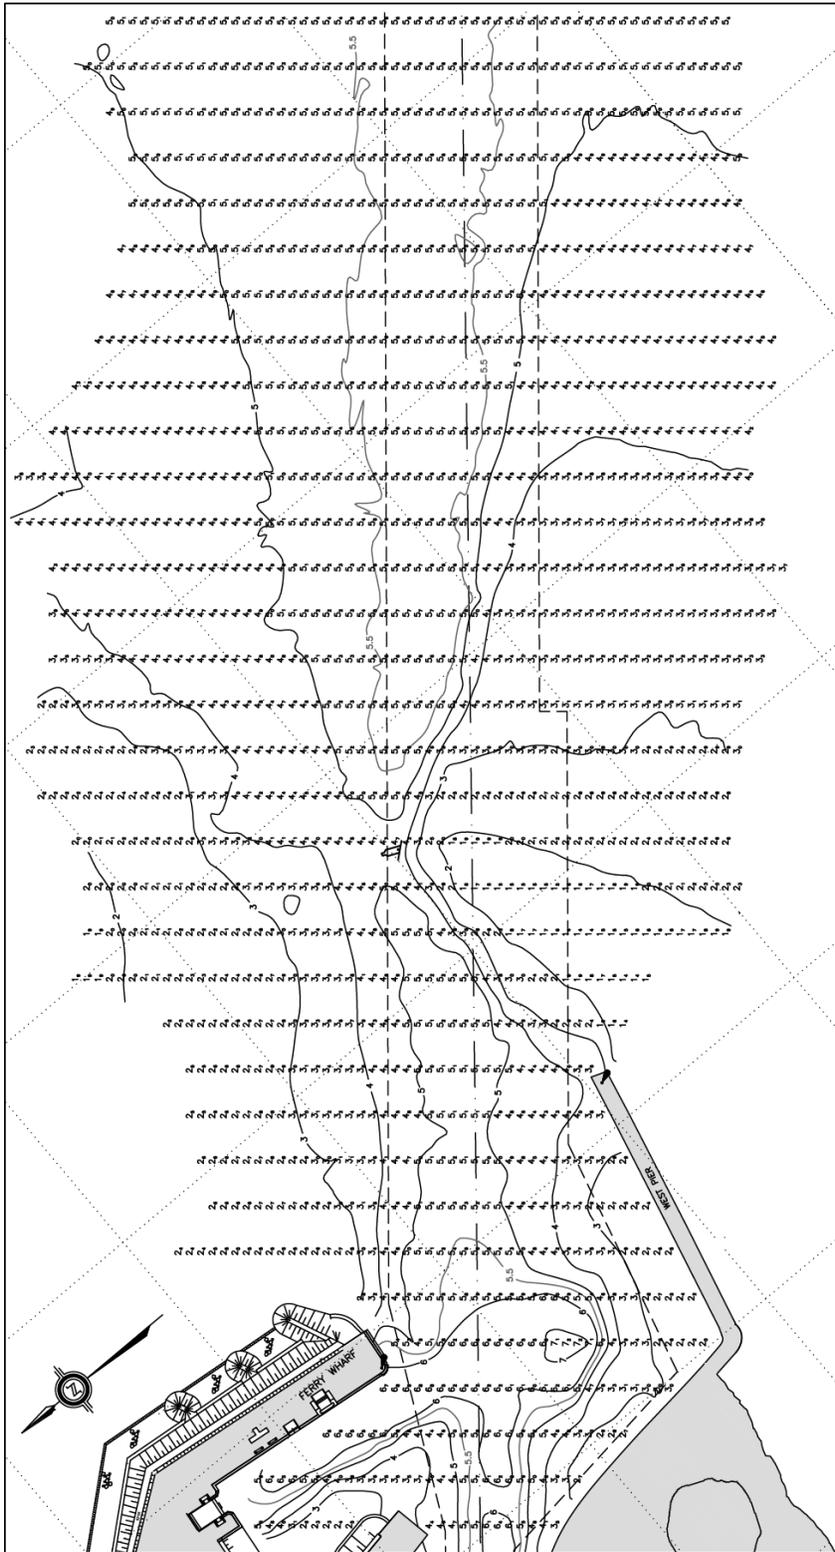
Appendix D – Post-occurrence sounding survey

A post-grounding sounding survey conducted on 17 October determined that the least water depth along the range line was 1.7 to 1.8 m (Appendix D). On 06 November, the CCG noted that the least water depth along the range line was about 2 m and that the range line no longer marked the best water depth coming into the harbour.
