MARINE INVESTIGATION REPORT

M12F0011

COLLISION

**FISHING VESSEL *VIKING STORM* AND
FISHING VESSEL *MAVERICK*
30 NAUTICAL MILES OFF LA PUSH, WASHINGTON,
UNITED STATES
28 SEPTEMBER 2012**

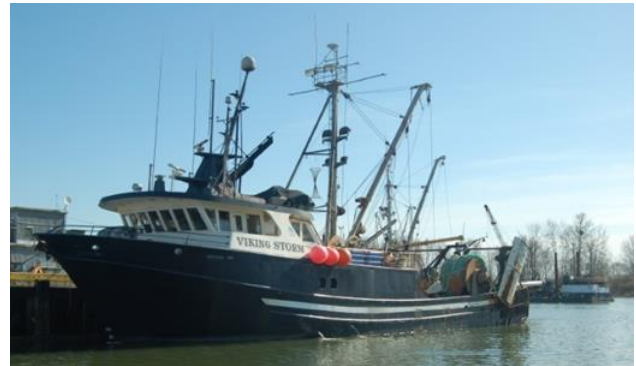
Figure 1. Photo of the *Viking Storm*

The *Viking Storm* is a large ³ fishing vessel outfitted for trawling; it has a welded steel hull and an aluminum deckhouse located forward of amidships (Figure 1). The deckhouse contains the galley, accommodations for 11 persons, the engine room entrance, and stairs to the wheelhouse.

The *Viking Storm*'s bow sustained minor damage above the waterline. The *Maverick* capsized and sank from the impact of the collision; the vessel was not recovered.

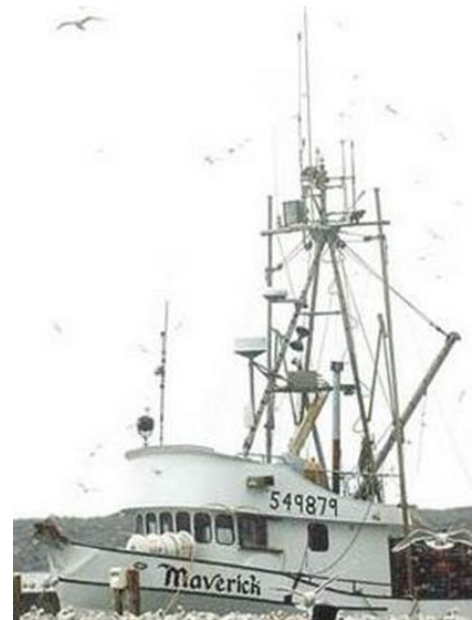
Figure 2. Photo of the *Maverick*

The *Maverick* was a fishing vessel of closed construction with a welded steel hull and deckhouse (Figure 2). At the time of the occurrence, the vessel was outfitted for longlining. The deckhouse was located forward of amidships and contained the conning station, galley, and master's accommodation, as well as the entrance to both the engine room and crew accommodation. The navigation and communication equipment was located near the conning station and included a radar, depth sounder, VHF radiotelephone, autopilot, chart plotter, and GPS. The vessel was not equipped with a watch alarm or an automatic identification system.

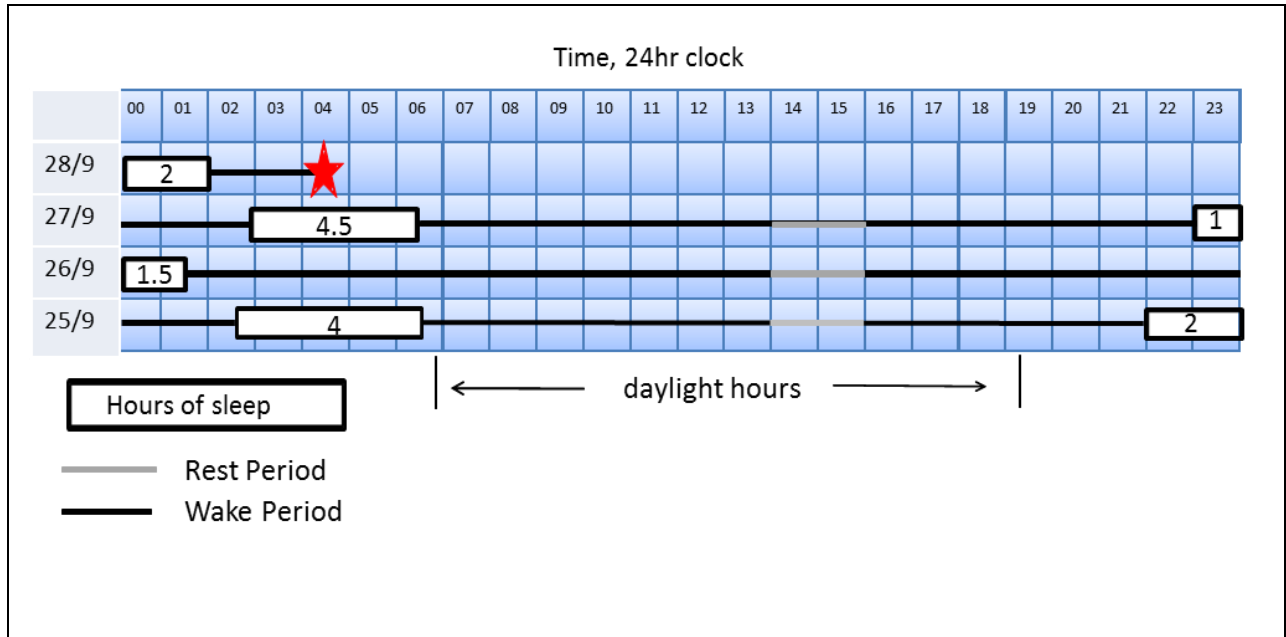
Appendix B – Sleep/rest/work schedule for the mate on the Viking Storm

Fishermen accept fatigue, mostly related to physical exertion and long work days, as a normal part of doing business. On average, a person needs about 8 hours of sleep per day, preferably obtained during 1 sleep period. A person obtaining less than the required amount of sleep develops a sleep debt, which results in performance degradation and errors due to lack of attention, alertness, and vigilance. The vast majority of fishermen report that they do not get 8 hours of uninterrupted sleep either on the vessel or at home between fishing operations and, as a result, use rest periods or napping to reduce tiredness.⁴²
