MARINE INVESTIGATION REPORT M13C0071

STRIKING AND SUBSEQUENT GROUNDING

**GENERAL CARGO SHIP *CLAUDE A. DESGAGNES*
IROQUOIS, ONTARIO
06 NOVEMBER 2013**

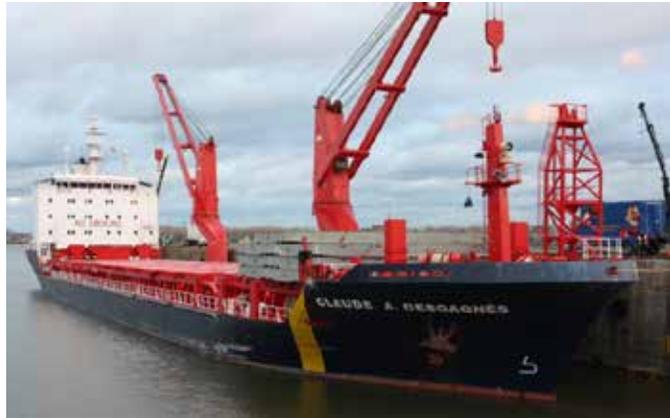
Photo 1. *Claude A. Desgagnes*

The *Claude A. Desgagnes* is a steel-hulled general cargo vessel with machinery spaces and accommodations aft (Photo 1). The vessel is fitted with 3 cargo holds serviced by 2 cranes mounted on the vessel's port side; each crane has a lifting capacity of 150 tonnes. The vessel also has a 500 kW bow thruster.

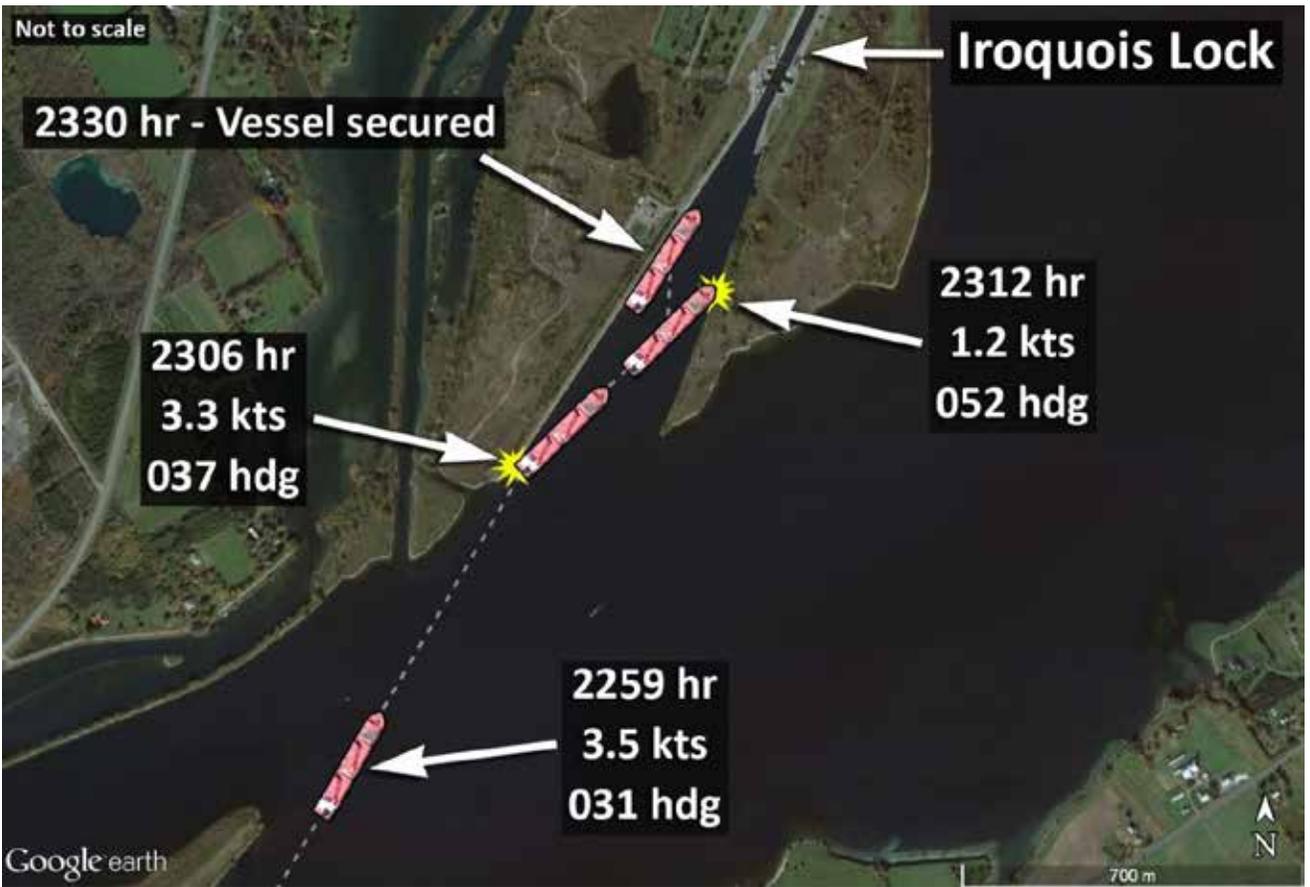
Appendix B – Occurrence location

2306 - Vessel strikes Iroquois Lock upper approach wall

2312 - Vessel runs aground

2330 - Vessel reported secured at Iroquois Lock upper approach wall
