**MARINE INVESTIGATION REPORT**  
**M13M0287**

**GROUNDING**

**ROLL-ON/ROLL-OFF PASSENGER VESSEL *PRINCESS OF***  
***ACADIA***  
**APPROACHING THE DIGBY FERRY TERMINAL**  
**DIGBY, NOVA SCOTIA**  
**07 NOVEMBER 2013**

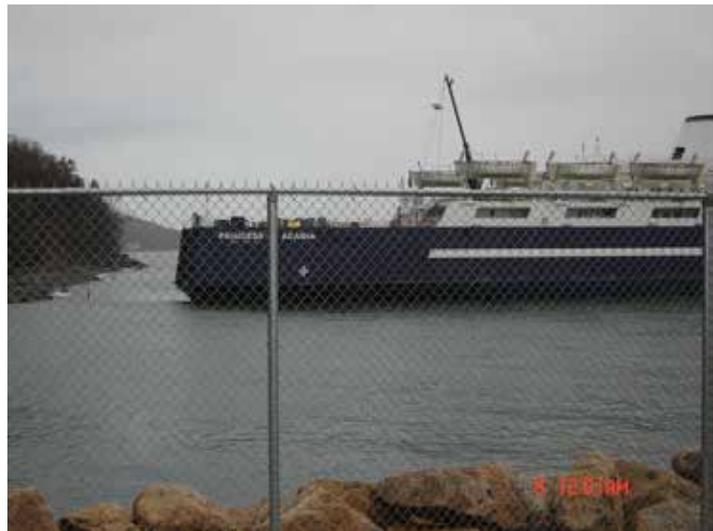
At 1156:25, the *Princess of Acadia* reached an astern speed of 3.7 knots, and an impact was felt on the vessel as it began grounding near the shoreline, at which point the master ordered the engine room to declutch the shafts. Just before the port shaft declutched, the port propeller made contact with the bottom. At approximately 1157, the vessel was aground about 0.1 nm NNW of the Digby terminal in position 44°39.8' N, 065°45.5' W (Photo 2).

Photo 2. *Princess of Acadia* aground

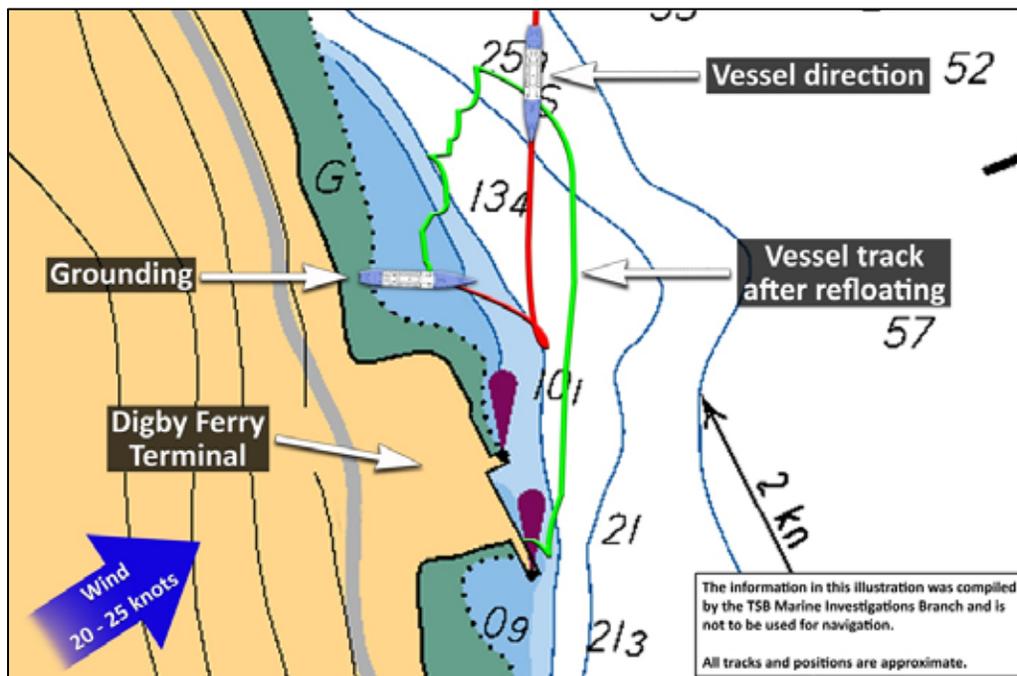
Figure 1. Vessel's track up to the grounding and after refloating

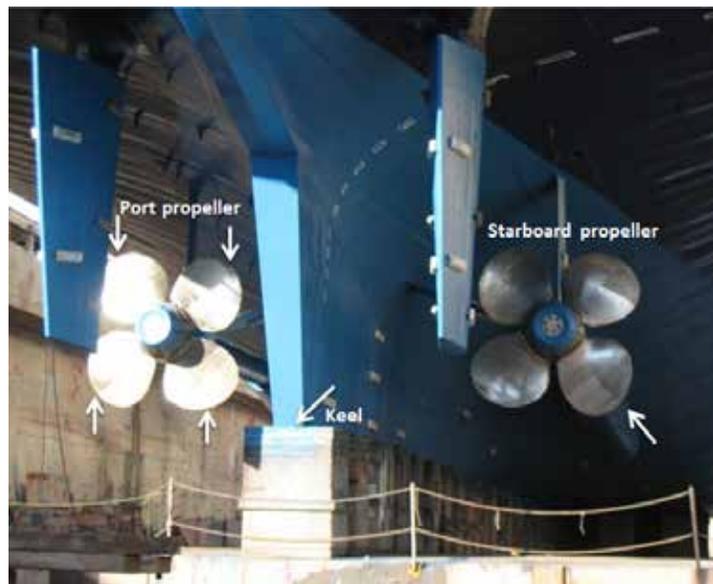
Photo 3. Approximate locations of damage (not shown)

The aftermost part of the vessel's keel was scratched as a result of the grounding, and 1 of the blades on the starboard propeller was bent forward. The 4 port propeller blade tips were all damaged and required smoothing (Photo 3).

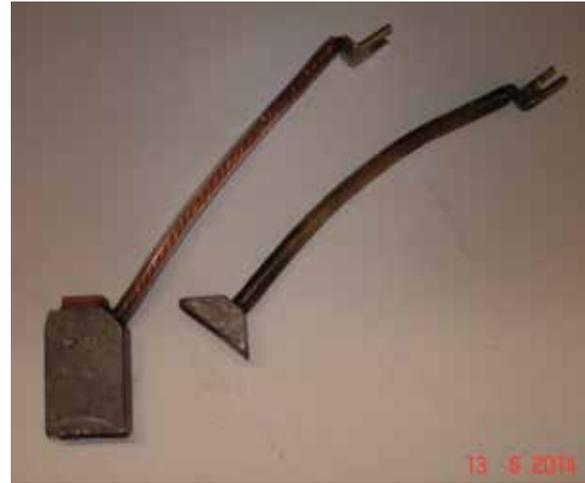
Exciter brushes can sometimes become jammed in the brush holder, preventing them from making continuous contact with the rotor. This can result in the brush arcing and unstable voltage. Arcing can cause the brush to heat up and deteriorate at a faster rate, resulting in carbon build-up. Brushes are also susceptible to breaking when in use.

In 1998, the company began using a softer graphite brush in the generators to reduce wear on the rotor slip ring. A post-occurrence examination of the No. 1 generator found that 1 of the brushes was approximately 80% deteriorated and had marks that indicated that arcing had occurred (Photo 4).

Photo 4. Comparison of a new brush (left) and the worn brush from the No. 1 generator (right)

There were 2 main generators powering the main switchboard when the bow thruster was started; however, the No. 1 main generator was losing excitation due to a deteriorated brush, causing the generator to produce less power. The No. 2 generator was unable to produce the additional power required to start the bow thruster, and the breaker tripped from current overload, causing the interlock to activate and disable the bow thruster. Simultaneously, the deteriorated brush likely began arcing, which would have shorted out that set of brushes and caused the voltage on the No. 1 generator to drop until the under-voltage trip opened the breaker, resulting in a loss of power to the main and emergency switchboards.

When a change of equipment, such as the switch to softer brushes, is made, it is important that the new equipment be inspected more frequently and that the results of these inspections be documented to build a maintenance history. This can assist in determining if any adjustments to the planned maintenance system are needed. In this case, the switch to softer brushes may have introduced new maintenance needs. However, maintenance and inspections of the brushes were not consistently documented, hampering the crew's ability to accurately determine when the brushes should be replaced.

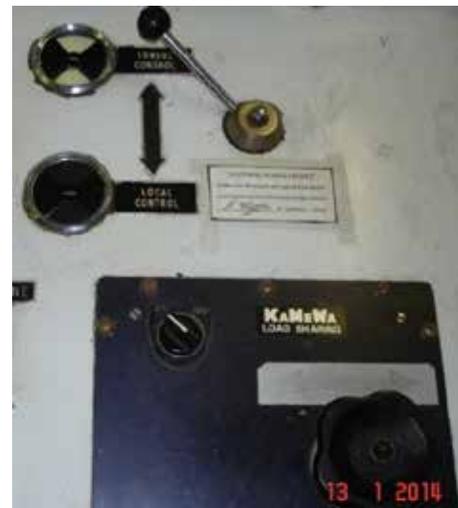
The TSB investigation found that a note stating “Clutching in Main Engines - Make sure all systems are operational before clutching in and transferring to bridge control” was posted above the CPP pumps on the main engine control console (Photo 5). There was no note posted on the CPP pumps.

Photo 5. Location of note in the engine
