**MARINE INVESTIGATION REPORT
M15C0045**

FIRE AND SINKING

**FISHING VESSEL *FREDERIKE. C-2*
RIMOUSKI, QUEBEC
28 APRIL 2015**

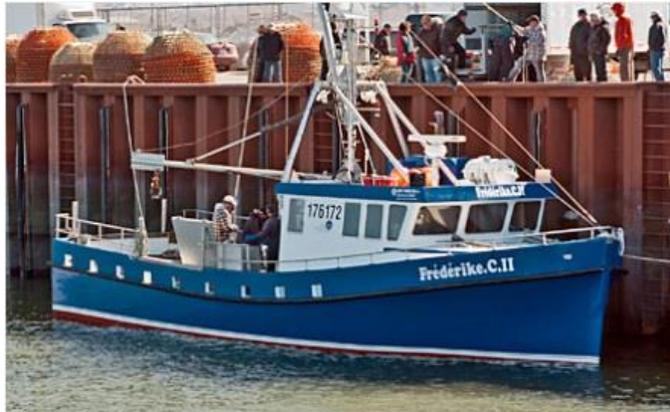
The *Frederike. C-2*¹ was a single-hulled small fishing vessel constructed of fibreglass over wood and used for snow crab fishing (Photo 1). The exposed fibreglass surfaces in the engine compartment were coated with an intumescent paint² to mitigate the localized fire hazard created by the internal combustion engines and the combustible construction materials.

Photo 1. *Frederike. C-2* (Source: Fabienne Gingras)

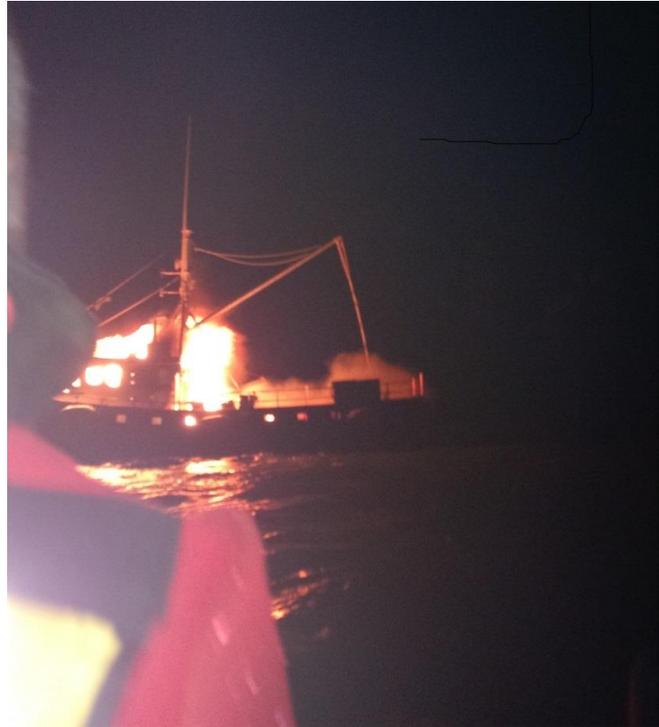
The life raft was detached from the vessel and drifted for about half an hour, ending up 30 metres away from the *Frederike. C-2*, which was by then fully engulfed in flames (Photo 2).

Photo 2. *Frederike. C-2* in flames (Source: Vincent Brière)

The vessel was a total loss due to the extent of the fire. The remains of the hull sank after drifting for 12 hours on the St. Lawrence River. The wreck has not been salvaged.

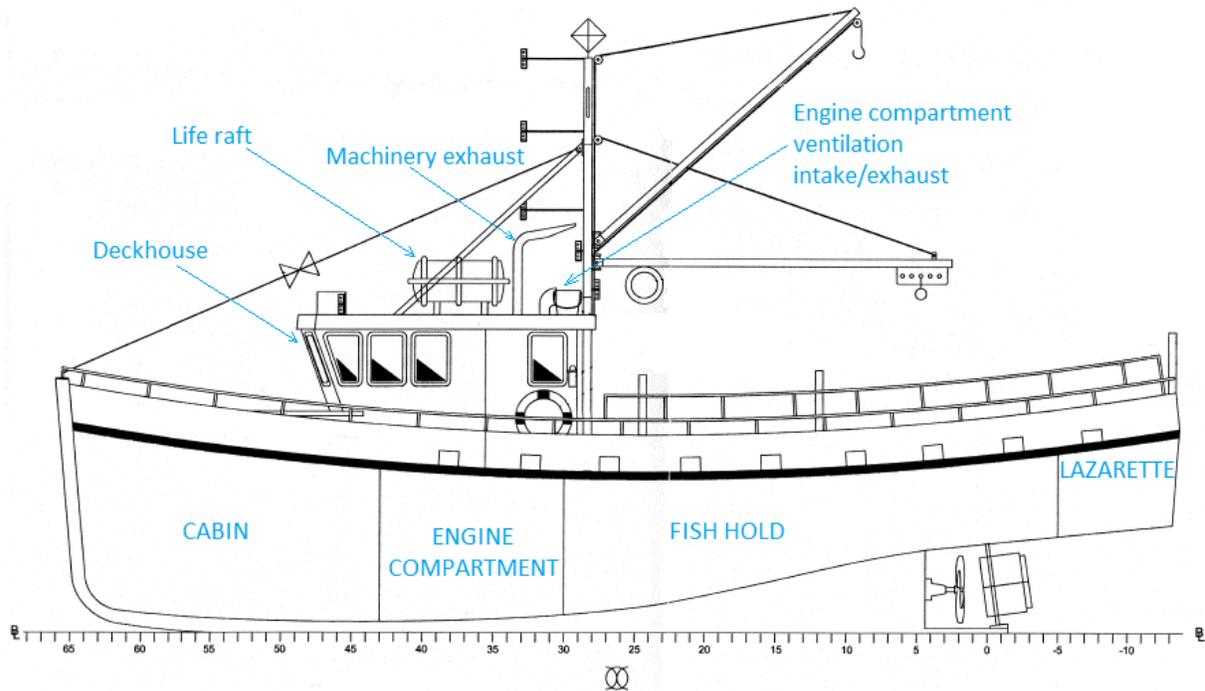
Appendix A – Layout of the Frederike. C-2, showing profile viewed from port side

The hull was subdivided by 3 transverse bulkheads into 4 compartments from forward: a cabin, accessed by stairs descending from the deckhouse, that provided accommodations for 4 people; an engine compartment; an insulated fish hold; and a lazarette that contained the steering gear and 2 diesel fuel tanks that supplied the engine compartment machinery (Appendix A).

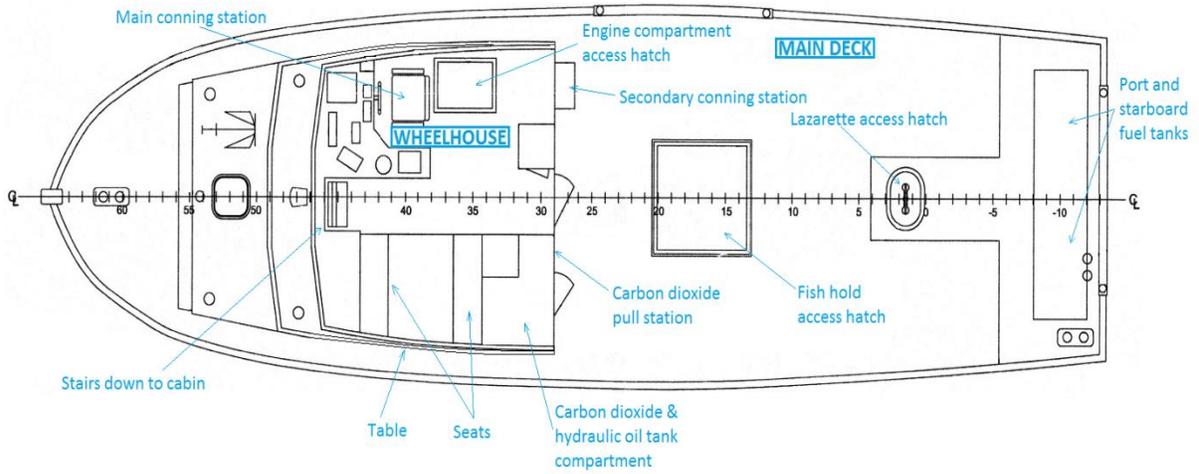
Appendix B – Layout of the Frederike. C-2, showing plan view, including wheelhouse interior

The deckhouse, located forward, consisted of the wheelhouse and a compartment containing 2 carbon dioxide (CO₂) cylinders, a hydraulic oil tank, and the shore power box. The wheelhouse contained a conning station on the starboard side fitted with a helm, an echo sounder, a magnetic compass, a radar, an electronic chart system, a global positioning system (GPS), an autopilot, a rudder angle indicator, the main engine control panel, 2 very high frequency (VHF) radiotelephones, and the bilge pump controls. A table with 2 bench seats was located on the port side, and a door leading to the main deck was located aft on the centreline. Beside the door were the navigation light control panel and the generator panel, which comprised the generator controls, gauges, and associated alarms. A secondary conning station was fitted outside on the starboard side of the main deck and consisted of a helm, a main engine control, and hydraulic controls for the fishing gear (Appendix B).
