# MARINE INVESTIGATION REPORT M16C0016

## **Striking of ice and subsequent flooding**

Fishing vessel *Saputi*  
Davis Strait, Nunavut  
21 February 2016

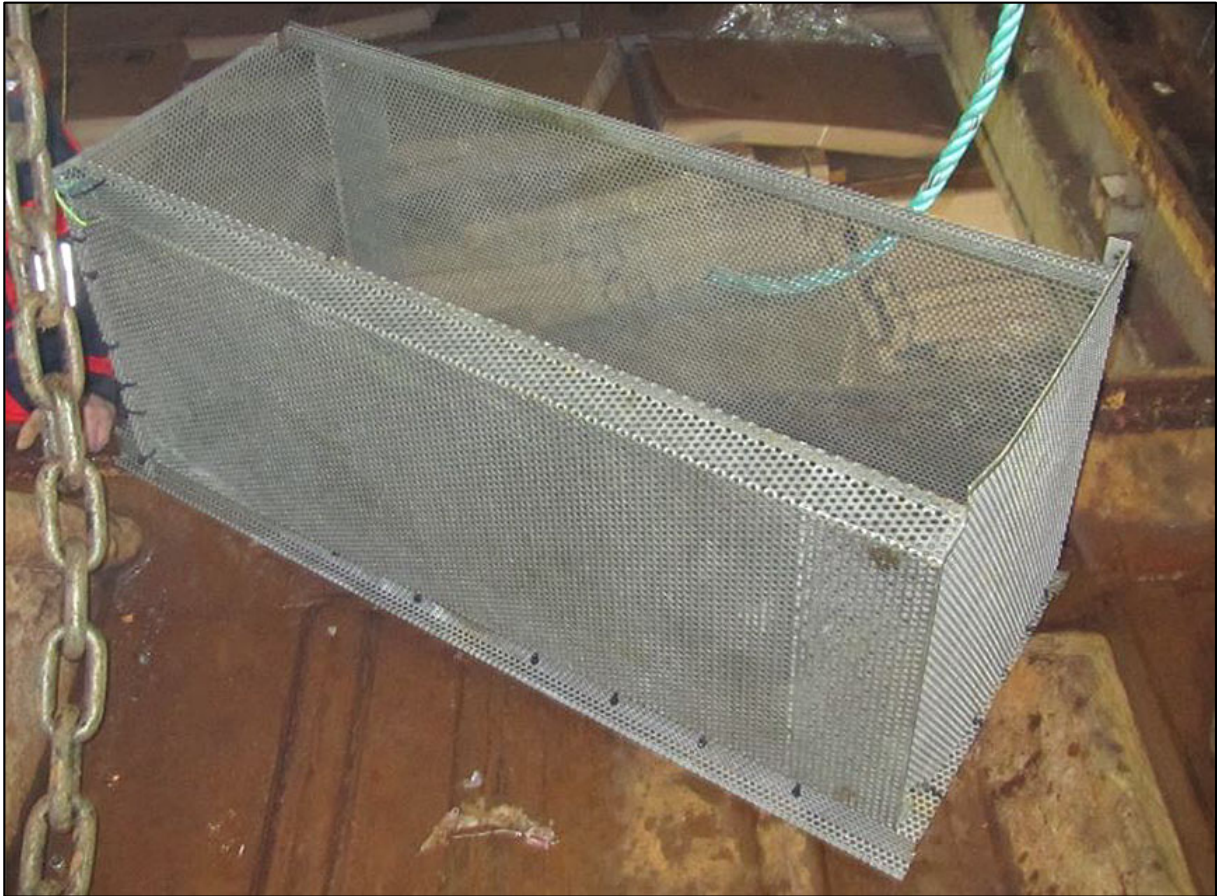
At 0251, the master advised JRCC Halifax that the vessel was unable to keep up with the ingress of water using the pumps on board, and requested additional pumps. The cargo in the hold was beginning to float and clog the suctions of the auxiliary pumps. The crew then created wells around the suctions, placing one pump in a perforated fish basket that kept the debris out of the suction. The crew used a metal chute to direct the water from the crack in the hull into a large fish vat, and placed an auxiliary pump in the vat.

Figure 2. Improved metal strainer (Source: Nataaqaq Fisheries)

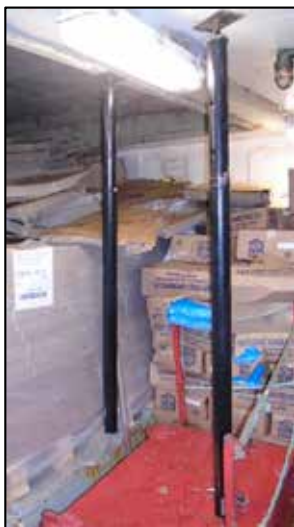
Figure 3. Jack posts used to secure hatches (Source: Nataaaqnaq Fisheries)

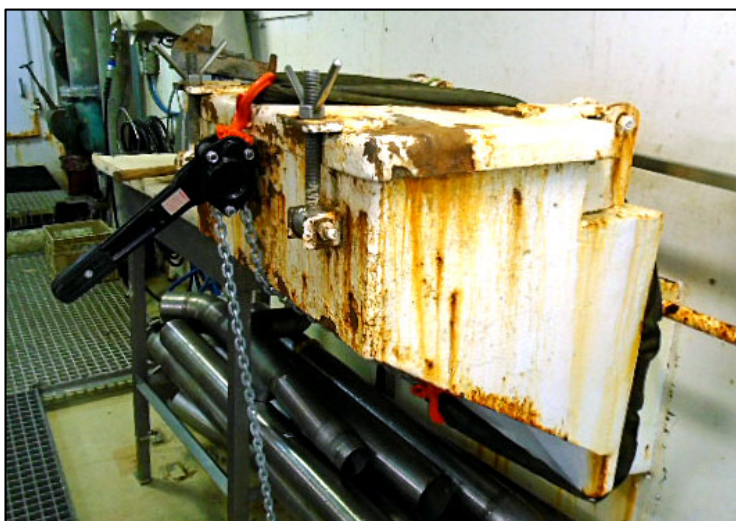
Figure 4. Chain hoist used to secure hatch (Source: Nataaaqnaq Fisheries)

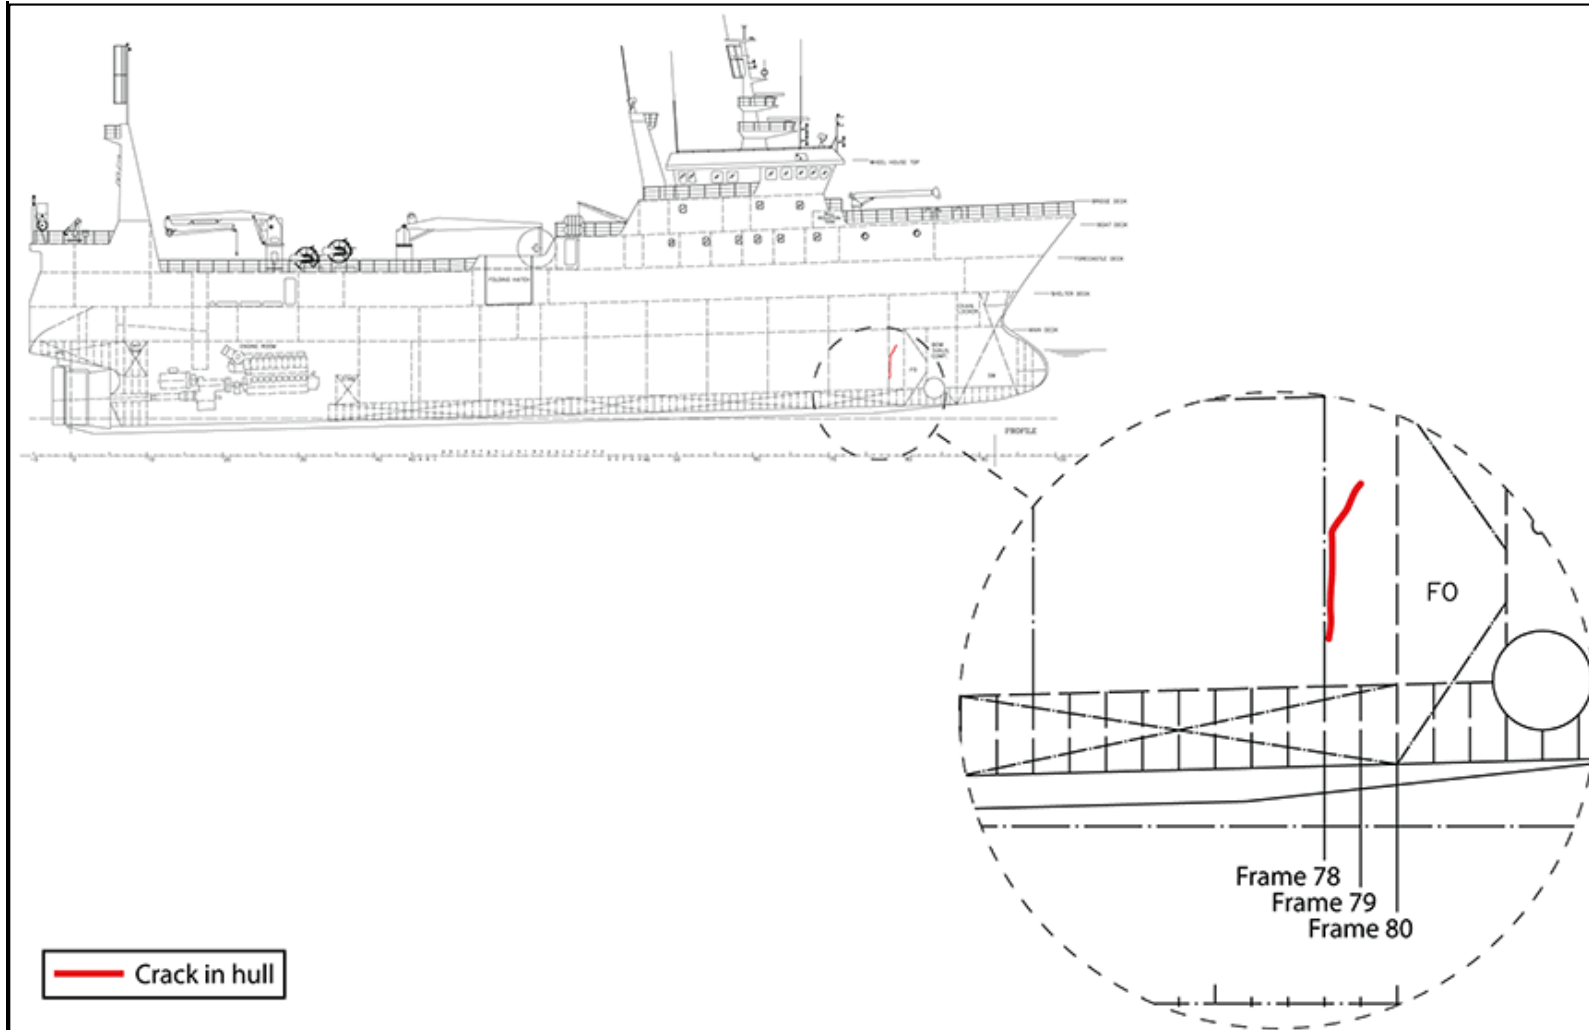
Appendix F – Sketch of damage – exterior

The vessel sustained a vertical crack in the shell plating on the starboard side within the strengthened ice belt between frames 78 and 79, at the forward end of the cargo hold. The crack measured 3000 mm; it originated approximately 3300 mm above the keel and ran upward. The shell plating between frames 75 and 80 was indented. The indentation had a maximum depth of 300 mm and measured 3200 mm wide by 3000 mm high. As a result, numerous frames were indented, and several stringers were indented, deflected, and cracked in way of the dent (Appendix F, Appendix G).

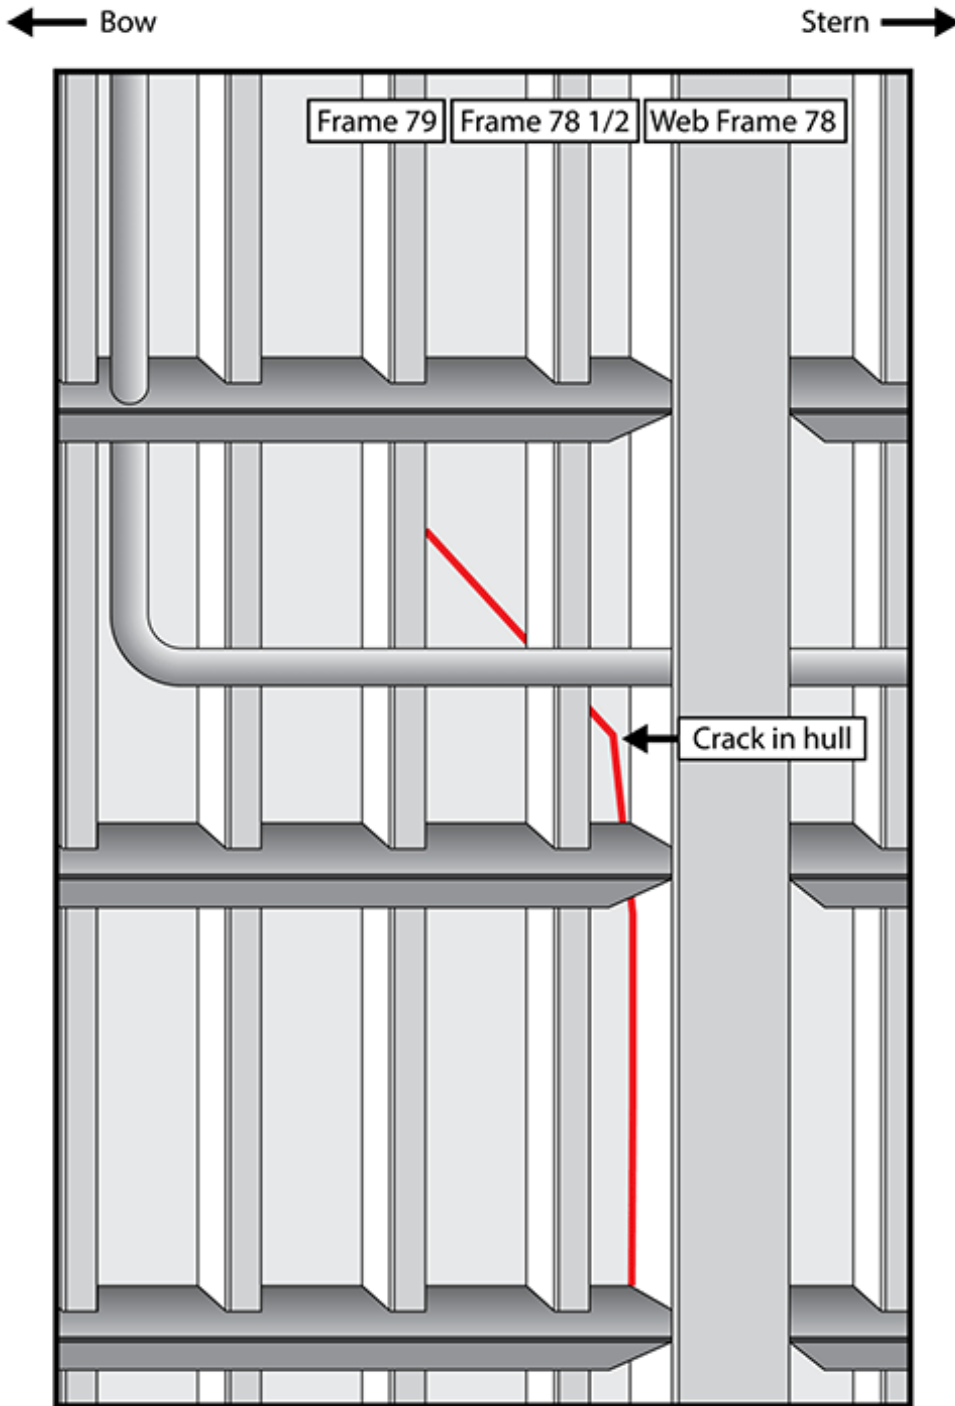
*Appendix G – Sketch of damage – interior*

At 2220, the crew had cleared the cargo from the damaged area and removed the panelling and insulation from the side of the cargo hold. The exposed area revealed a crack running vertically along a hull frame, upward from the deck of the cargo hold, and measuring approximately 1.5 m in length and 1 cm in width at its widest. There was a significant volume of water entering the vessel through the crack, but at that point, there was no water in the forward bilge well of the cargo hold. The engineers set up and started both auxiliary pumps to assist the vessel's bilge pump with controlling the water ingress.

applying a second patch. This increased the water ingress dramatically. The second patch was applied but was less successful because the impact had pushed the shell plating forward of the crack inward approximately 3 cm, preventing a tight seal.

The transverse bulkhead forming the forward end of the cargo hold at frame 80 was also indented but not breached. At the estimated forward draft of 4.7 m, the centre of the crack would have been 1.4 m below the surface of the water outside of the vessel at the time of impact.
