MARINE INVESTIGATION REPORT

M17A0390

Grounding

Bulk carrier *SBI Carioca*

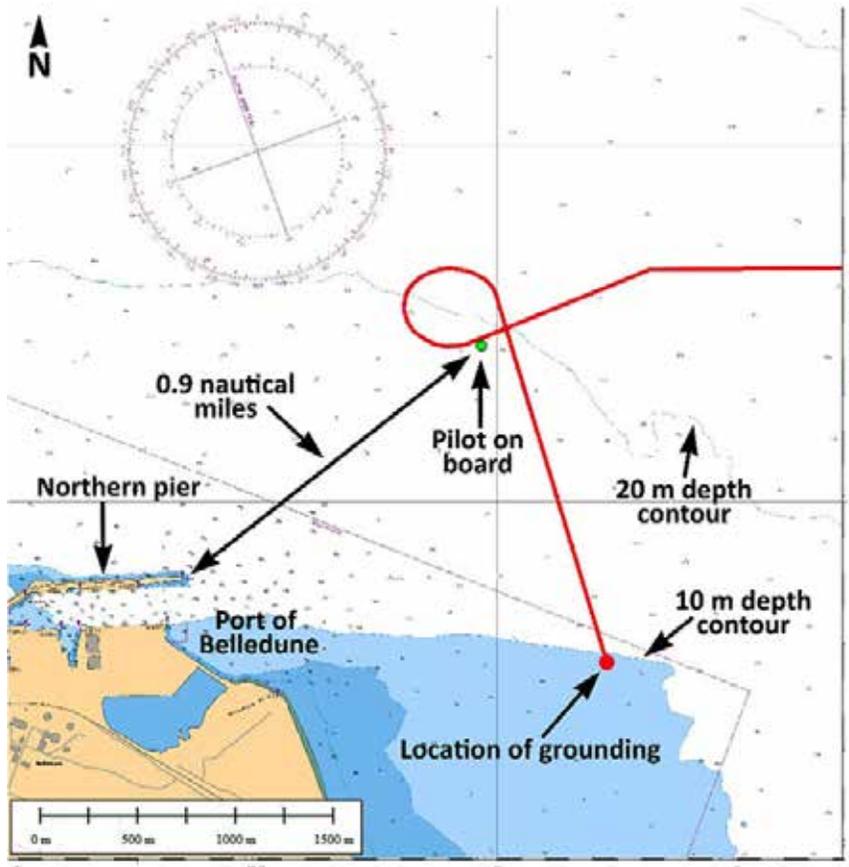
When the *Atlantic Teak* approached the *SBI Carioca*, the crew on board the *Atlantic Teak* observed that the *SBI Carioca*'s pilot ladder was dragging in the water and requested that the crew of the *SBI Carioca* raise it. This delayed the pilot's boarding of the vessel by about 4 minutes. By the time the pilot was on the bridge, at 0655, the *SBI Carioca* was 0.9 nm northeast of the pier (Figure 2).

Figure 2. Depiction of SBI Carioca's track with the location where the pilot boarded, the 20 m and 10 m depth contours, and the location of the vessel grounding (Source: Canadian Hydrographic Service, with TSB annotations)

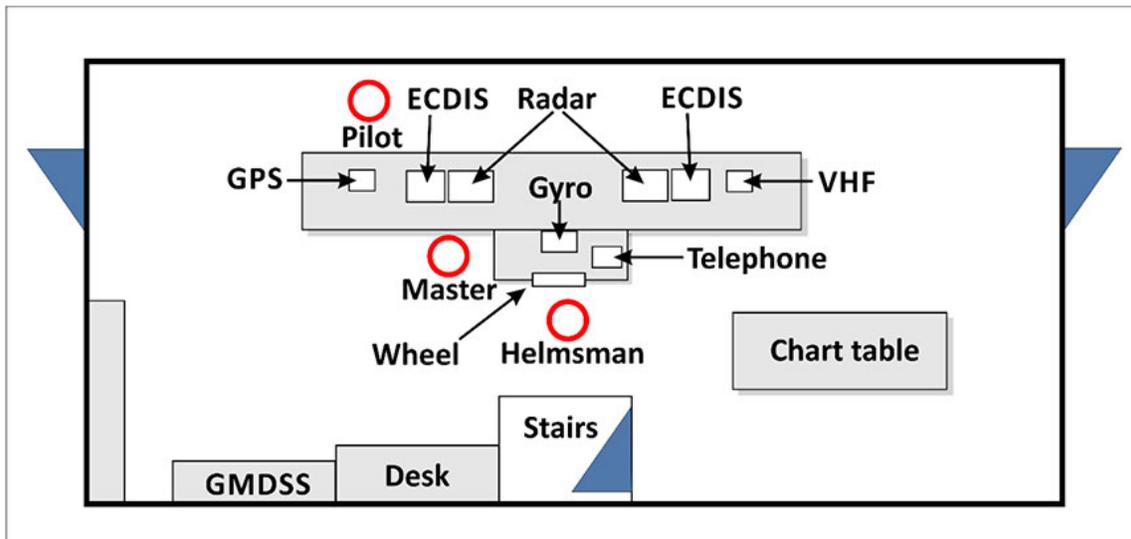
The pilot, who was standing ahead of the console and facing the wheelhouse windows (Figure 3), ordered numerous and varied manoeuvres for the vessel and tugs in an effort to slow the vessel down and alter its course toward the pier. The pilot was not monitoring the radars or ECDIS, and he issued helm orders without further communicating to other bridge team members his plans for an alternative approach to the pier.

Figure 3. Layout of the SBI Carioca's wheelhouse, showing the navigation equipment and the positions of the bridge team at the time of the occurrence

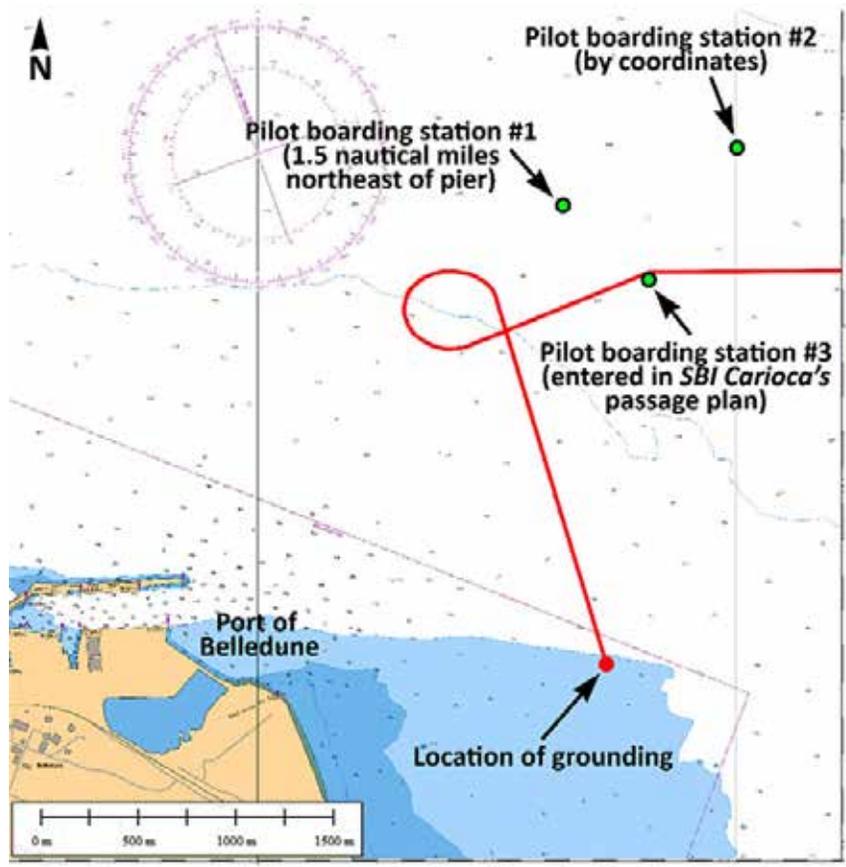
Figure 4 shows the positions of the pilot boarding stations near the Port of Belledune. In the figure, “Pilot boarding station #1” refers to the boarding station designated as Position (A) in the Port of Belledune’s *Port Information and Advice to Masters*. “Pilot boarding station #2” also refers to the boarding station designated as Position (A); this position is derived from coordinates, rather than from bearing and distance.

Figure 4. Pilot boarding stations near the Port of Belledune, shown with the location of the vessel grounding (Source: Canadian Hydrographic Service, with TSB annotations)

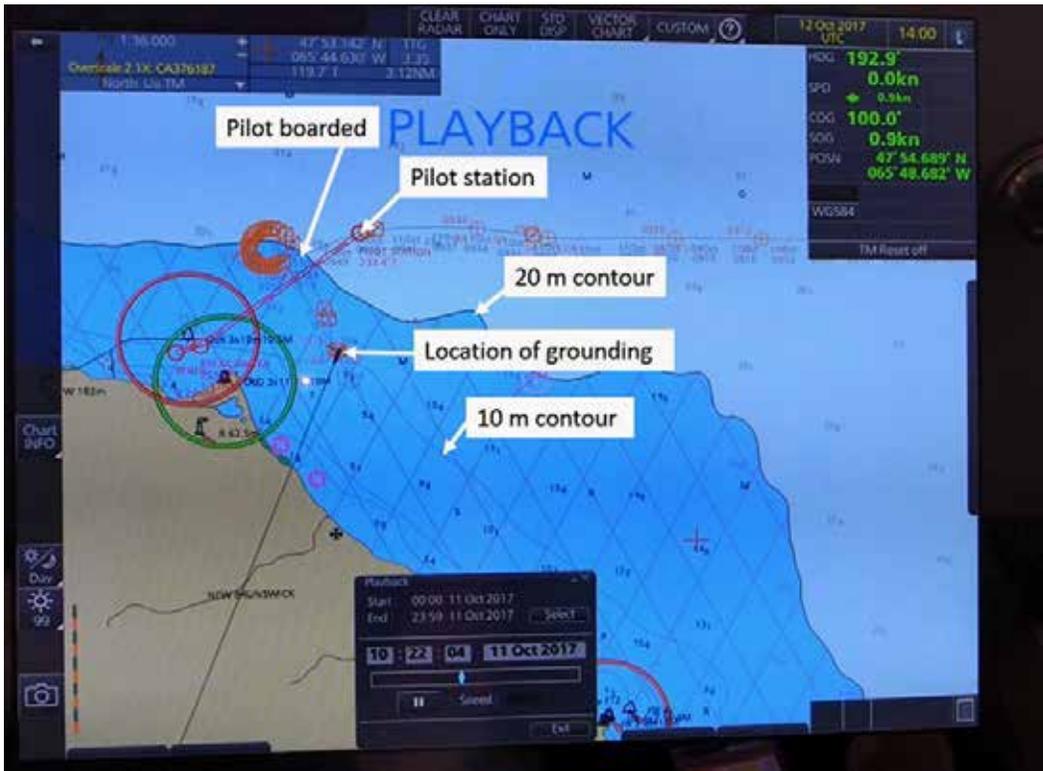
The ECDIS on board the *SBI Carioca* has a variety of safety settings that the crew can select. These include settings to differentiate depth contours with shades of blue to indicate the depth contour above which the vessel can navigate safely. In this occurrence, the crew set all waters shallower than 20 m as dark blue, with no differentiation between the 20 m depth contour and the 10 m depth contour. The 10 m depth contour is less than the vessel's 12.65 m draft (Figure 5), even at high tide.¹²

The *SBI Carioca's* passage plan indicated that 14 m had been selected as the safety depth contour, in accordance with the vessel's safety management system. The ECDIS did not have an alarm set to go off if the vessel crossed that safety depth contour.

Figure 5. Screenshot of the SBI Carioca's ECDIS showing 20 m and 10 m safety contours, with annotations showing the pilot station, the location where the pilot boarded the SBI Carioca, and the location of the grounding
