MARINE INVESTIGATION REPORT

M17C0035

Flooding

Fishing vessel *L.K.C*
Sept-Îles, Quebec, 45 nm E
21 April 2017

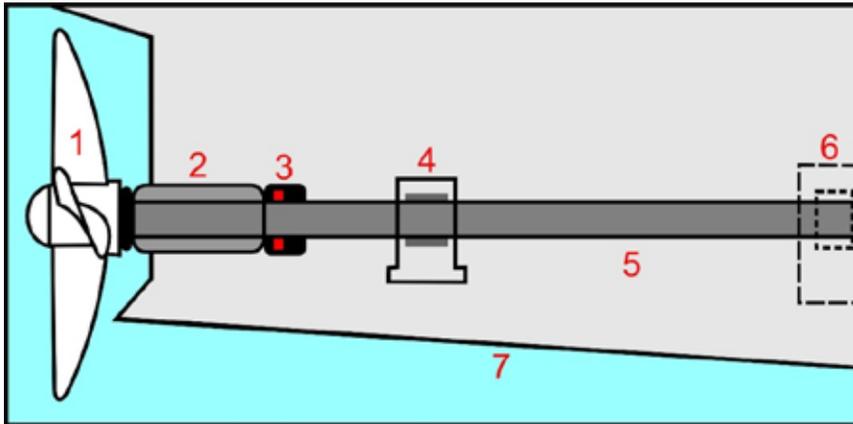
Figure 2. Propulsion shaft arrangement, showing 1: propeller; 2: water-cooled stern tube; 3: mechanical seal; 4: intermediate bearing; 5: propulsion shaft; 6: engine and gearbox; and 7: keel

It was concluded that the mechanical seal or its mounting was likely to have been damaged or altered when the bearing failed during the vessel's first voyage, but the type of damage that caused the stern tube seal to lose its watertightness during the occurrence voyage could not be determined.

The investigation found that the engine room of the *L.K.C* flooded due to a leaking mechanical seal at the stern tube. Although the exact cause of the seal's failure could not be determined, it is likely that the seal was damaged or altered when the intermediate bearing failed during the vessel's first voyage. By the time the crew became aware of the water ingress in the engine room, the water level had risen to a level that rendered the hydraulic and electric pumps inoperable.

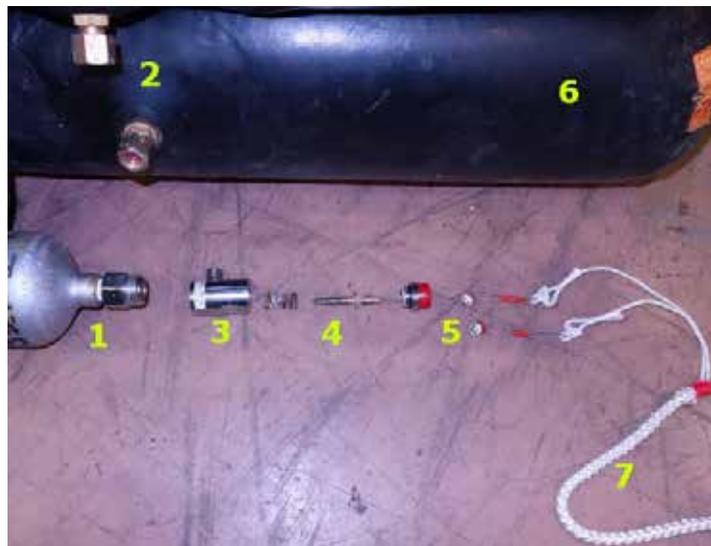
Figure 3. Life raft cylinder arrangement showing 1: cylinder head (contains membrane); 2: raft couplings for cylinders; 3: T-valve; 4: spring, firing pin; 5: arming nut, firing wire and fusible parts; 6: raft bottom chamber; 7: tug line (attached to painter)

The investigation therefore determined that the most likely cause of the life raft chambers' failure to inflate was insufficient gas content in the corresponding cylinders.

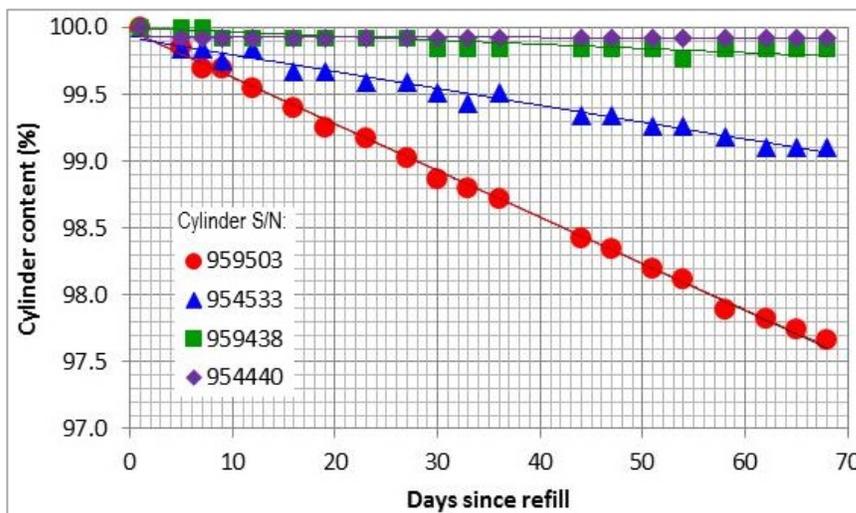
Figure 4. Graph showing the leakage over time of the 4 cylinders, shown in percentage value. According to the manufacturer's service manual, 2% was the maximum acceptable level of leakage.

Short leak tests conducted after filling and based on weight measurement or cylinder immersion, such as those practised at the service station or the subcontractor's cylinder- and gas-service facility, were found to be ineffective, because the time for detection of a leak was too short.
