Marine Transportation Safety Investigation Report M17C0292

PERSON OVERBOARD

Bulk carrier *Federal Champlain*
Thunder Bay, Ontario
08 December 2017

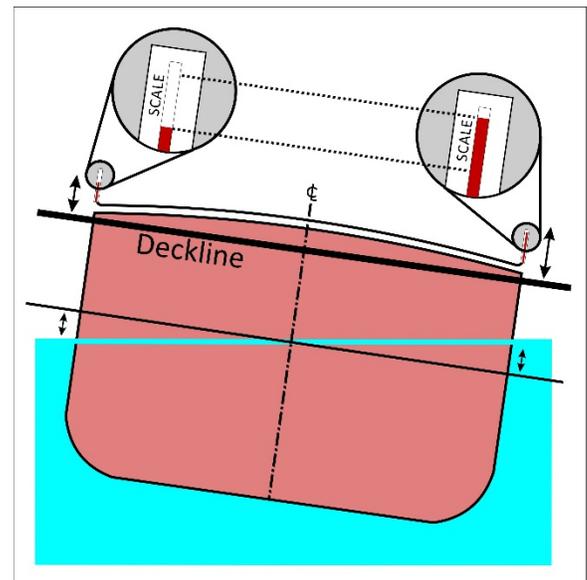
Figure 2. Diagram of a manometer installation on a vessel

Because of the cargo's high loading rate (3000 to 3500 metric tonnes per hour) and the seaway draft restrictions, the drafts had to be closely monitored during the trimming stage. The master therefore ordered the chief officer to install a manometer on the main deck centred between fore and aft and extending from port to starboard (Figure 2). The manometer was filled with a solution of water and antifreeze.⁴

By 1930, with 700 metric tonnes of cargo to be loaded, the liquid in the manometer began to freeze, resulting in false readings. To continuously monitor the vessel's drafts, the master ordered the chief officer to read the vessel's fore, aft, and amidships draft marks from the wharf. The master also ordered the third officer to read the amidships draft marks on the seaward (port) side using the certified embarkation ladder that was rigged to the port-side guardrail.

- The ladder was used to take draft measurements because the water/antifreeze solution in the manometer had frozen. Consequently, the third officer had to sit on the ladder's aluminum steps for 20 minutes in cold weather, and his ability to move was restricted.
- The crew members on deck were unable to recover the third officer by using the lifeline.
