# MARINE TRANSPORTATION SAFETY INVESTIGATION REPORT M20C0145

## **STRIKING OF BERTH**

Bulk carrier *CSL Tadoussac*  
Port of Québec  
Québec, Quebec  
10 June 2020

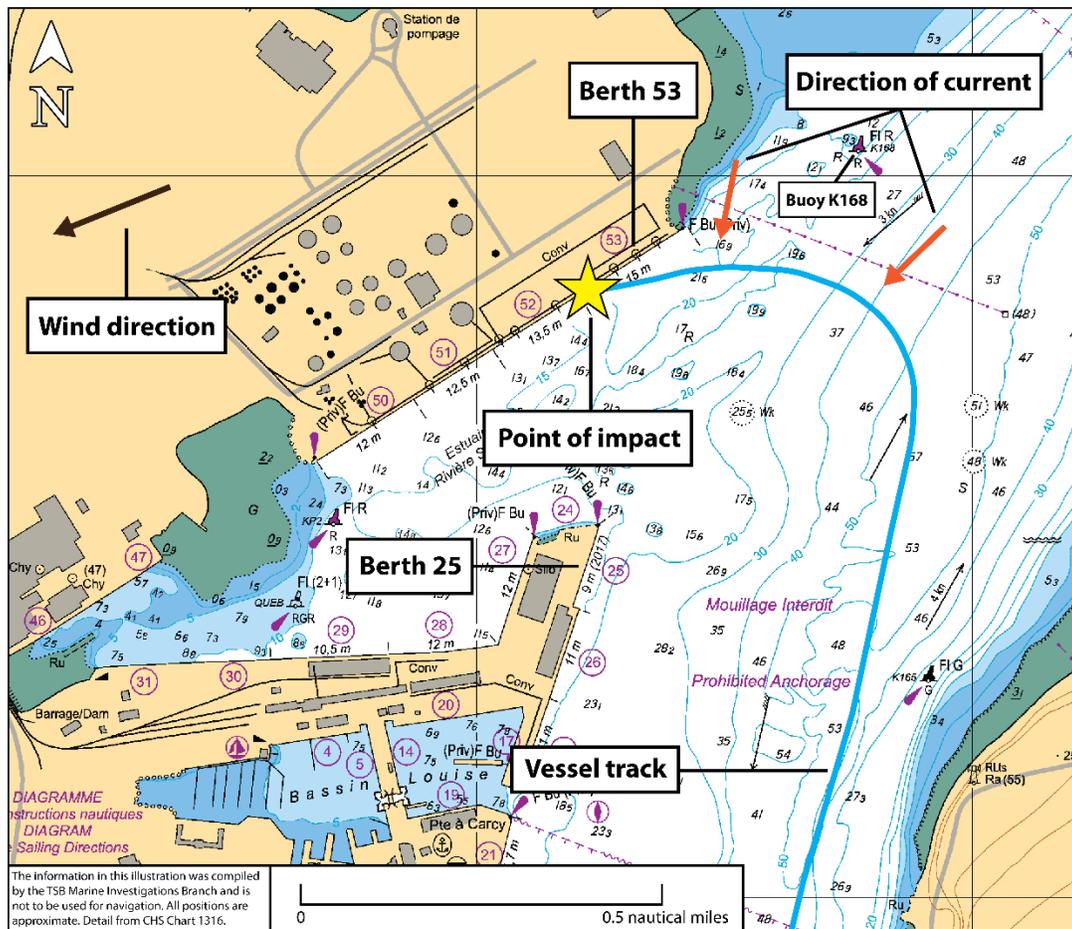
At approximately 0726, the vessel was abeam of berth 25. The vessel's speed was 3 knots<sup>5</sup> and its heading was 17° gyro.<sup>6</sup> To turn the vessel to port toward berth 53, the pilot ordered the rudder hard to port and the bow thruster to full power, also to port. The pilot then ordered the master to reduce the vessel's speed (Figure 4).<sup>7</sup>

Figure 4. Chart showing the location of the occurrence and the vessel track, as well as the wind direction and the general direction of the current at the time of the occurrence (Source: Canadian Hydrographic Service Chart 1316, with TSB annotations)

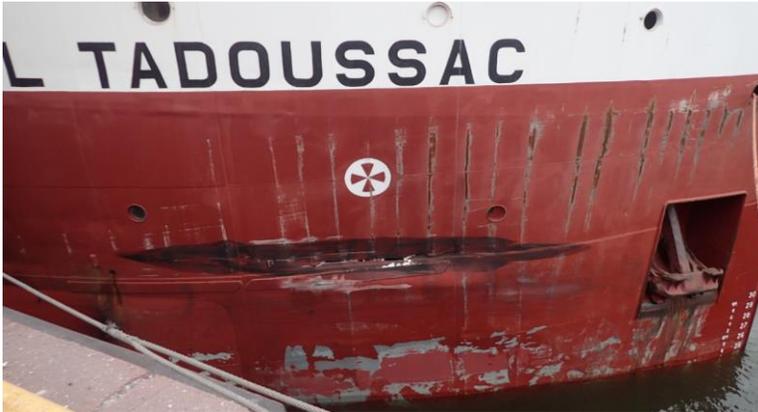
The vessel sustained the following damage (figures 5 and 6):

Figure 5. Damage to the vessel's starboard bow (Source: TSB)

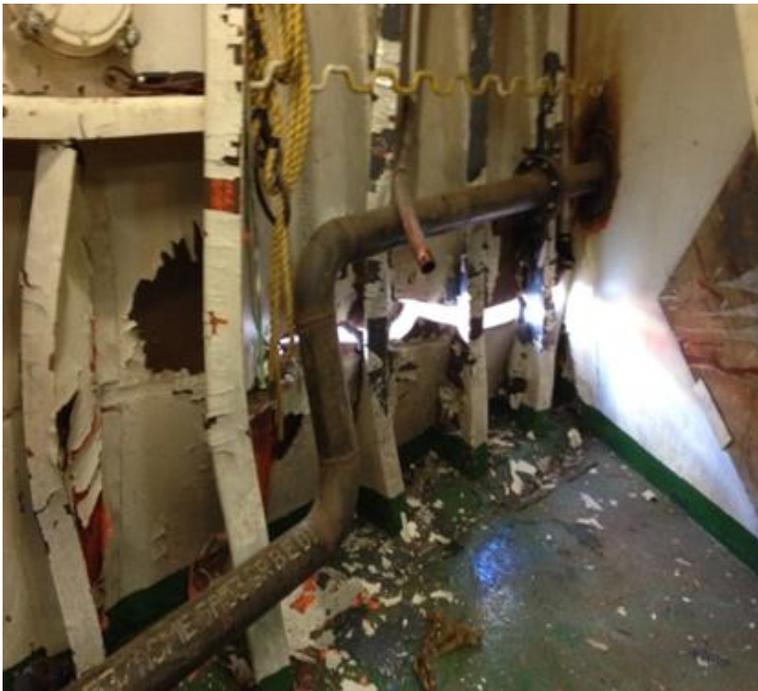
Figure 6. Inside view of damage to the vessel's starboard bow (Source: Canada Steamship Lines)

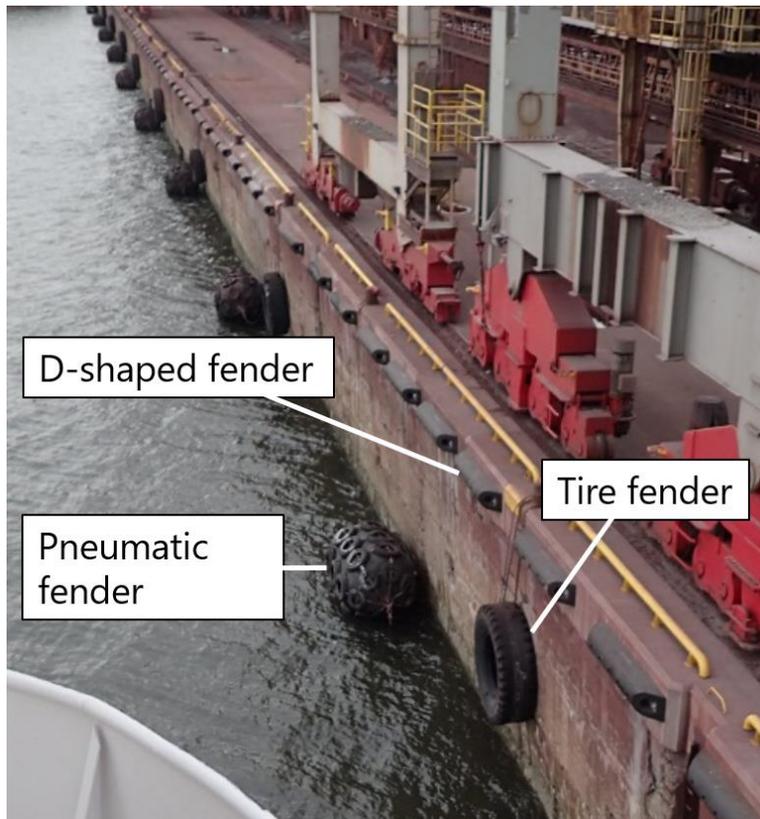
Figure 7. Fendering system for berth 53 (Source: TSB)

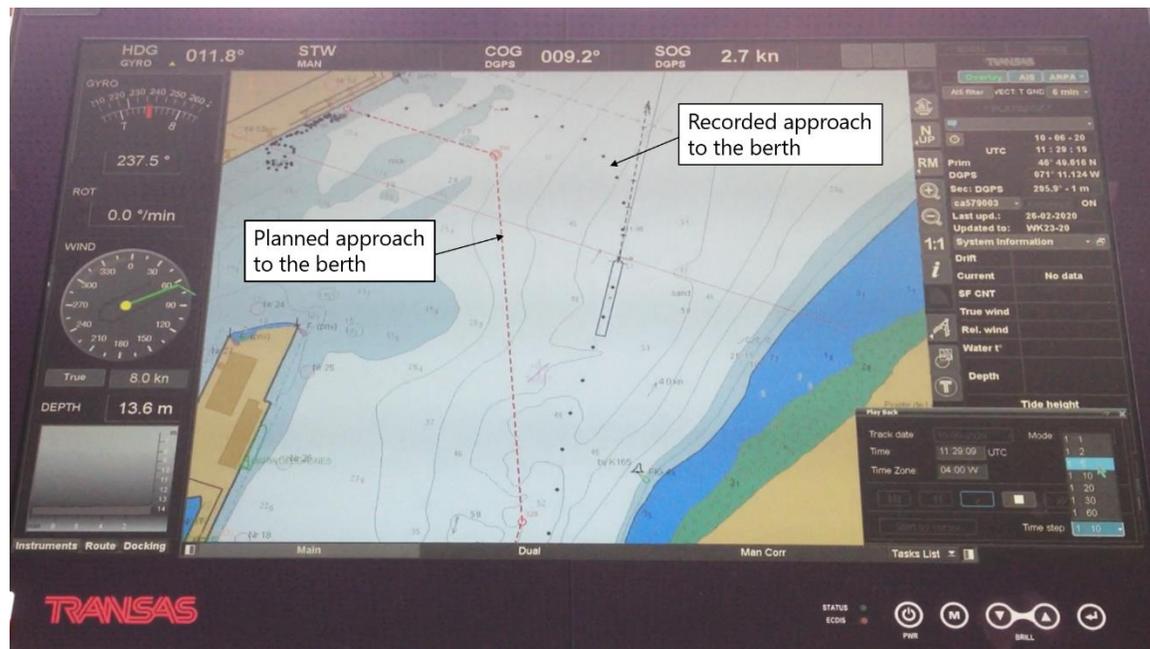
A general passage plan from Conneaut to the Port of Québec was prepared well in advance of the occurrence voyage by a second officer and approved by the master. This general plan was input into the ECDIS, and was used for each voyage the vessel made from Conneaut to the Port of Québec. A paper version of this plan was printed and, per common practice, some details such as the voyage date and chart corrections were amended for the occurrence voyage. The berthing portion of the passage plan consisted of 2 legs and 3 waypoints, with the final waypoint at berth 53. The plan did not detail the manoeuvres required for the vessel to complete a turning circle and come alongside berth 53 (Figure 8).

Figure 8. Photograph of the vessel's electronic chart display and information system, showing the vessel's planned and recorded approaches to berth 53 (Source: TSB)
