## **PIPELINE INVESTIGATION REPORT**

**P07H0040**

### **CRUDE OIL PIPELINE – THIRD-PARTY DAMAGE**

**KILOMETRE POST 3.10, WESTRIDGE DOCK TRANSFER LINE**

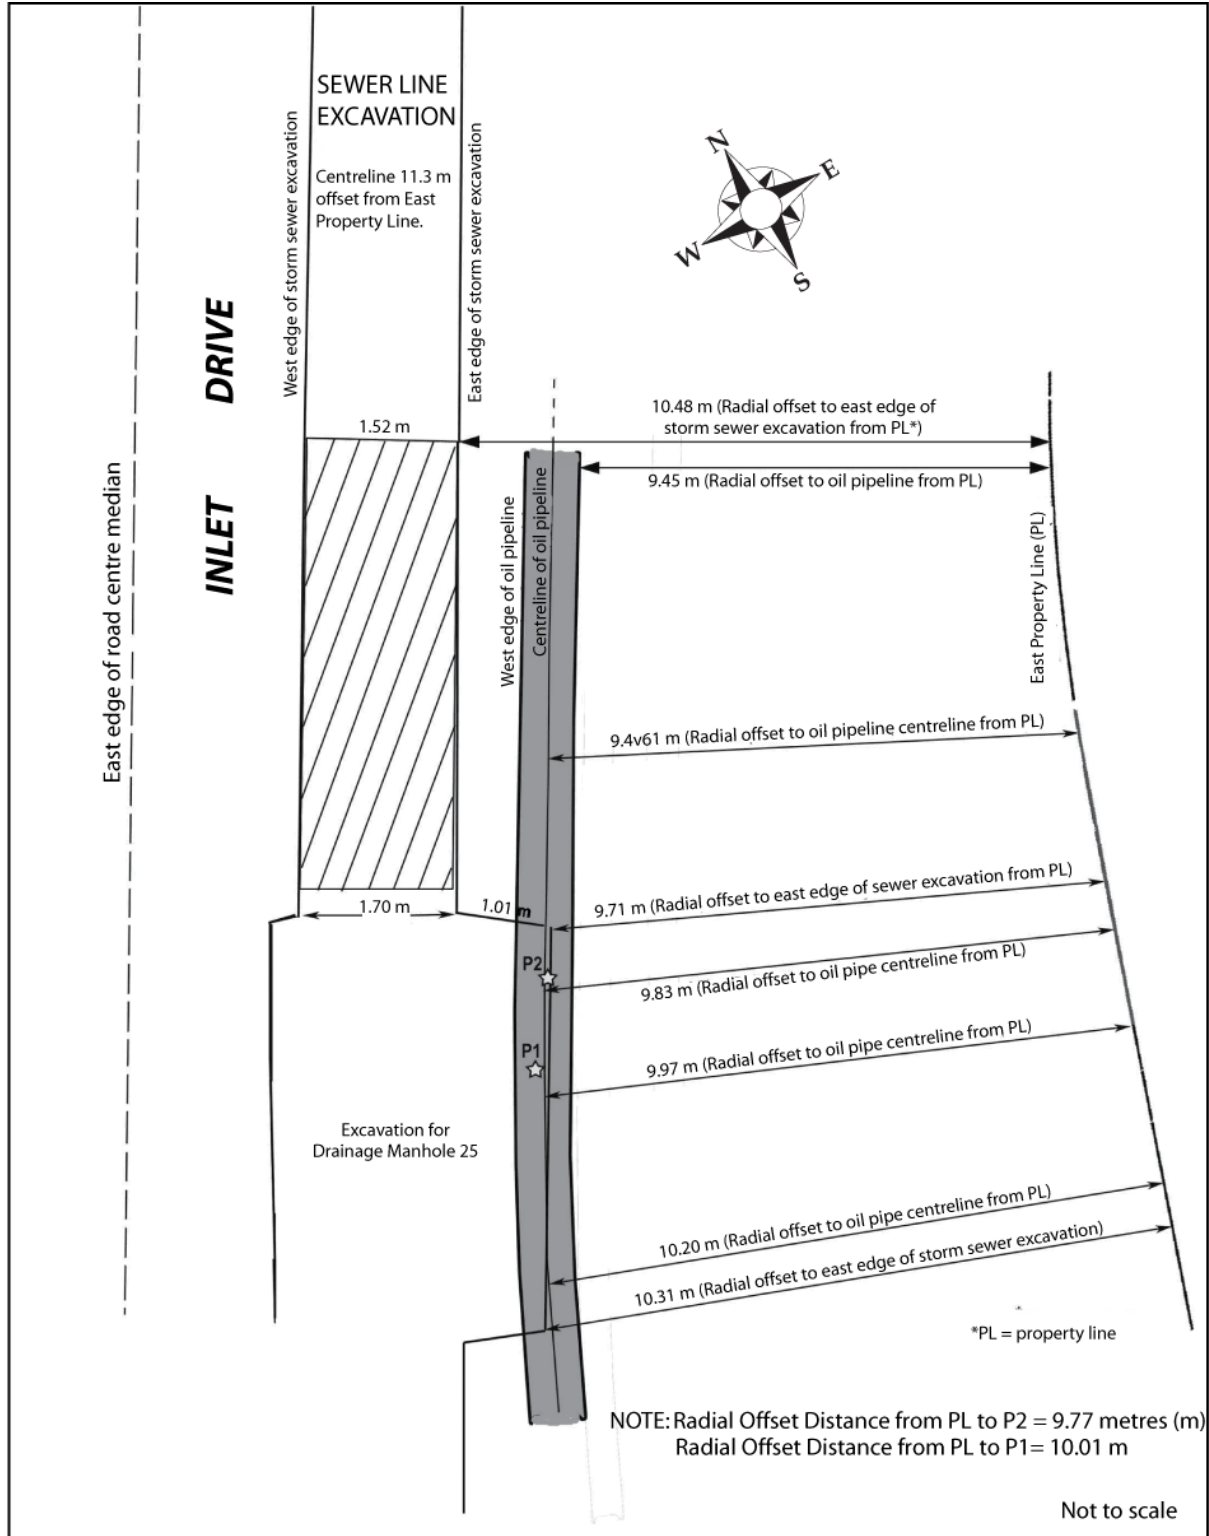
Appendix C – Westridge Dock Transfer Line – Inlet Drive, Burnaby, British Columbia – Post-Occurrence As-Built Survey (Source: TSB Illustration)

A post-occurrence site survey revealed that the offset location of the Westridge Pipeline varied from 4 m to 9.8 m from the east property line of Inlet Drive, instead of the constant 8.5 m offset that had been shown on the design drawings. The survey also showed that the sewer trench was excavated according to the design offset of 11.3 m. At the rupture site, the survey revealed that the Westridge Pipeline was only 1.5 m from the centreline of the sewer trench, instead of the 2.8 m separation that had been shown on the design drawings Rev. 1 and Rev. 2 (see Appendix C).

1. The field location of the Westridge Pipeline was not accurately indicated on design drawings, which were based on a 1957 drawing, resulting in an alignment conflict with the trench of the proposed sewer line.
