**PIPELINE INVESTIGATION REPORT  
P13H0107**

**RUPTURE**

**TRANSCANADA PIPELINES LIMITED (NOVA GAS  
TRANSMISSION LTD.)  
NORTH CENTRAL CORRIDOR LOOP (BUFFALO CREEK WEST  
SECTION) CHAINAGE 27+996 M  
NEAR FORT MCMURRAY, ALBERTA  
17 OCTOBER 2013**

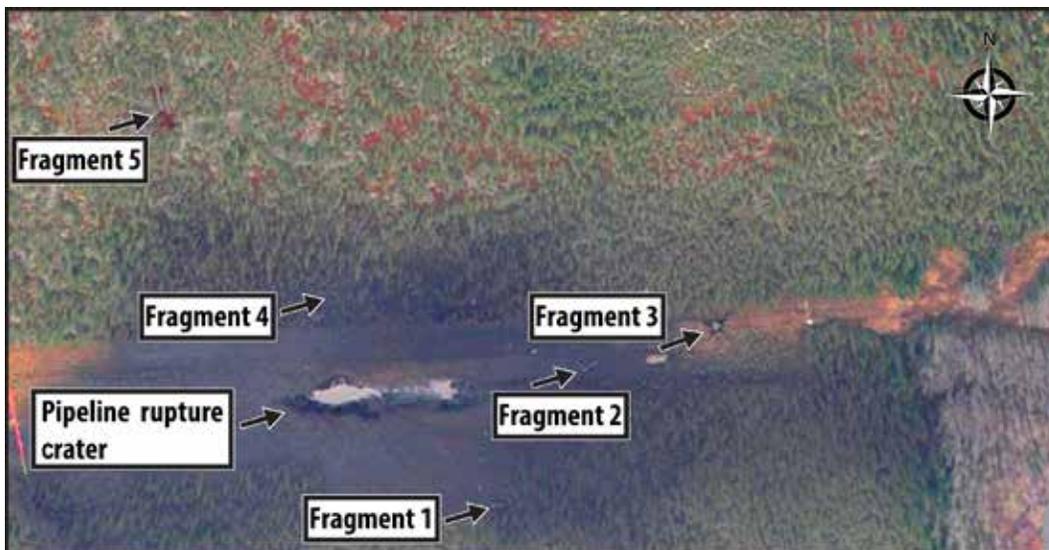
Figure 2. Aerial photo of pipe fragment locations

- The pipeline rupture had created a crater approximately 15 m wide, 50 m long and 5 m deep.
- Five pipe fragments were ejected during the rupture and were located within about 130 m of the line break site (Figure 2).
- Fragment 3, located approximately 30 m from the edge of the rupture site, was a 3D-forged 12-degree elbow<sup>3</sup> with short pups<sup>4</sup> attached to each end (Figure 3).
- The soil condition at the rupture site consisted of an organic deposit approximately 0.5 m to 1.5 m thick with underlying clay.
- Approximately 200 m east of the rupture site, the terrain changed to a mineral soil on the banks of the Wabasca River.
- Approximately 350 m west of the rupture site, there was a wetland area.

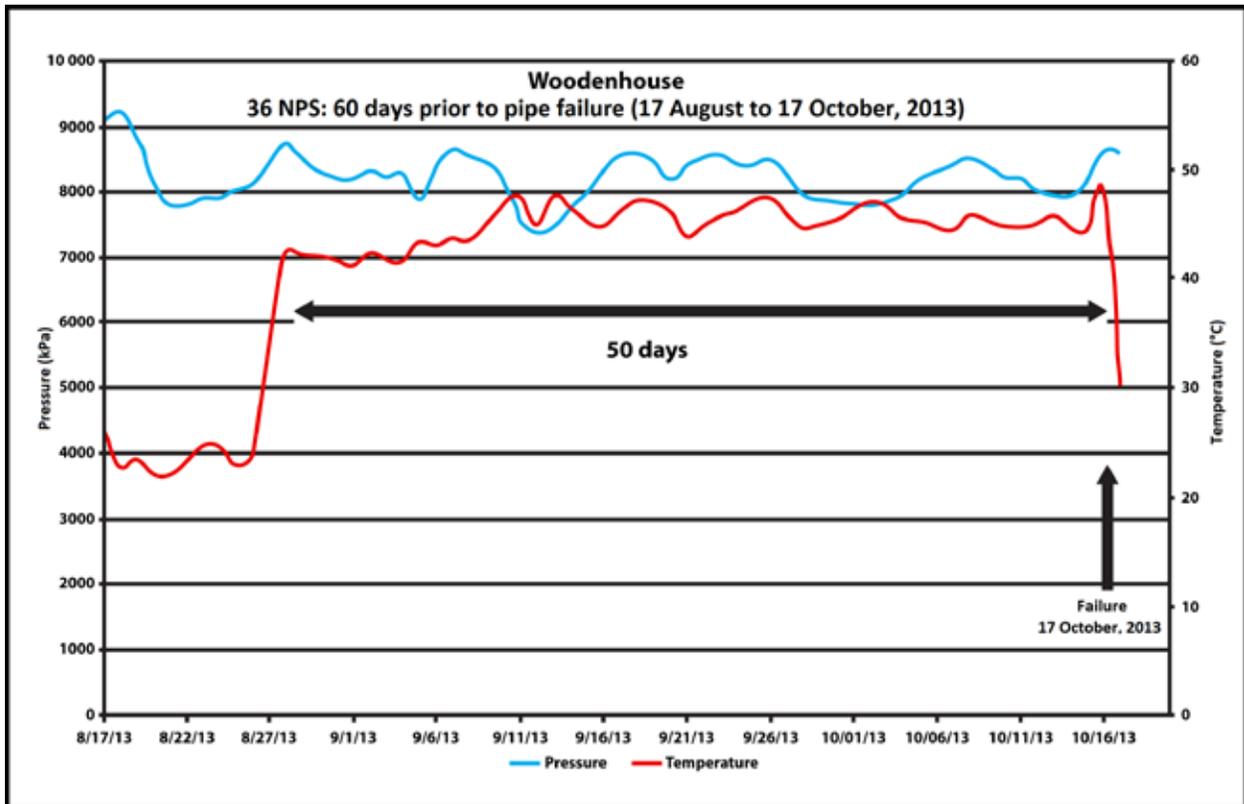
Figure 5. Temperature and pressure history prior to rupture

Approximately 50 days prior to the rupture, there was a step increase in the discharge temperature at the Woodenhouse compressor station, due to an increased horsepower requirement to meet downstream customer demand.

As such, in the 50 days prior to the rupture, the pipeline had been experiencing a sustained elevated discharge temperature of at least 42 °C at the Woodenhouse compressor station (Figure 5). At this location, the pipeline had not previously experienced this range of elevated temperatures for an extended period of time.

During normal pipeline operations, thermal expansion had developed in the pipeline that exerted force on the elbow, resulting in increased stress at the intrados of the elbow. Over a 50-day period prior to the rupture, the pipeline had been operating at a sustained temperature ranging from 42 °C to 48 °C and at a maximum pressure in the range of 9200 kPa.

Under the direction of NEB Inspection Officer Order KF-001-2013, the pipeline was returned to service on 21 November 2013 with the conditions that there be a maximum pressure of 7168 kPa for the valve section NCC 30-1-BV to NCC 20-1-BV, and that the discharge temperature be restricted to 35 °C at the Woodenhouse compressor station.

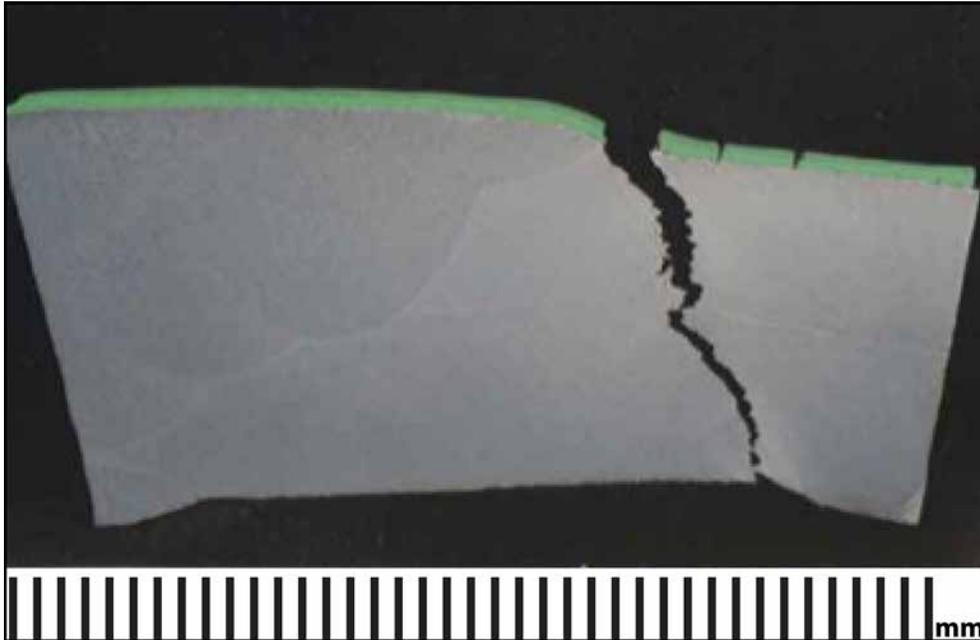
Photo 1. Metallurgical cross section near initiation site

Laboratory analysis determined that the failure initiated within the 12-degree elbow. Prior to rupture, the elbow had been altered to about 15.4 degrees and had expanded about 5.9%. The failure initiation point was located mid-span of the elbow and coincident with the toe of the intrados weld cap. From the initiation point, the fracture had propagated through the wall thickness at approximately 45 degrees (Photo 1). The fracture was entirely ductile in nature, resulting from stresses that exceeded the strength of the elbow.

Mechanical testing<sup>15</sup> (i.e., yield strength, ultimate tensile strength and percent elongation) determined that the elbow had not been compliant with CSA Z245.11 grade 550. The mechanical testing results were however compliant with CSA Z245.11 grade 483, which was the specified grade for the matching pipe. Charpy impact testing<sup>16</sup> determined that the elbow and the pups from each side of the elbow had met the requirements of CSA Z245.11. There was no indication of corrosion, stress corrosion cracking, mechanical damage, or material and manufacturing defects.
