RAILWAY OCCURRENCE REPORT  
R96S0106

TRESPASSER FATALITY

VIA RAIL CANADA INC.

TECUMSEH, ONTARIO

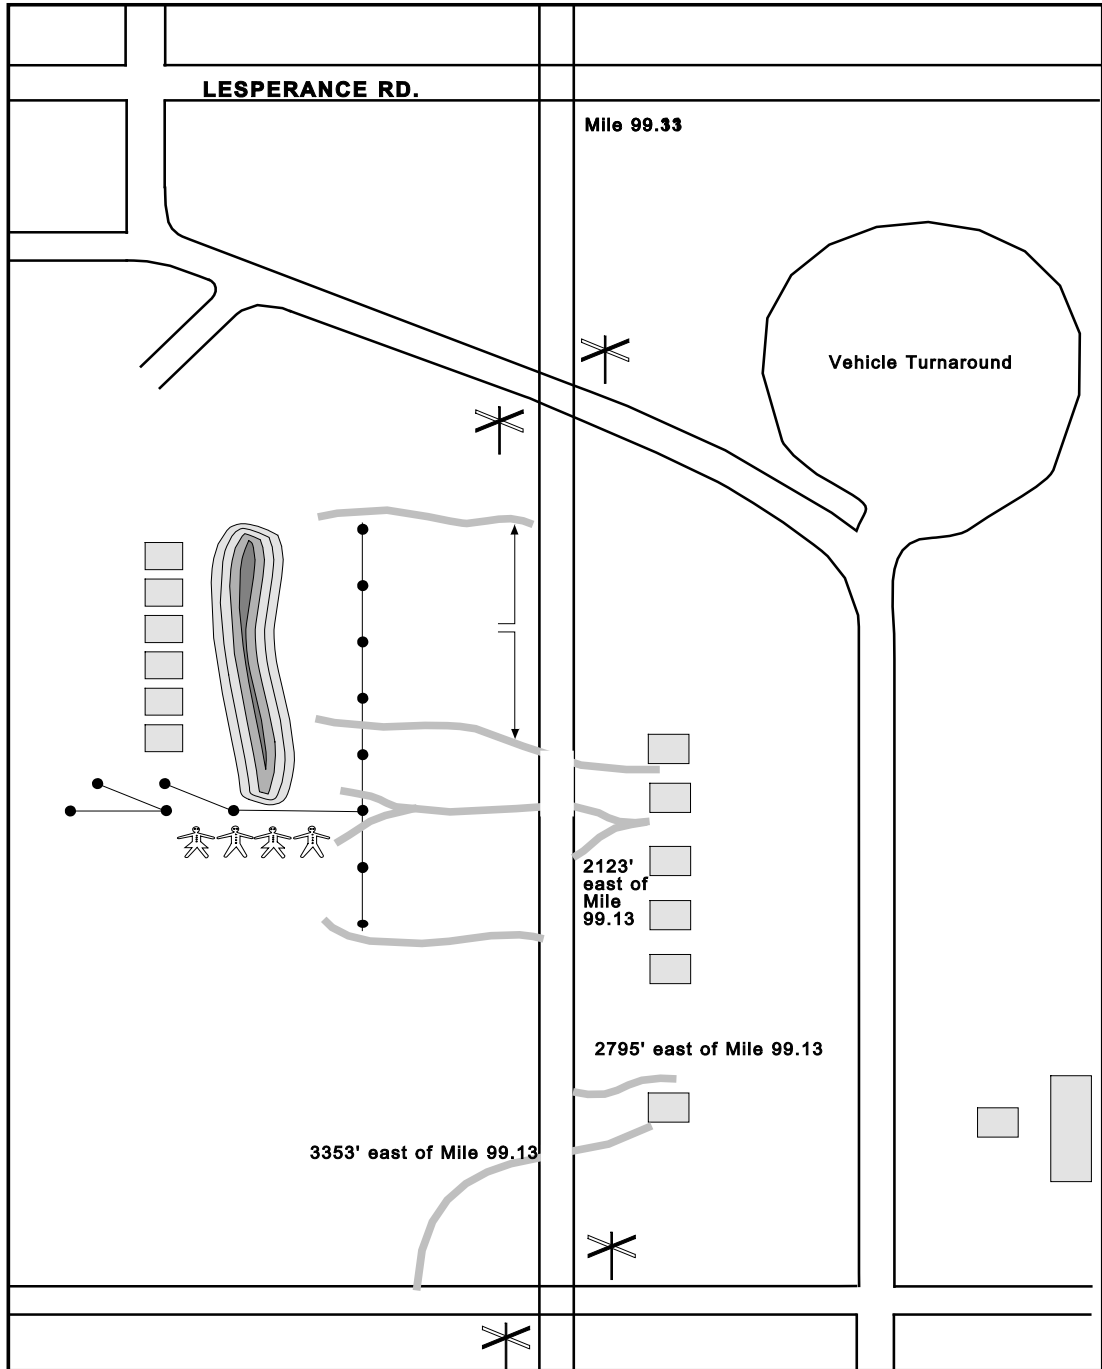
## 1.9 Occurrence Site Information

In the immediate vicinity of the occurrence site, the subdivision consisted of a single, tangent, east/west main track. Tecumseh Road intersects the main track at Mile 99.13 and turns east approximately one block north of the right-of-way. The road then parallels the main track, separated from the track by private lands. There were no barriers to restrict access to the railway right-of-way. Between Mile 99.13 and the Manning Road crossing,
