RAILWAY INVESTIGATION REPORT
R98T0141

COLLISION

ST. LAWRENCE & HUDSON RAILWAY
MILE 37.8, GALT SUBDIVISION
CAMPBELLVILLE, ONTARIO
17 JUNE 1998

Report Number R98T0141

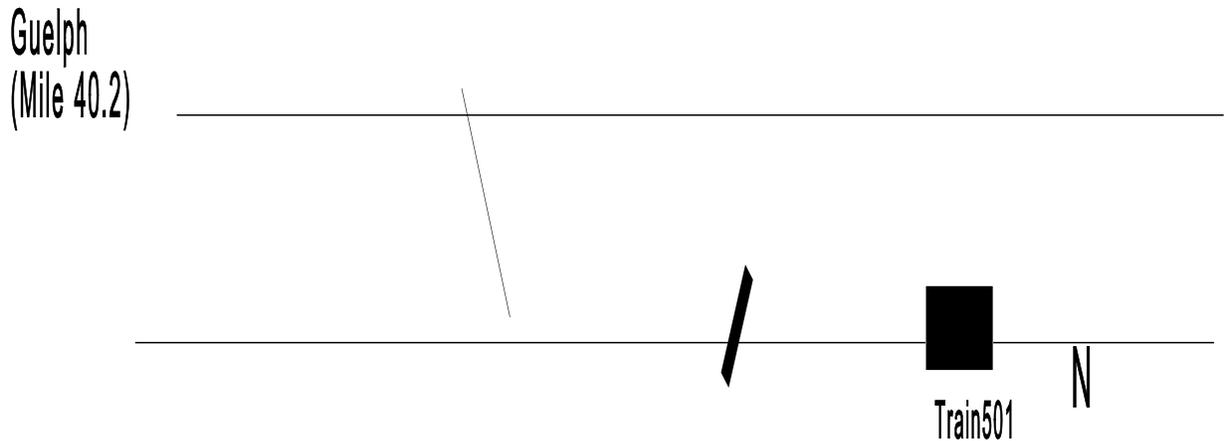
A track maintenance work program involving the replacement of track ties was in progress. At the time of collision, the main body of the tie gang was working on the south main track, between Signal 402 at Mile 40.2, the west end of Guelph Junction, and Signal 388-3 at Mile 38.85, Guelph Junction East (Figure 1). A smaller group was working under the direction of a sub-foreman on the south main track at Campbellville, approximately one mile east of the main gang, unloading ties from a lorry with a tie crane.
