RAILWAY INVESTIGATION REPORT

R02D0069

MAIN TRACK DERAILMENT

MILE 117.68, JOLIETTE SUBDIVISION

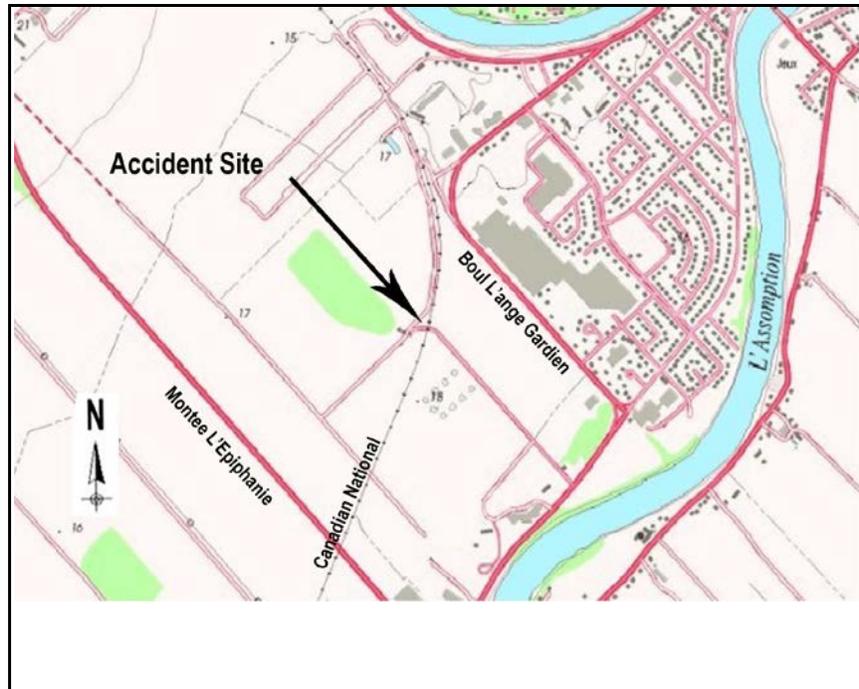
The derailment occurred in a 2-degree right-hand curve, on a 0.1 per cent descending grade in the direction of travel (see Figure 1). Approximately 100 feet north of the private crossing, located at Mile 117.69, wheel marks were visible on the track structure (ties and ballast). Over a distance of 600 feet north of the wheel marks, on the west side of the track, the ties were skewed and the south rail anchors had moved up to two inches from the ties. There were no signs of rail creep on the east side.
