RAILWAY INVESTIGATION REPORT
R06Q0096

MAIN-TRACK TRAIN DERAILMENT

CANADIAN NATIONAL
FREIGHT TRAIN M-36231-25
MILE 153.2, LAC-SAINT-JEAN SUBDIVISION
CHAMBORD, QUEBEC
27 AUGUST 2006

Report Number R06Q0096

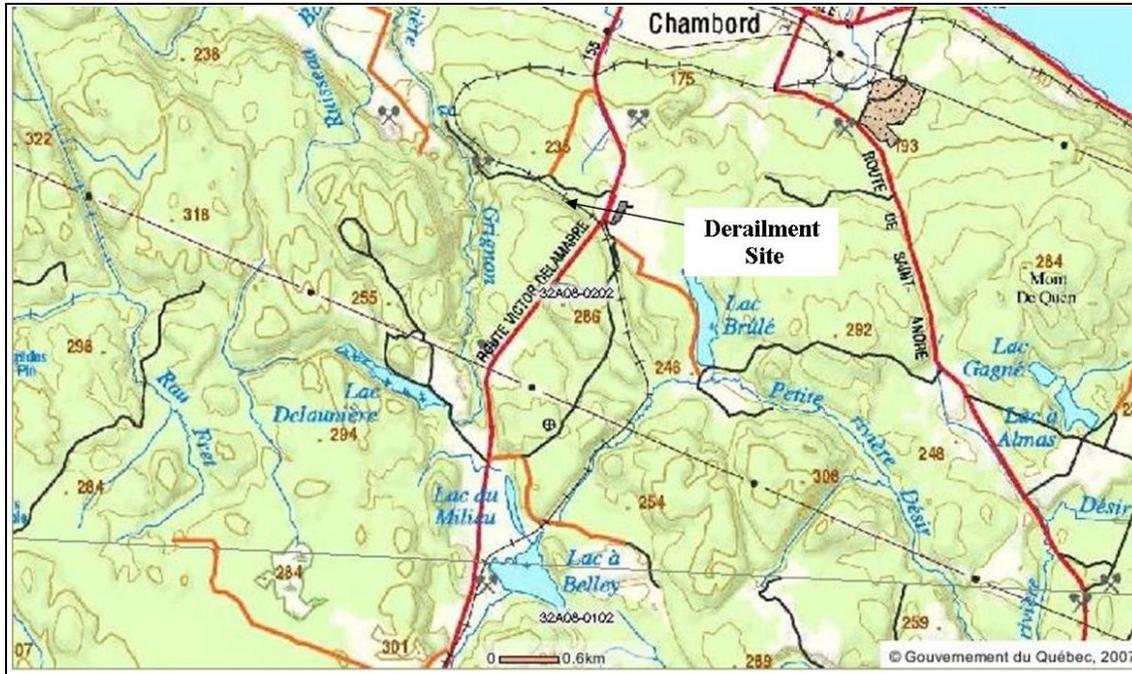
The track has a reverse curve configuration with a descending gradient to the north (direction of train movement) that varies from 0.0 to 1.0 per cent. The reverse curve consists of a two-degree, left-hand curve followed by a six-degree, right-hand curve. There is a public highway crossing in the left-hand curve and there are four private or farm crossings within one-quarter mile of the derailment in the right-hand curve (see Figure 2).

Figure 2. Derailment site

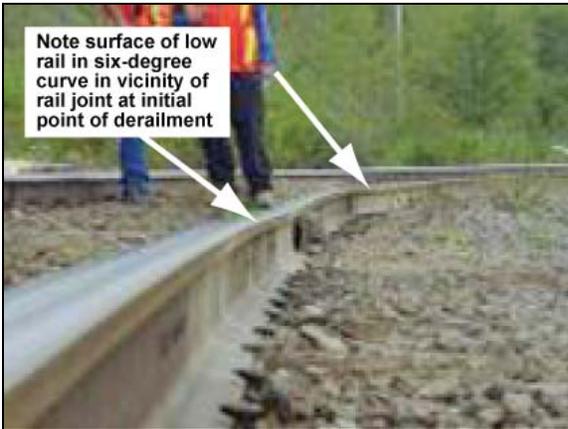
There were two rail joints, one located in each rail of the right-hand curve, staggered 10 feet apart. There was indication of vertical movement of the track structure under 12 ties on the field side of the low rail due to tie pumping. The web and base of the rail were muddy at this location as a result of the pumping. Additionally, there were small voids at the ends of the ties on the high rail indicating that the curve was moving slightly to the inside. The first marks on the head of the high rail were noted at Mile 153.2, approximately 11 feet north of a low spot on the low rail where the ties were pumping (see photos 1 to 3). The marks went to the field side of the high rail within 65 feet.

- There were two adjacent spots in the low rail where the difference in cross-level was $5 \frac{5}{8}$ and $5 \frac{7}{8}$ inches. In addition, there was $\frac{3}{4}$ inch of vertical movement under the ties due to the previously described pumping conditions.

Photo 1. View of track surface looking northward from low rail in six-degree curve

Canadian National (CN) has been addressing superelevation on the Lac-Saint-Jean Subdivision through undercutting, surfacing, and localized work. In 2005, 22 miles were undercut and 40 miles were undercut in 2006. Approximately 10 000 ties were installed ahead of the undercutter in 2005 and more than 15 000 ties in 2006. Furthermore, in the fall of 2006, CN advised that it has enhanced the track inspection on the Lac-Saint-Jean Subdivision by increasing the frequency of track geometry car tests.

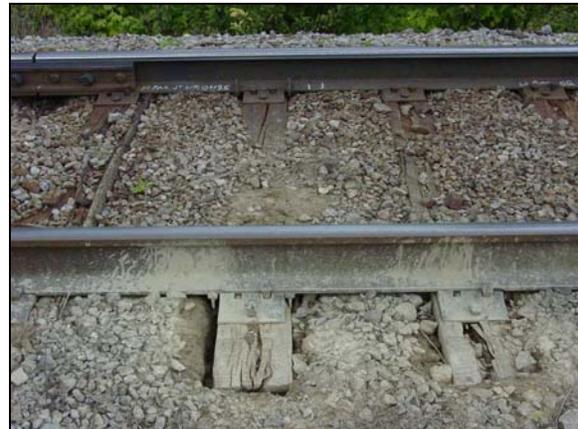
Photo 2. View of tie conditions on low rail of six-degree curve

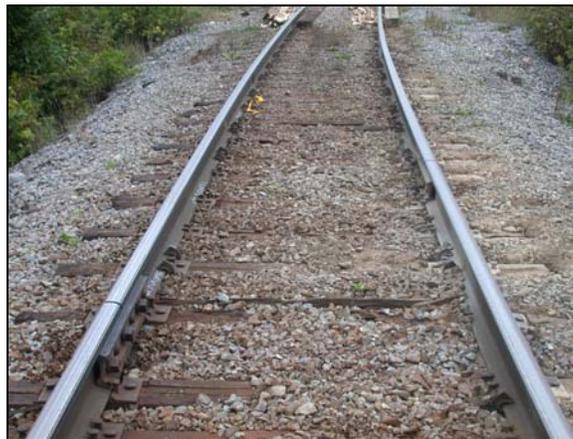
Photo 3. View looking northward showing location of rail joints

The natural rock-and-roll movement of the high-sided wood chip gondola cars was furthermore amplified by the pumping of the ties and the 10-foot spacing between the staggered joints, which was only slightly longer than the length of a freight car truck. As the cars were entering the exit spiral of the six-degree, right-hand curve, the combined effect of the excess superelevation and the pumping ties in the presence of the staggered rail joints resulted in wheel lift and the subsequent derailment of the loaded wood chip car to the field side of the high rail. As the car ran derailed, it damaged the track, resulting in the derailment of 11 other cars.

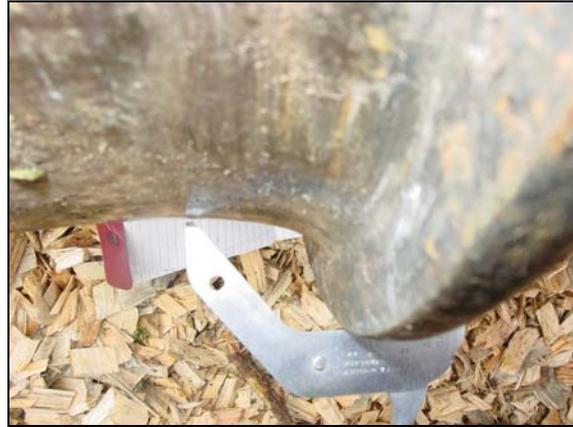
One derailed wheel set was noted to have a flange height of more than 1 ½ inches, exceeding the TC-approved *Railway Freight Car Inspection and Safety Rules* limit (a high-flange condition, see Photo 4).

Photo 4. High-flange condition on one wheel set

Although one of the derailed wheel sets was noted to have a high-flange condition, it was not considered to have been a contributory cause to the accident because wheels with high flanges are not typically prone to derailments involving wheel lift. The high flange and the condition of the centre plate rim, given its concealed location, were not detected during the safety inspection at Garneau Yard by qualified inspectors, highlighting the limitations of visual inspections in train yards to detect such conditions.

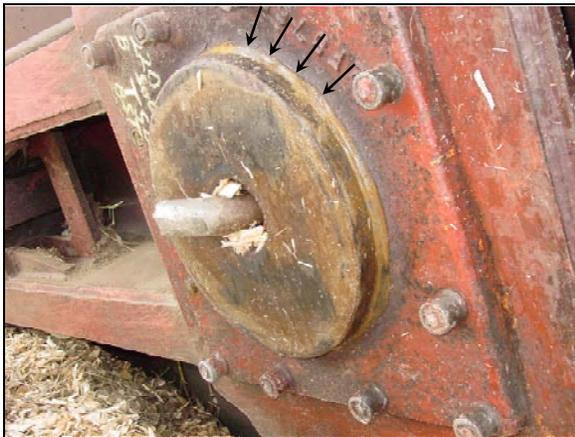
The centre plates on the second and third derailed wood chip cars were examined. Both the truck and body centre plates were noted to have wear beyond the vertical surfaces at the outer radii of the centre plates (see Photo 5 and Photo 6). The centre plate conditions would not have been easily identified during safety inspections of railway cars in a train due to their somewhat concealed location under the car body.

Photo 5. Body centre plate (B-end). Arrows point to wear area

- The wear areas on the centre plates were relatively equal and symmetric, suggesting that the wear was caused during rock-and-roll motion, which is not unusual for high-sided cars.
- The rim of the truck centre plate had been in long-term contact with the base of the body centre plate, which is a condition not allowed by the Association of American Railroad (AAR) rules.
- Even light rim contact off-centre can produce extra wheel unloading and increase rotational resistance moment of the truck.

The examination of the centre plates on the wood chip cars revealed that the cars were rocking and rolling to the extent that there was contact at the centre plate bowl rim locations. This modified the load distribution at the car body-to-truck interface and consequently affected the rock-and-roll and curving characteristics of the cars. Furthermore, the asymmetrical loading of the car contents was biased towards the low rail, resulting in wheel unloading on the high rail.

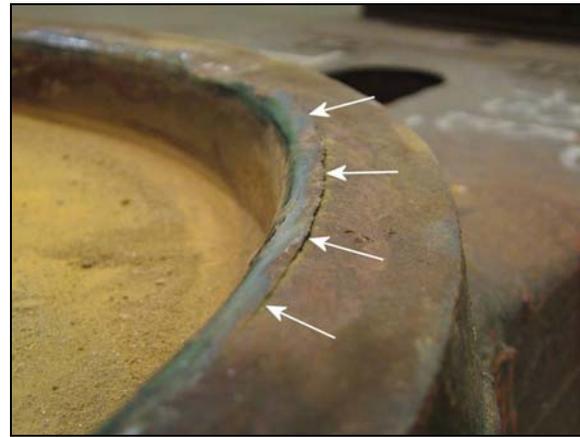
Photo 6. Edge of truck centre plate with raised lip that was smeared from contact wear
