RAILWAY INVESTIGATION REPORT
R07D0009

MAIN-TRACK TRAIN DERAILMENT

CANADIAN NATIONAL
FREIGHT TRAIN M-31031-10
MILE 99.13, DRUMMONDVILLE SUBDIVISION
DRUMMONDVILLE, QUEBEC
12 FEBRUARY 2007

Report Number R07D0009

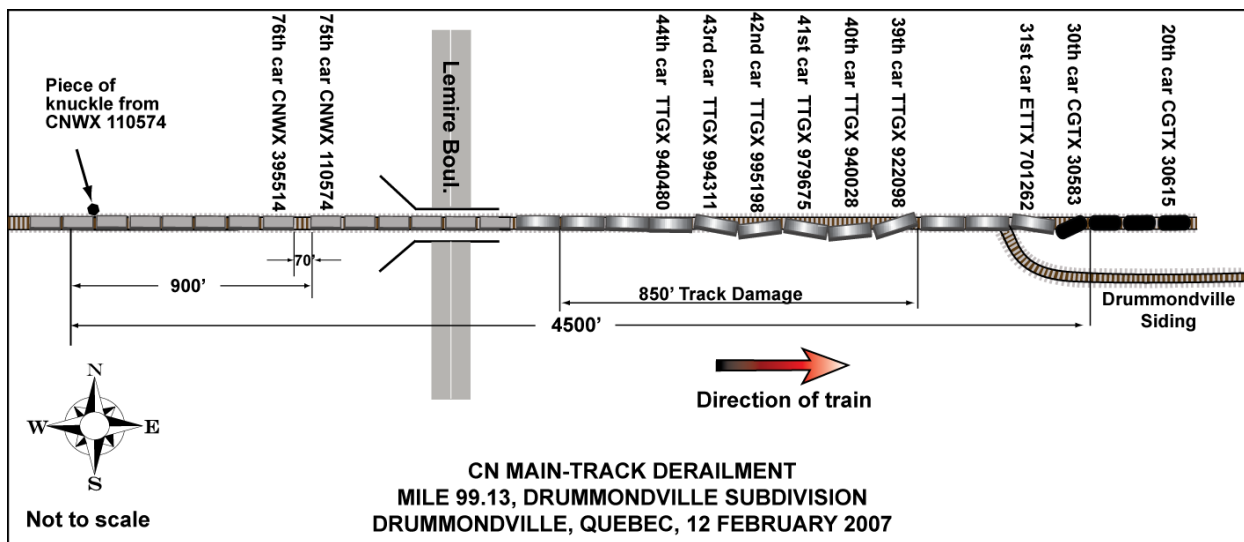
All derailed cars remained upright and sustained minimal damage. The cars jackknifed along the main track and derailed in two groups. The 30th car (CGTX 30583), a 59-foot-long empty tank car, and 31st car (ETTX 701262), a 93-foot-long loaded multi-level automobile car, separated and derailed at Mile 99.13. Wheel flange marks were observed on the head of the south rail between the two cars. The trailing end of the 30th car derailed to the south side of the track while the south-side wheels of the 31st car's lead truck dropped between the rails, near the Drummondville Siding west switch at Mile 99.20 (see Figure 2).

The second group (39th to 44th cars) were all 93-foot-long loaded multi-level automobile cars that derailed at Mile 99.24. Each of these cars came to rest across the track; the rails had rolled out from beneath them. The Drummondville Siding west switch and approximately 850 feet of main track were damaged. The derailed cars were examined and no pre-derailment defects were noted.

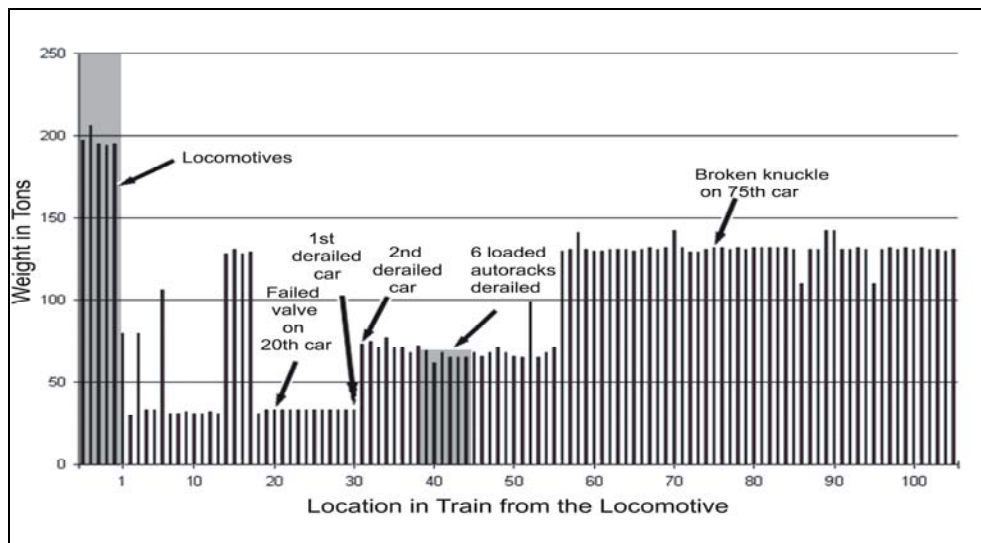
Figure 3. Train tonnage distribution

The train was marshalled with a mix of 23 empties and 7 loads in the head-end 30 cars, followed by a block of 25 loaded multi-level automobile cars equipped with long travel (10 inches) hydraulic end-of-car cushioning devices (EOCCD) and a block of 50 heavily loaded grain cars equipped with conventional draft gears on the rear of the train (see Figure 3).

The Association of American Railroads (AAR) *Train Make-Up Manual*³ indicates that cars equipped with EOCCD add to train slack and can greatly increase in-train forces. Specifically, the manual states that large blocks of EOCCD-equipped cars should not be placed ahead of large blocks of loaded cars with conventional draft gears.

Train marshalling practices and length affect the magnitude of the in-train forces. When trains are marshalled with light cars at the head end and heavy cars at the tail end, the head end will decelerate sooner and faster than the tail end, particularly if the locomotive independent brake remains on. The heavy cars at the tail end, with their greater momentum, will run into the slowing cars at the head end, generating high run-in buff forces. The amount of slack and the run-in buff forces are further increased on long trains, and on trains containing cars equipped with long travel hydraulic EOCCD. All of these characteristics were present in the train. While it was marshalled in accordance with CN and regulatory requirements, it was not configured in a way that minimized in-train forces.
