RAILWAY INVESTIGATION REPORT
R07H0015

RUNAWAY ROLLING STOCK

RUNAWAY CUT OF CARS

SMITHS FALLS, ONTARIO

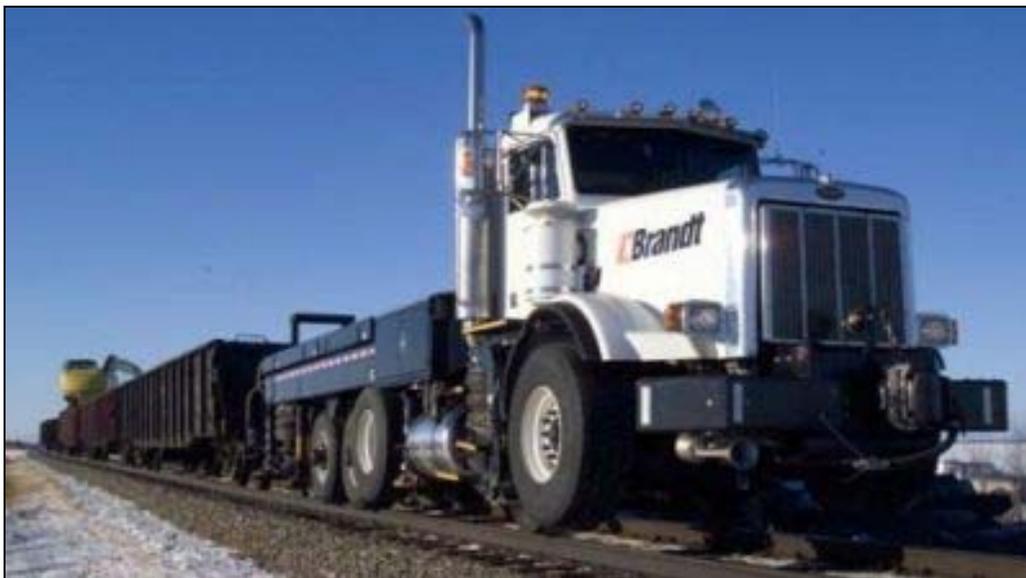
Photo 1. Brandt hi-rail truck

The cut of cars was handled using a highway tractor truck that had been modified to operate on rails. This reconfigured truck is known as a Brandt hi-rail truck (see Photo 1). On 03 July 2007, the Brandt truck had an air system failure that affected its braking capability and its ability to recharge braking systems on rail cars.

On 04 July 2007, when the Brandt hi-rail truck was used again to move the cut of cars, there was insufficient air supply to recharge the braking systems of the rail cars. In addition, due to the lack of air, the normal practice of performing a push-pull test¹ on the parked cars and testing the effectiveness of the securement of the three cars could not be made.

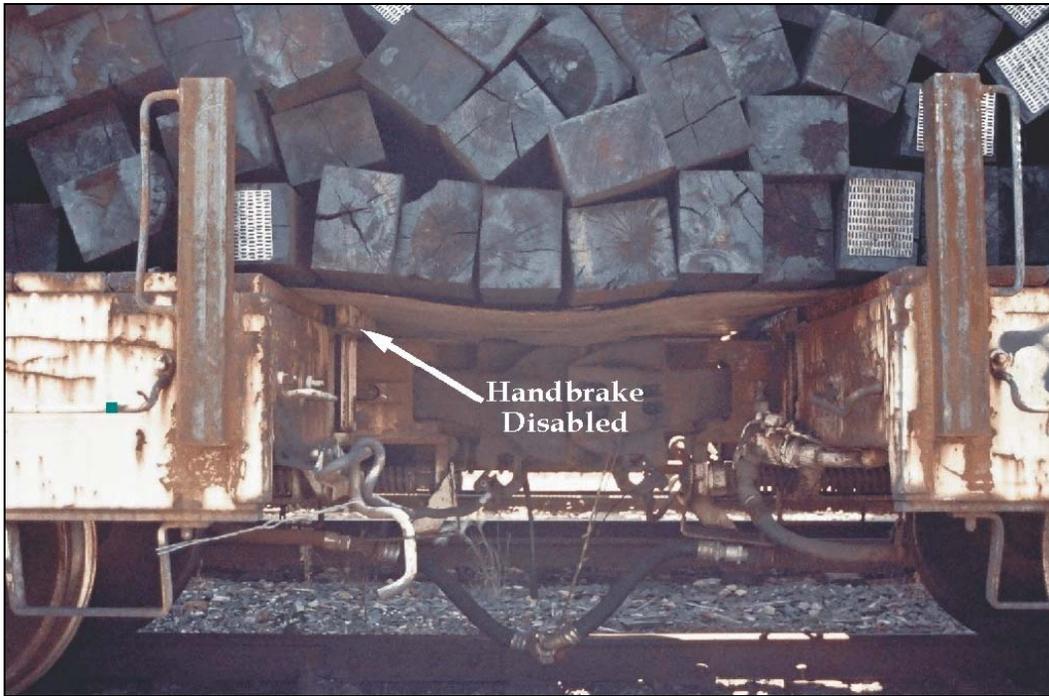
Photo 2. Custom modification to coupled cars

Post-incident examination of the rail cars revealed that two of the original three operating hand brakes had been made inoperative by a custom modification. The two areas between the three rail cars had been covered by steel plates to enable continuous loading of ties for the length of the three coupled rail cars (see Photo 2).

Because this type of rail car is equipped with a stem-type hand brake, the rail car modifications, implemented by the Engineering Services group, resulted in the disabling of two of the three hand brakes. CPR's Equipment Engineering group was not involved in the custom modification, and mechanical personnel had not inspected nor certified the rail cars after they were modified.

In addition, examination of the cut of cars revealed that two of the three stem-type hand brakes had been made inoperative by a prior custom modification by non-equipment personnel. The two areas between the three rail cars had been covered with steel plates to enable continuous loading of ties for the entire length of the three coupled cars. The single remaining hand brake was designed to apply the brakes on one truck only.

The flat cars had steel sheeting bridging the two areas between the cars to facilitate the handling of a larger load of ties continuously over the three cars. This modification, implemented by the railway's Engineering Services group, resulted in covering over the hand brake wheel located on the end of and between the cars. With this modification, two of the three original hand brakes were rendered inoperative. When custom modifications affecting rail car braking systems are performed without involving the railway's Equipment Engineering group, the adequacy of the braking systems may be compromised, leading to an increased risk of uncontrolled movements.

CPR removed the three 80-ton steel deck flat cars (SOO 5002, SOO 5010, and SOO 5017) from this service and replaced them with rail cars having side sill-mounted hand brake levers that applied the brake shoes to all wheels. In addition, CPR issued internal instructions to its Engineering Services group that modifications to car equipment must first be approved by its Equipment Engineering group.

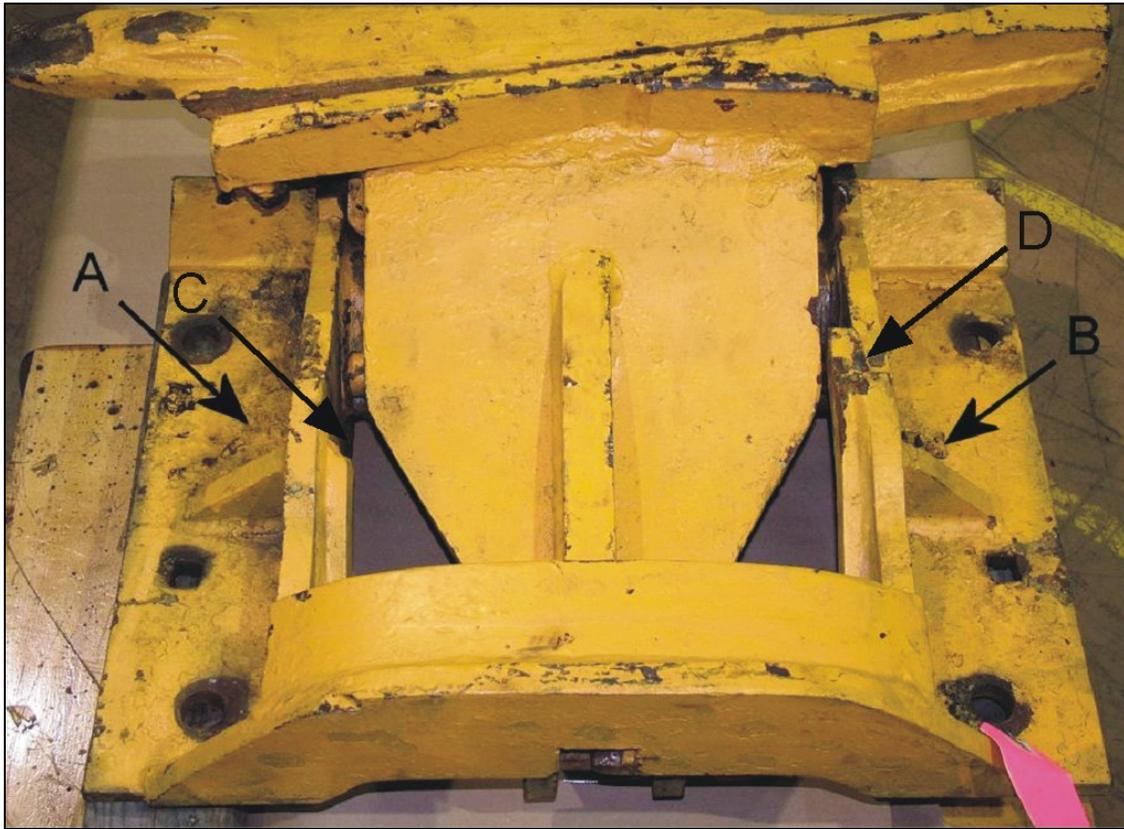
Photo 3. Sliding-type derail from installation at east end of Smiths Falls Yard

- The derail had been in the derailing position when the cut of cars passed over it.
- The sliding portion of the derail had dislodged from its functional location inside the derail casing.
- The derail casing had the end of one hold-down shelf broken away (refer to label "C" in Photo 3). This was old damage that had been painted over.
- The other hold-down shelf was bent with a broken weld (refer to label "D" in Photo 3). This was recent damage, likely from this incident.

- The crossties that supported the derail were not sound. Two of the securing spikes³ were missing (refer to positions indicated in Photo 3 as “A” and “B”).
- A cross-elevation of 11/16 inch was measured at the location of the derail, with the derail installed on the higher rail.

The derails installed at Smiths Falls Yard were incorrectly sized and were anchored to deteriorated ties using only six of the available eight fastener holes. In this state, the derail's ability to function as intended was compromised because the impact forces from the uncontrolled movement pulled the derail from the ties. Before this occurrence, the ties at the derail installation had been identified as requiring renewal. However, this maintenance had not been completed.

A cross elevation of 11/16 inch was measured with the higher rail being that with the derail. This would tend to crowd the wheels toward the opposite low rail. Sound engineering practice suggests that the derail be on the lower rail.

Subsequent to this occurrence, CPR changed out the two derails at Smiths Falls Yard. A switch point derail was installed at the occurrence location. At the second location, the previous No. 6 derail was replaced with a No. 8 derail.

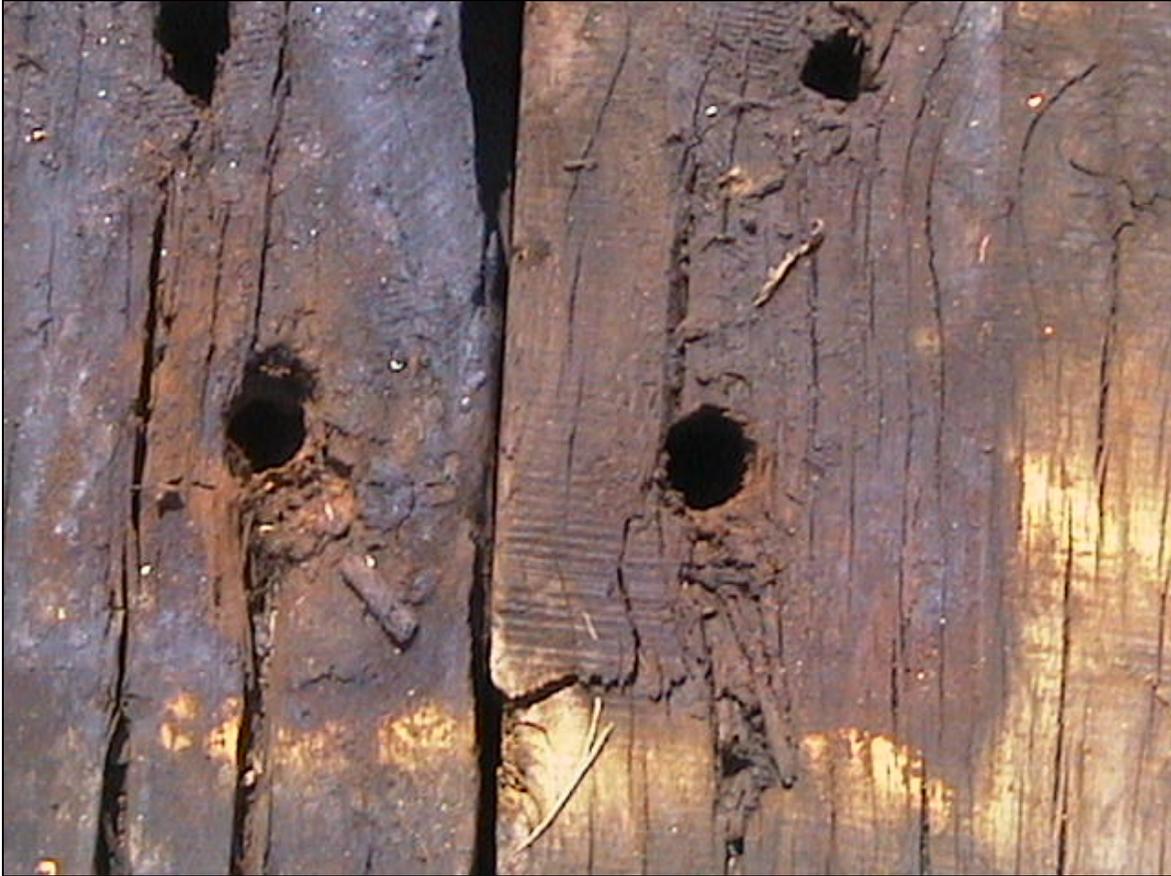
Photo 4. Deteriorated spike holes in crossties

In April 2007, CPR had conducted an annual yard inspection at Smiths Falls Yard. During this inspection, no defects were noted for the derail installation at the east end of Smiths Falls Yard. However, it was noted that the ties at the occurrence location were old and that the spike holes were deteriorated (see Photo 4). In addition, the inspection noted that the crossties at this location should be replaced. The crossties had not been replaced before the occurrence.
