RAILWAY INVESTIGATION REPORT
R07Q0001

MAIN-TRACK TRAIN DERAILMENT

CANADIAN NATIONAL
FREIGHT TRAIN M-308-31-06
MILE 78.13, MONTMAGNY SUBDIVISION
MONTMAGNY, QUEBEC
07 JANUARY 2007

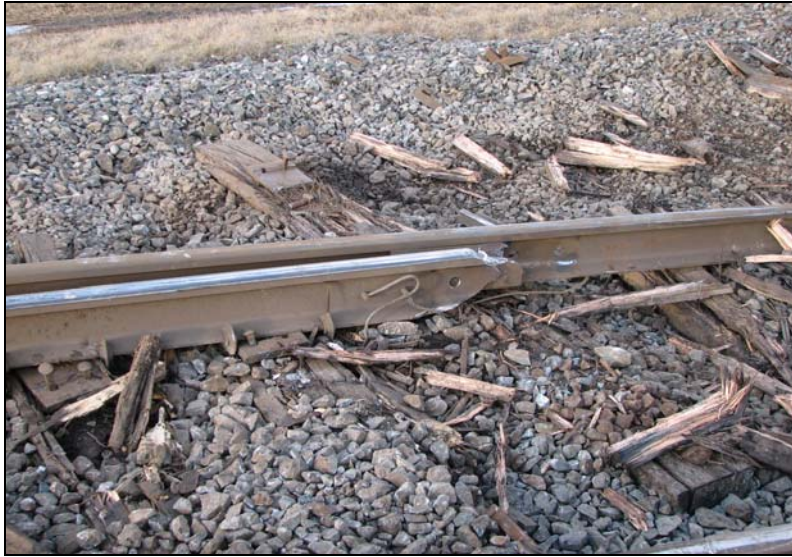
The tie immediately beneath the heel block joint was severely damaged during the derailment; however, it showed signs of previous degradation and had several old longitudinal splits (see Photo 1). This tie was the only switch tie that did not shift laterally during the derailment.

Photo 1. Track ties beneath the heel block joint

The condition of the switch plates, the plastic deformation of the bolt holes, and the degradation of the switch tie located immediately under the heel block were indicative of inadequate track support and pumping under traffic. The repetitive movement under each passing truck led to the looseness and the fracture of the bolts of the north heel block joint and increased the risk of crack development. Once initiated on the north switch point rail, the cracks propagated horizontally between the bolt holes and then vertically at the bond wire hole, breaking the rail and causing the derailment of the train.

The pumping in the north heel block area due to the degradation of the switch tie and the looseness of different components exacerbated load impact and contributed to the development of fatigue cracks.

A temporary slow order at 40 mph was set after the derailment and is still in force. The entire turnout was removed and replaced by standard track and all rail joints were eliminated in the Montmagny area to reduce track discontinuities and improve track quality. The frequency of inspection has been increased; the track will be inspected twice per month on foot and will be ultrasonically rail tested 12 times a year. Canadian National (CN) has amended switch designs and removed heel blocks.

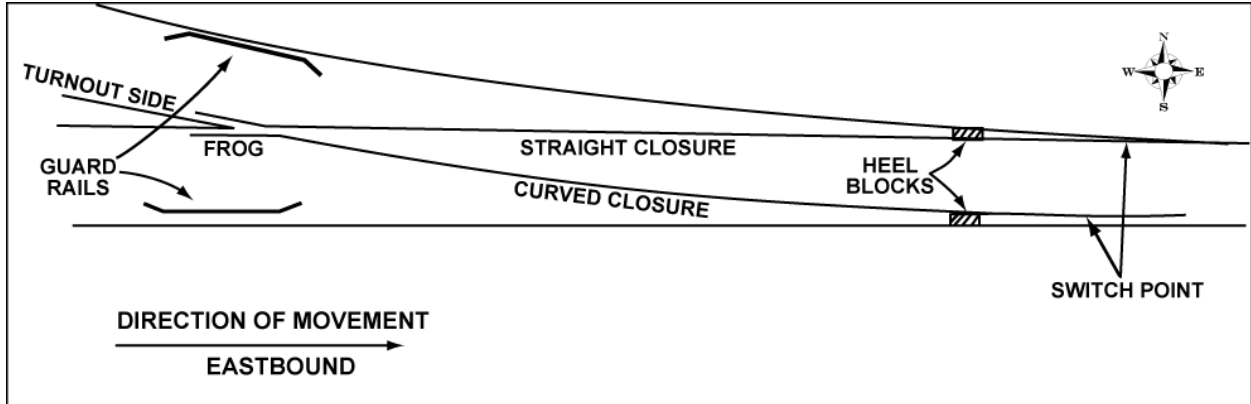
Appendix A - Turnout Diagram

The turnout located at Mile 78.13 was a CN No. 12, 115-pound, hand-operated (CN Standard Plan Drawing TS-012) with the switch points facing east (see Appendix A). There were no records on the origin and history of the north switch point rail. It was rolled in 1965 but was probably never installed in track before its installation at the accident site in 2004. It had less than 2 mm of wear.
